GEOTECHNICAL - NEOTECTONIC FOUNDATION CONDITIONS OF THE MENDENITSA CASTLE (FTHIOTIDA, CENTRAL GREECE)

I. MARIOLAKOS¹ & H. KRANIS¹

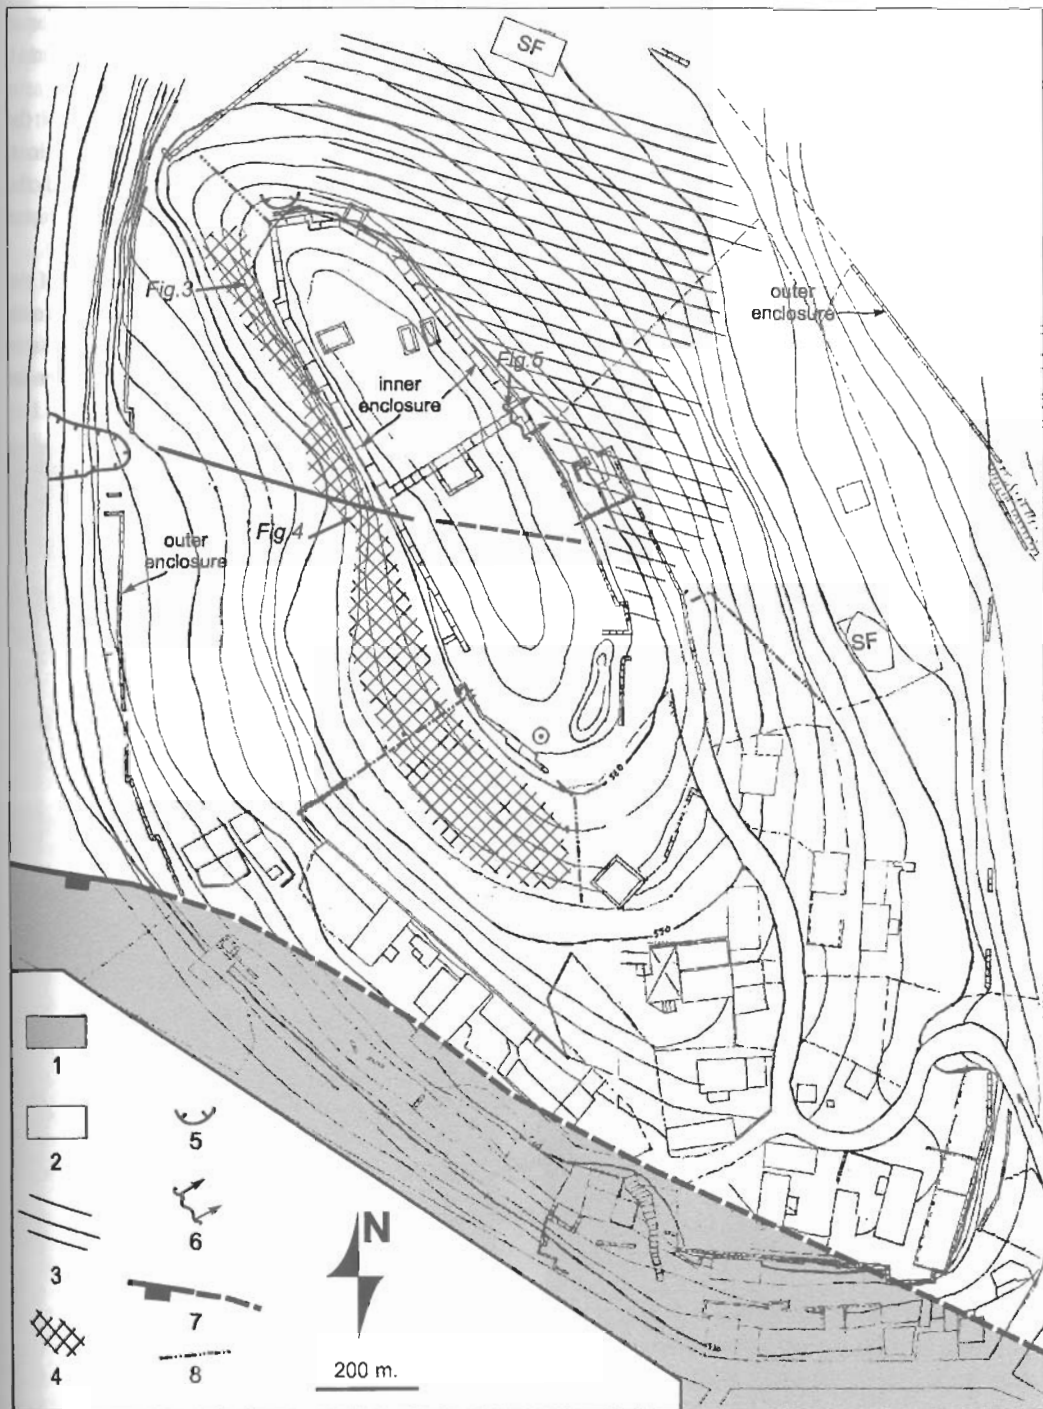
Fig. 2: Geologic - tectonic map of Mendenitsa horst. 1. Mendenitsa formation; 2. dolomites; 3. regolith; 4. cataclasite; 5. subsidence; 6. super-structure fracture and displacement; 7. fault; 8. wire fencing; SF: sheepfold. Contour interval: 2m.

The main tower also faces the danger of complete collapse, while local subsidence is observed at the northwestern edge of the castle (Fig. 2) and must have been caused by a collapsed tunnel dug to connect the castle with the nearby village (Karavidia).

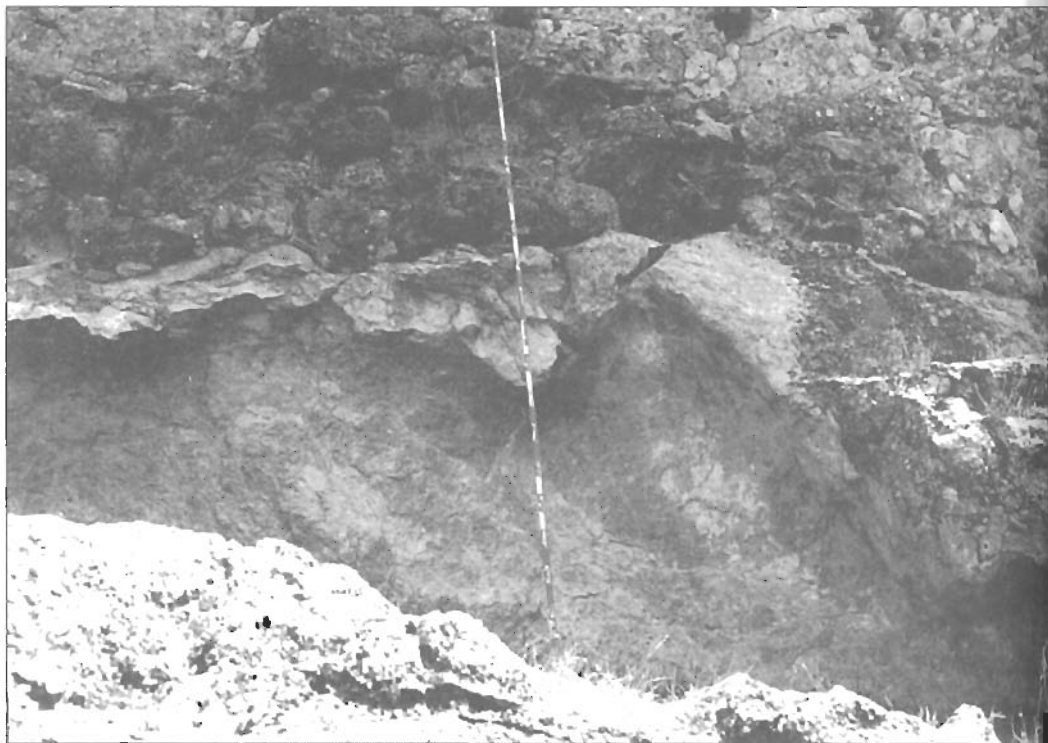
The castle has been founded on the tectonized dolomites (Fig. 3). On the northeastern slope of the acropolis occurs a 10-30 cm.-thick regolith, stabilised by the existing shrubs and other plants. This regolith is less developed on the southwestern slope, mainly because of the increased gradient there. At the same side of the hill, the terrain is craggy, with outcrops of the unweathered dolomites protruding all over the slope.

Fig. 3: Foundation of castle directly on the tectonised dolomite (cataclasite), 2-m. rod for scale. For location of photo see fig. 2.

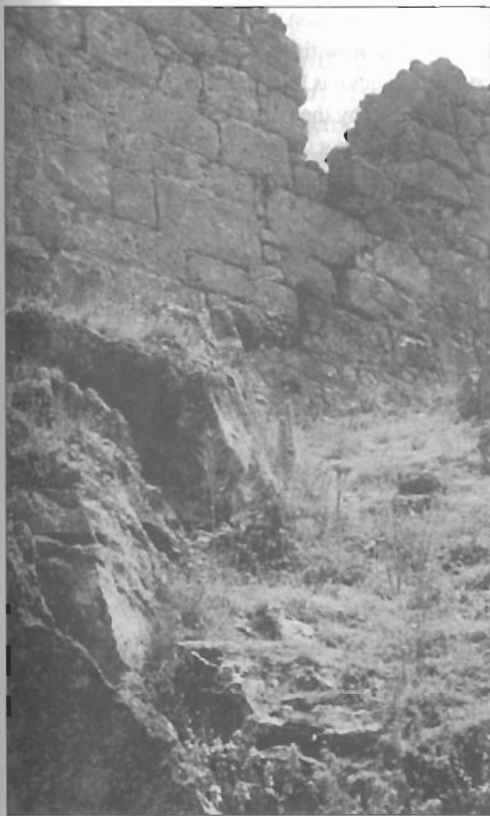
A smaller-order linear tectonic feature is located within the horst. It is a WNW-ESE fracture (Figs. 2 & 4) and appears to have affected the castle itself. It has displaced and destroyed a part of the southwestern inner wall and may be responsible for the collapse of a large portion of the southeastern inner wall.

Fig. 4: Fault within the Mendenitsa horst, affecting the superstructure. For location see fig. 2.

- The restoration of land use around the castle, that is removal of the sheepfolds and of wire fencing between the two enclosures.
- Stabilisation of the slope, with any appropriate means (mainly plantation)
- Instrumental monitoring of the fault that affects the superstructure itself, so that all necessary steps can be taken to avoid further negative consequences by fault creep.
- Immediate restoration works on the foundation of the northeastern wall and sealing and reinforcement of the fracture that threatens this part with total collapse.

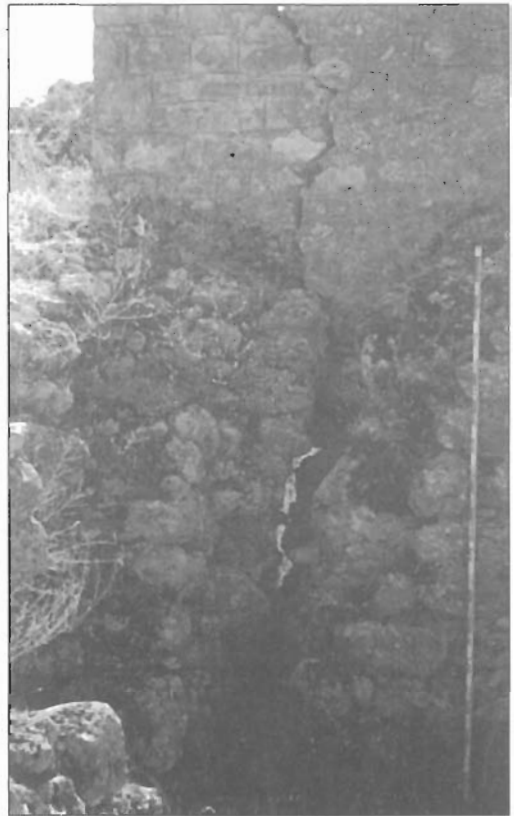
Fig. 5: Active fracture within the the superstructure. 2-3 m. scale bar. For location see fig. 2.
