## CONDITION OF THE SEA WALL AT FARM COVE, AUSTRALIA

D. DRAGOVICH<sup>1</sup>

The history and present condition of the sandstone sea wall at Farm Cove, are described. The wall has cultural and historical significance and forms the seaward margin of land reclaimed for the Royal Botanic Gardens over the period from 1849 to 1879. The landward fill reaches to high tide mark and the wall extends about a further metre above this level. Both stones and mortar are subject to very active salt weathering. Maintenance has involved block replacement, repointing, cementing over numerous lower course blocks, use of epoxy cement, and infilling of weathered surfaces. Pitting/hollowing is most frequent in the top course of stones. Past unsympathetic repairs include use of a weatherable reddish sandstone, and sawn blocks of durable pale sandstone.

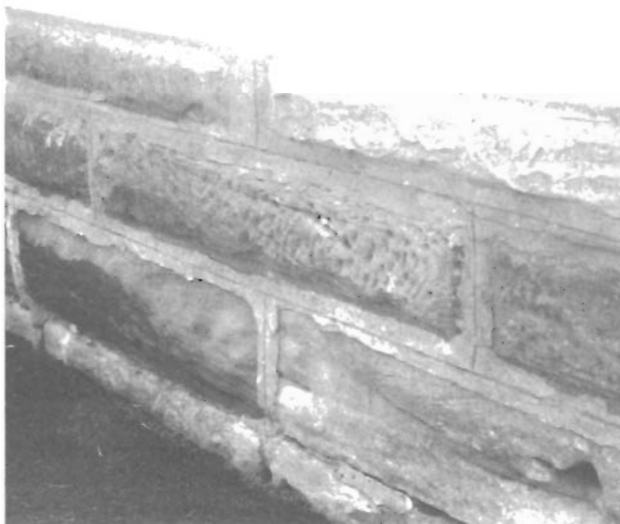
Many stones are insufficiently weathered to warrant replacement or cement-coating but do show pitting or hollowing (Figure 2). Pitting/hollowing was most evident at Site A, where all stones in the top course were affected and six stones in the middle course (Figure 3). Five of the cement-covered blocks in the lower course showed fretting/pitting. At Site B, eight of the middle course stones were pitted/hollowed, along with others in the top and lower courses. Nine of the ten stones in the top course at Site C had pitting/hollowing. The lower course at Site C was artificially pitted with tool marks from stone working but a number of these marks seemed to show enlargement from weathering. In total, pitting/hollowing was most evident in the top course of stones (Figure 3) with more than 80% of stones affected.

**Fig.2. Cement-coated block in top course, pitting in middle course, and surface recession of reddish sandstone in lower course. Wide re-pointing has been used to cover weathering.**
