SAFETY ASSESSMENT AND PROTECTION OF MONUMENTS LOCATED IN CAVES – A CASE STUDY FROM THE CITY OF VOLOS, GREECE

Loupasakis C.¹, and Nikolaou N.¹

Abstract

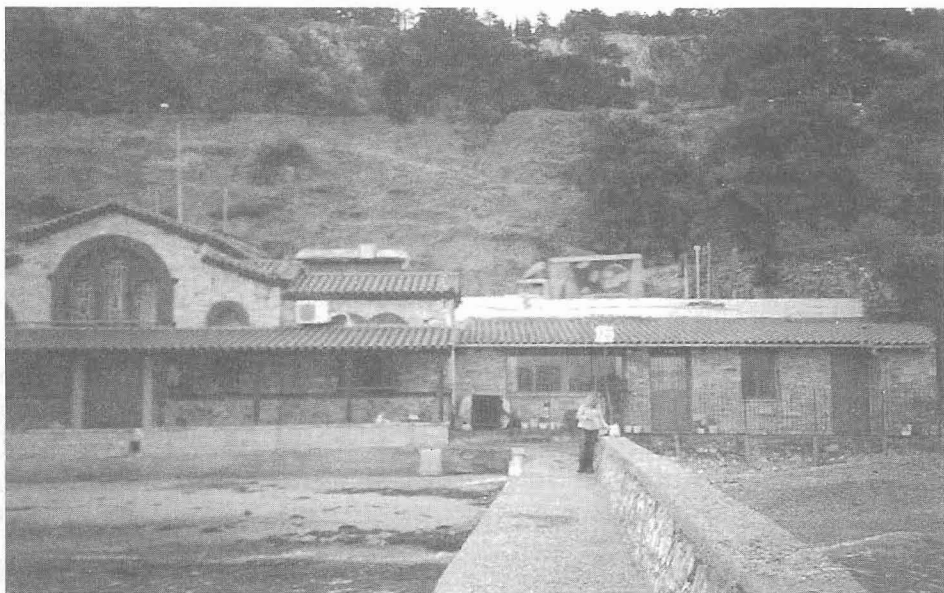
Figure 2 – Front view of the holy shrine. The coastline and the position of the national road are clearly presented

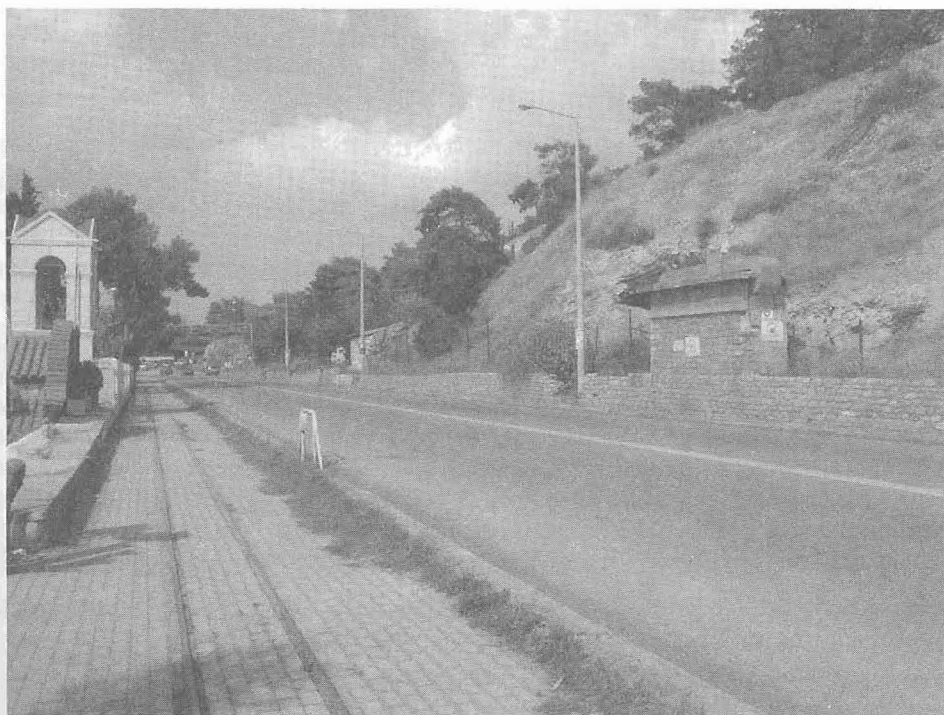
Figure 3 - The national road and the railway line passing over the ceiling of the cave

- Imposition of measures for the reduction of the over crossing vehicles' speed (warning traffic plates, speed control radars etc.). This measure aims to the reduction of the dynamic loading and the vibrations affecting the cave. Note that, because of the nearby industries the road is frequently crossed by heavy tracks.

- Installation of antivibration layer along the section of the road and the railway line over crossing the cave. This measure, also, aims to the reduction of the dynamic loading and the vibrations affecting the cave.

- Imposition of measures for the prohibition of the vehicles' parking over the cave (forbidding traffic plates etc.). This measure aims to the reduction of the static loading of the cave's roof.

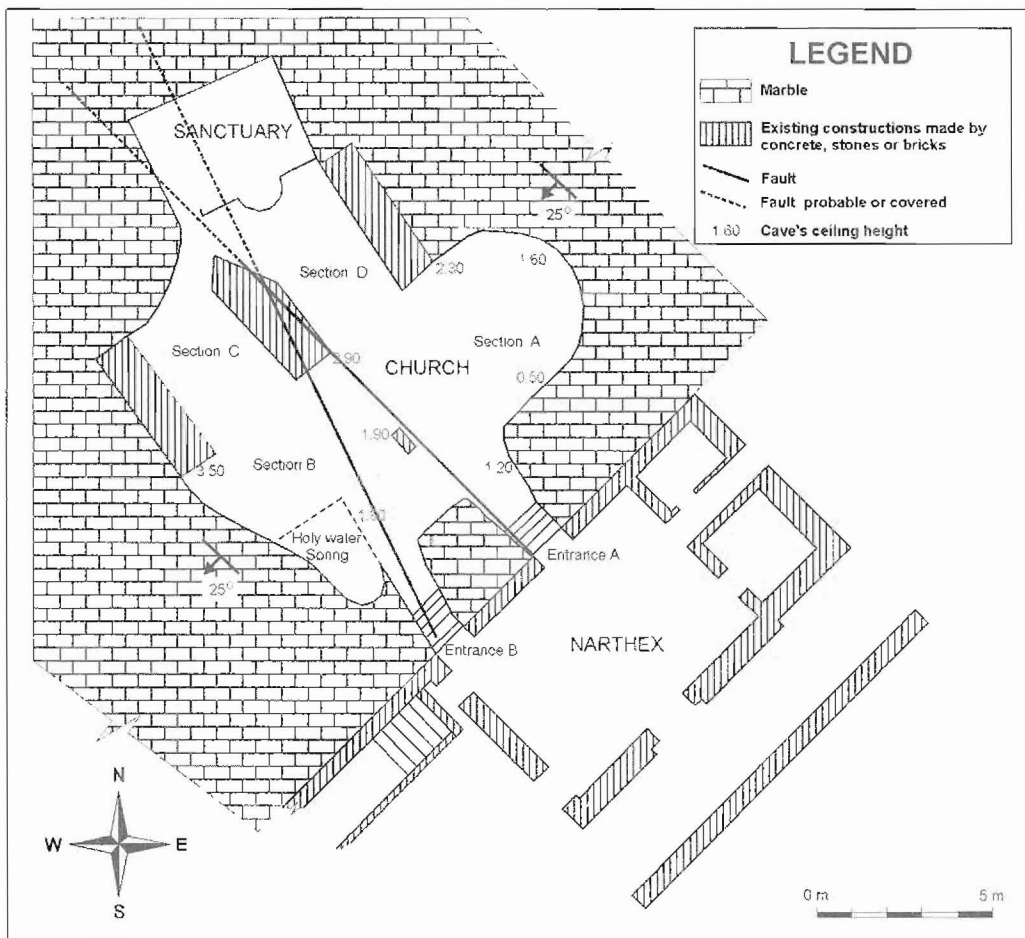
The cave is intersected by two faults, F_1 : 334/82 and F_2 : 315/70 (Fig. 4). The generation mechanism of the cave is related directly with the existence of those faults. As mentioned before

Figure 4 - Top view of the holy shrine presenting the morphological and the geological settings of the cave

Based on the stability of the roof, the cave can be distinguished in two main sections. The first one includes sections C, D and the Sanctuary and the second one the sections A and B. The main difference between the two sections is the distance between the ceiling of the cave and the level of the over crossing road. The inner section of the cave (consisting of sections C, D and the Sanctuary) is higher and as a result the marble layer on the ceiling is thin. On the contrary, the outer section of the cave (consisting of sections A and B) is shorter and the marble layer is much thicker. Generally, the height of the cave decrease respectively to the dip direction of the bedding and the thickness of the marble on the roof decrease proportionally to the height (Fig. 4).

The floor level of the cave is almost 50 cm under the floor level of the narthex. As mentioned before, the narthex was constructed over the sea level in order to protect the cave from the waves. So, the cave traps the underground waters gushing out temporarily along the faults, causing the cave to flood. For that reason the cave's floor is surrounded by a drainage channel leading the water to the sea. Before the installation of the church a temporary spring was located in the south corner of the cave at the "holy water spring" location (Fig. 4).

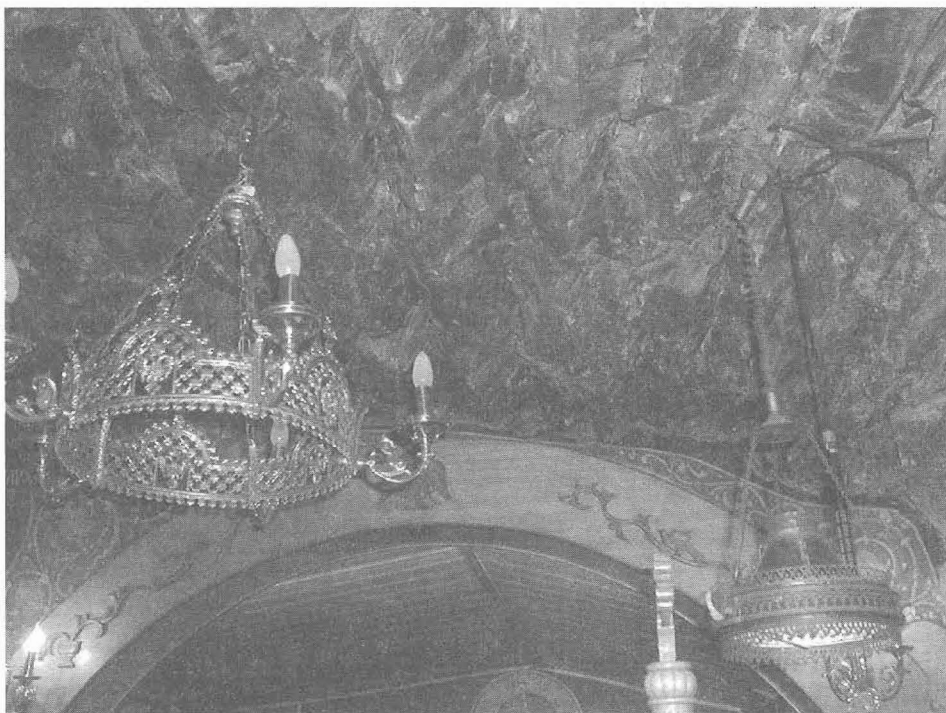
The reduced thickness of the marble layer on the ceiling of several sections caused, in the past, serious stability problems. Those problems were probably located during or right after the construction of the over crossing road and they led to the construction of rigid arcs consisting of marble blocks and concrete. In figure 4 it is shown that those arcs extent only in the sections C, D and the Sanctuary. Sections C and D are separated by a column constructed in the middle of the inner section in order to decrease the span between the walls and in order to increase the bearing capacity of the arcs. The Sanctuary, because of its reduced size, is supported only by one arc. The inner section of the cave is sufficiently supported by those arcs. The oversized columns, the reduced height of the cave and the reduced span of the arcs provide a stable and safe environment. No rock falls have been reported in this section of the cave.

Those arcs are covered by stones of the surrounding marble, by wood or by hagiography and they fit completely with the interior of the holy shrine. Figure 5 presents a view of the ceiling on section D and on the Sanctuary (section D is covered by marble stones and the Sanctuary is covered by wood). Also, figure 6 presents a side view of the arc covered by hagiography.

Figure 5 - Ceiling view of the Sanctuary and of section D. Sections supported by rigid arcs constructed by marble blocks and concrete. The Sanctuary is covered additionally by wood

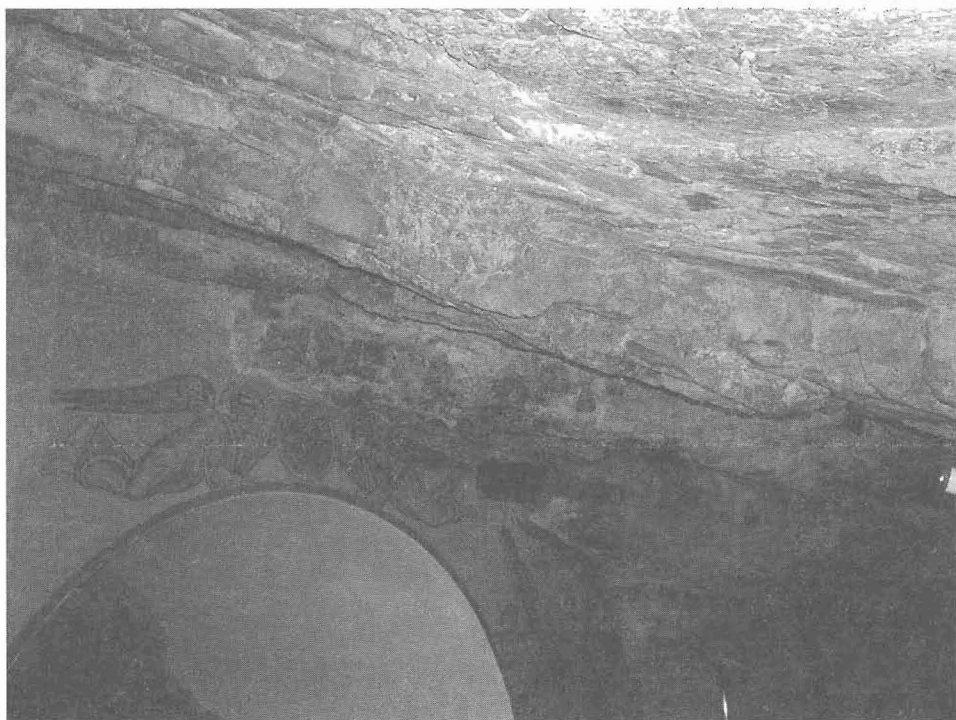
The outer section of the cave is unsupported and the shape of the ceiling is completely formed by the bedding surfaces. Although that, the mechanical characteristics of the marble rock mass are very good, the intersection of the cave's roof by the faults, the relatively large unsupported bedding plates and the extensive spans between the walls of the section generated several stability problems.

Figure 6 - Ceiling view of section A. Unsupported Section. This picture clearly presents a side view of the arc supporting section D, covered by hagiography

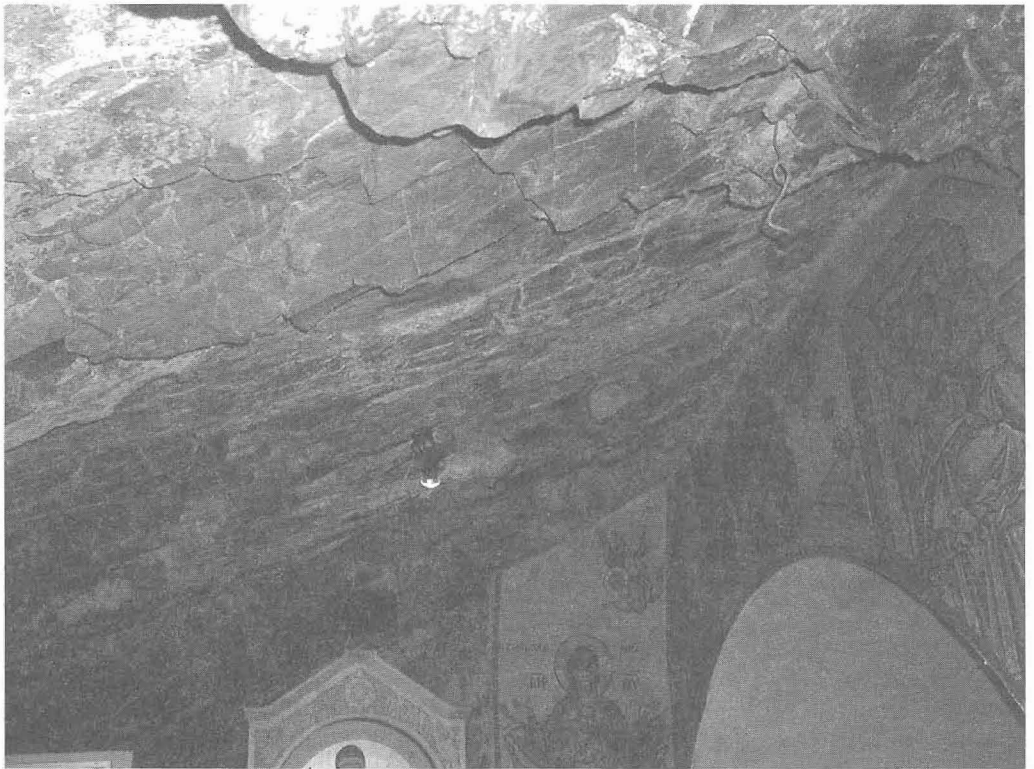
According to the church-wardens, numerous small to medium size gravels failed from the ceiling during the last year, causing relatively small damages to the floor and to the pews of the church. Luckily no injuries were reported. Those gravels were detached from the areas surrounding the two faults and from the north western corner of section B (Fig. 7). Mylonitic materials or joints with very low spacing characterize the intensive fracturing of the rock mass in those areas.

Figure 7 - Ceiling view of section B. Unsupported Section. The north western corner of the section, appearing the rock falls, is clearly presented

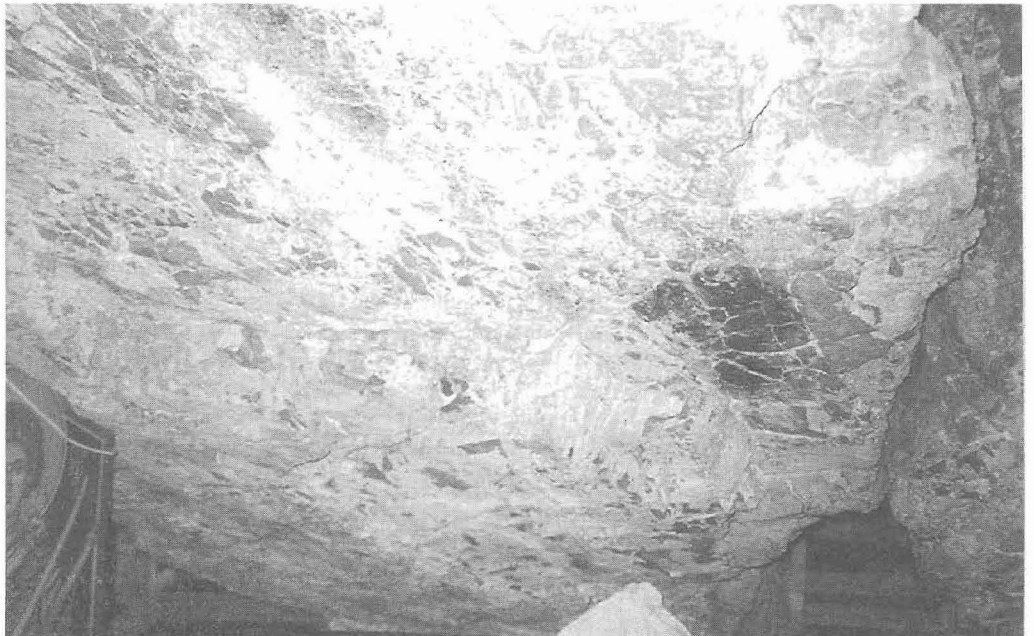
Figure 8 - View of the wedge formed by the faults intersecting the cave. The concrete column constructed for the support of the wedge is visible on the left side of the figure

- Installation and systematic observation of geodesic mark along the ceiling of the cave, for the prevention of large rock mass movements. Although that, the stability of the wedge does not appear to cause any problems, all extra precautional measures must be taken in order to reassure the safety of the numerous visitors.

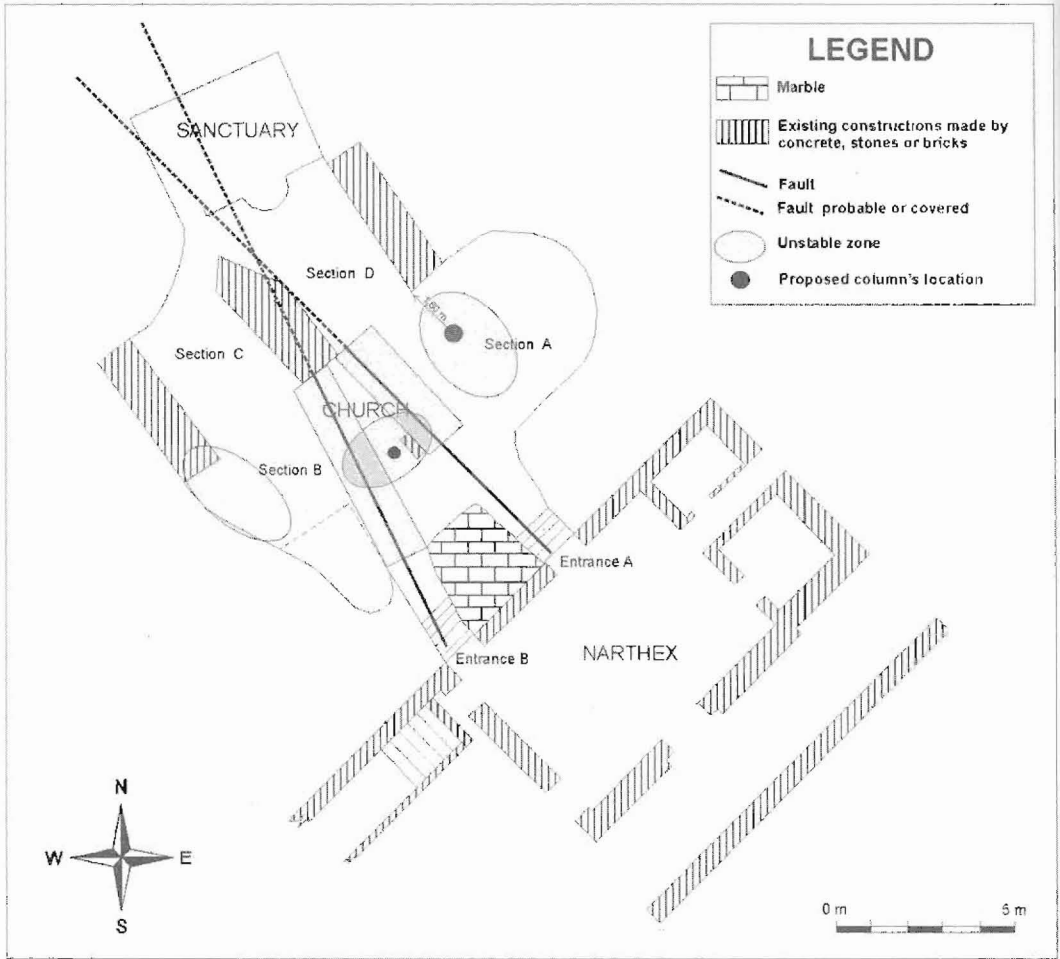
Except from the areas with the intensive fracturing, there were located two areas where gradual bending of the bedding plates and proportional loosening of the rockmass along the bedding surfaces is observed. Those areas are located in the middle of wide unsupported arcs. The first one of the above mentioned arcs is located in the middle of section A and the second in the middle of the wedge located between sections A and B (Fig. 8). Although that, along the wedge a concrete column was constructed for the prevention of the loosening of the rock mass, the position and the orientation of the column did not efface the problem. The exact locations of all the above mentioned unstable areas are pointed on the top view of figure 9.

The stability of the wedge does not appear to be a threat because it is supported by three columns. Two of them are constructed by concrete or by marble stones and concrete and the other one constitutes a natural extension of the wedge's marble. Those columns are clearly presented in figure 9.

Figure 9 - Top view of the holy shrine presenting the position of the unstable zones and the proposed support measures (Loupasakis and Nikolaou 2005)

- Construction of one concrete column in the middle of each one of the two unsupported arcs, for the prevention of the rock mass loosening. The exact locations of the columns are presented in the top view of figure 9.
- Systematic inspection and removal of the over hanging rock blocks, especially along the intensively fractured zones. The rock blocks must be removed without the imposition of force which can cause further loosening of the rock mass.
- Application of soldering resins along the zones with the mylonitic materials. The intensive fracturing of the rock mass along the faults makes the hand collection of the blocks impossible.
