12th INTERNATIONAL CONGRESS OF THE GEOLOGICAL SOCIETY OF GREECE  
PLANET EARTH: Geological Processes and Sustainable Development

## GEOLOGICAL AND GEOTECHNICAL BEHAVIOUR OF EVINOS DAM FOLLOWING THE IMPOUNDMENT

Angelopoulos A.<sup>1</sup>, Soulis V.J.<sup>2</sup>, Malandraki V.<sup>3</sup>

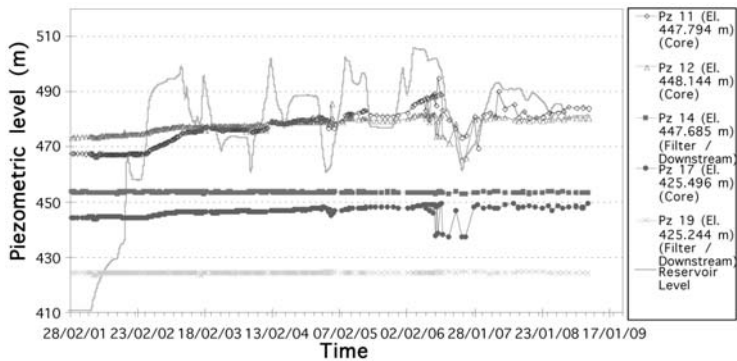
A large number of vibrating wire piezometers were installed in the shoulders and the core of the dam. The pore water pressure development differs through the dam due to the partial saturation and the low permeability values of the core. Piezometers Pz11-19 are placed in Section VI of the Evinos dam. In fig. 2 piezometers Pz11, Pz12 and Pz17 initially show no response in the changes of the reservoir level. In March 2006 the reservoir has overflowed. This period lasted for 3 months initiating the response of piezometers to the changes of the reservoir level. Piezometer Pz11 is more sensible to changes of reservoir level. This behaviour indicates that a flow net has been gradually started to establish in the core even for higher values of the reservoir level. Piezometers Pz14 and Pz 19 which are installed in the filter zone (free drainage material), showed a constant piezometric level through time. In fig. 3 the changes in the piezometric level of piezometers Pz31-33-34 are

**Fig. 2:** Evolution of piezometric level in piezometers located in Section VI of the dam.

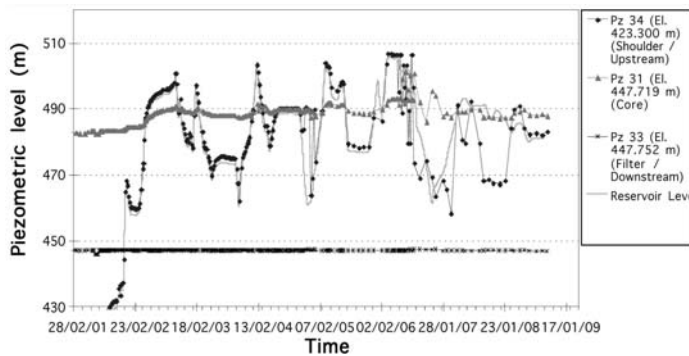
**Fig. 3:** Evolution of piezometric level in piezometers located in Section IX of the dam.

shown. These piezometers are placed upstream, downstream and at the core of the dam's body in section IX. Piezometer Pz34 which is installed upstream generally follows the fluctuation of the reservoir level. However, there was a period of drop of the reservoir level in the end of 2007 that Piezometer Pz34 didn't follow. Piezometer Pz 33 is placed in the filter zone downstream the dam's body. It shows no changes in its piezometric level as it is a free drained material. The study of the pore pressure development generally confirms the successful response of dam's core.

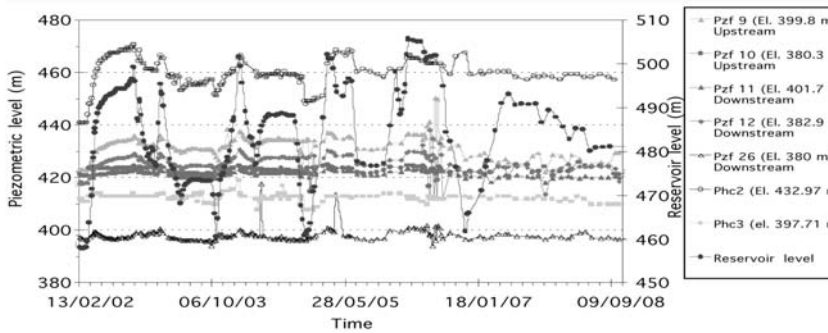
Piezometers are also placed in the foundation of the dam to inspect both the piezometric level in the foundation and the effectiveness of the grout curtain. In fig. 4 changes of the piezometric level measured in piezometers placed along Section VI can be depicted. Piezometers Pzf 11, Pzf 12, Pzf 26 show constant piezometric level through time. Piezometers installed upstream Pzf9, Pzf 10 show roughly constant piezometric level (about +420), which is influenced by the level of rainfall. Hydraulic piezometers are also installed through the grout curtain tunnel. Phc 2 follows the changes observed in the reservoir level. Phc 3 is less sensible to changes of the reservoir level. The response of piezometers placed in the foundation of Evinos Dam show little infiltration from the reservoir.

Fig. 4: Evolution of piezometric level in piezometers located in the foundation of the dam.

- Piezometers placed downstream the grout curtain show considerably low piezometric level which demonstrates the efficiency of the grout curtain.
- Surface monumental stations placed on the dam crest (S68-72 downstream), indicate “extension” of the dam’s crest towards downstream, as well as a normal evolution of settlement.

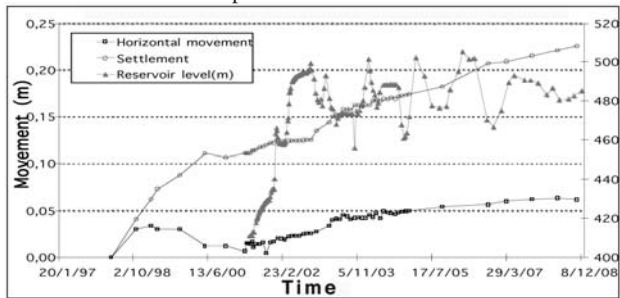
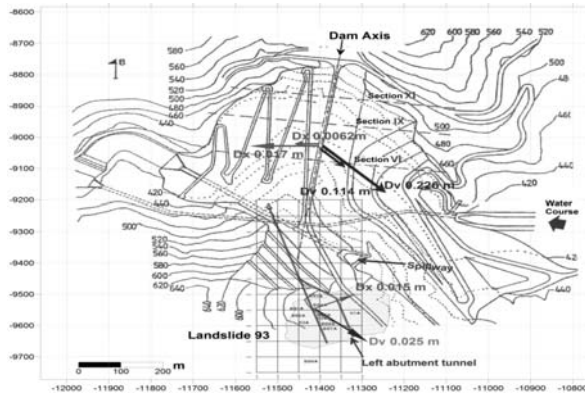
Fig. 5: Cumulative mean displacements and settlement in the dam's Crest.

Additionally the evaluation of the stability of Evinos Dam is carried out through the systematic measurement of horizontal and vertical movement of the dam's crest. In the dam's crest a number of surface monumental stations have been positioned upstream and downstream the dam's longitudinal axis (S24 -S33 upstream, S64-S73 upstream, Dounias, 2006). In fig. 5, the evolution of horizontal and vertical movements in respect with time are depicted for the same group of stations. The horizontal movement of the dam's crest is gradually increasing through time, although its magnitude is negligible. The settlement of the dam is increased following the impoundment of the reservoir. A slight increase of settlement rate is recorded even in the 4th period of operation in the dam's crest (February 2005-November 2008, Angelopoulos et.al., 2007,2008). During this period of operation the maximum settlement recorded is of the order of 5.2cm. The total settlement of the dam's crest is of the order of 22.6 cm and is regarded as safe. In fig. 6 the cumulative horizontal displacements  $D_x$  and settlement  $D_v$  for the group of stations S68-S72 in the dam's crest is presented. In the same figure the cumulative displacements  $D_x$  and settlement  $D_v$  for the group of stations B03-B07 in the area of the landslide of the left abutment '93 is also presented. The small vector denotes the displacements values and settlement in the date of impoundment (11/2001), the large vector denotes the displacement and settlement in the end of 2008 (12/2008).

**Fig. 6:** Cumulative displacements  $D_x$  and settlement  $D_v$  for the group of stations S68-S72 in the dam's Crest, for the group of stations B03-B07 in the area of 1993 Landslide.

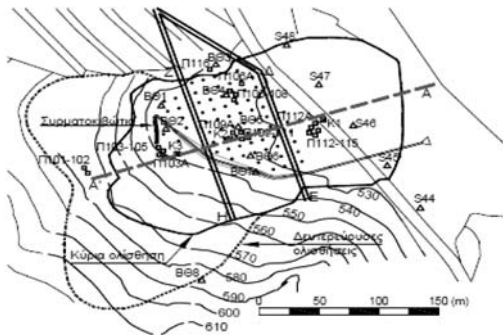
**Fig. 7:** Drainage tunnels and piezometers located in the area of the Landslide of the left abutment '93.

In August 1993 a landslide occurred in the left abutment of Agios Demetrios just before the entrance of the spillway. The stabilization works included the construction of a drainage tunnels together with the construction of wells. The behaviour of the stabilization measurements are monitored by in-situ measurements in a) piezometers, b) inclinometric - settlement columns, c) surface monumental stations, d) devices measuring the flow in the exit of the drainage tunnels. In fig. 7, the stabilization measurements are depicted together with the positions of piezometers and surface monumental stations (Dounias & Dede, 2006).

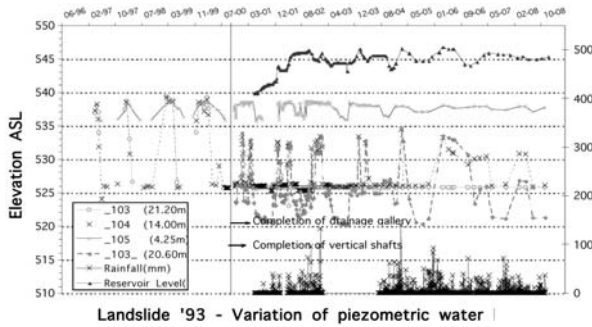
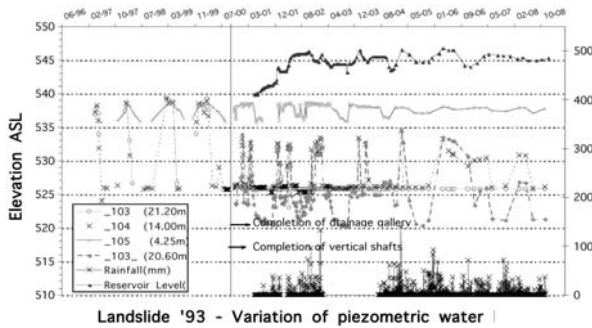
The piezometric levels are continuously monitored after the completion of stabilization works. Piezometers are placed in different depths within the landslide's body. The deepest one is placed inside the substratum. In figs. 8, 9 the fluctuation of peizometric level in respect with time can be depicted. In the same figures the fluctuation of rainfall and the fluctuation of the reservoir's water level are recorded during the monitoring period. The stabilization works succeeded in reducing the piezometric level of deep piezometers that exhibit an immediate response in respect to the rainfall but they also exhibit an immediate pore pressure decrease. The piezometers located in depth up to 15.00m (i.e Π105 depth 4.25m, Π108 depth 12.30m, Π111 depth 12.20m, Π115 depth 11.40m) ex-

Fig. 8: Piezometric measurements of group Π103-Π105

Fig. 9: Piezometric measurements of group Π112-Π115.

cept the piezometer Π104 (depth 14.00m) show reduced fluctuation of piezometric level after the completion of drainage tunnels. Piezometers placed in deeper levels (i.e Π106 depth 30.00m, Π109 depth 32.80m) do not exhibit any fluctuation of their piezometric level and they are considered as dry. In spring 2006 the dam has overflowed for a total period of three months. Piezometers Π103A and Π104 maintained their high piezometric level besides the substantial drop in the reservoir's level.

- Drainage interventions are considered effective; as it is proved they have led to a considerable water level decrease in the deeper piezometers in both landslides.

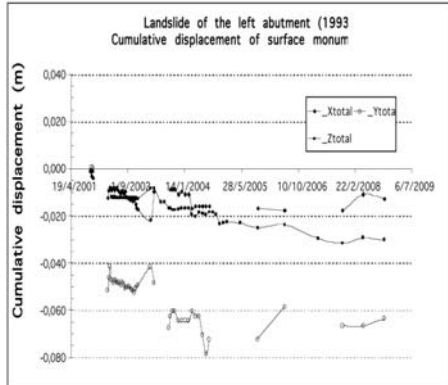
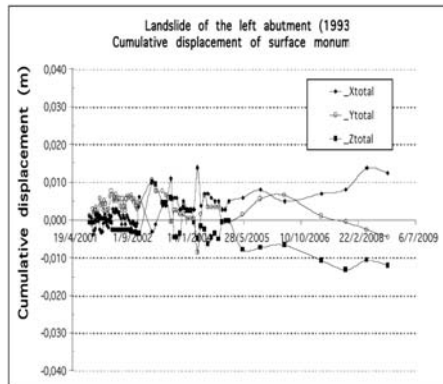
Fig. 10: Measurement of displacements in station K1 nearby piezometers Π112-115.

The surface monumental stations (K1, K2, K3 and BΘ1-BΘ8) have been placed inside the area of the landslide aiming to capture possible excessive settlement and horizontal movement (Figs 10, 11).

**Fig. 11:** Measurement of displacements in station K2 nearby piezometers Π109-111.

The stabilization works succeeded in reducing the overall movements to values between the limits of the instrumental measuring fault. Station K1 is located near by the group of piezometers Π112-115, while station K2 is located nearby the group of piezometers Π109-111.

- The horizontal displacements and settlement measured in surface monumental stations (K1, K2, K3) suggest that the landslide of the left abutment '93 is not active.

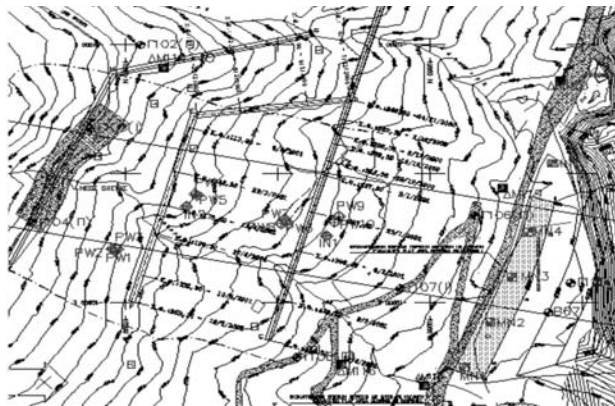
**Fig. 12:** Drainage tunnels and piezometers located in the area of the Road Landslide.

The landslide occurred at the Agios Demetrios – Arahova Country Road during the construction of the Evinos reservoir project (1993). The stabilization interventions included the construction of toe berms, drainage tunnels, and surface runoff collection works. The behaviour of the stabilization interventions are monitored by in-situ measurements in a) piezometers, b) inclinometric-settlement columns, c) surface monumental stations, d) devices measuring the flow in the outlet of drainage tunnels. In fig. 12, the stabilization interventions are depicted together with the piezometers and surface monumental stations (Dounias et al., 2006).

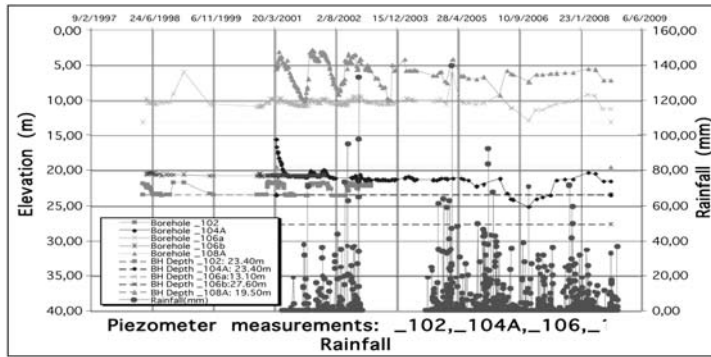
Fig. 13: Piezometric Measurements of Group Γ102, Γ104A, Γ108A and Γ106a & b.

Piezometers are installed in the area of Agios Demetrios-Arahova Country Road Landslide to record the fluctuation of piezometric level upstream and downstream the drainage tunnel. In fig. 13, the history of fluctuation of the piezometric levels of piezometers Γ102, Γ104A, Γ108A and Γ106a & b is presented. In the same fig. 13 the rainfall level curve is also depicted. The piezometers that are located in depth levels greater than 15m are affected by the drainage tunnel and show decreased piezometric levels in respect with piezometers placed in depth levels smaller than 15m. The measurements of piezometers placed deeply in the area of landslide are affected by the reservoir’s water level rise.

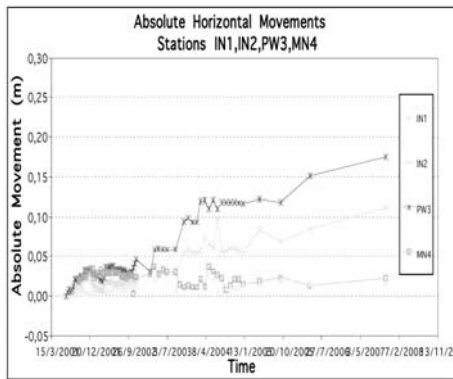
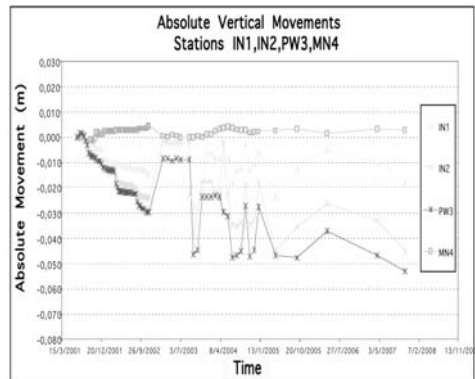
Fig. 14: Measurement of horizontal displacements in the area of Road Landslide.

Fig. 15: Measurement of settlement in the area of Road Landslide.

In figs 14, 15 the horizontal displacement measurements together with the settlement measurements are shown for the area of the landslide. The horizontal displacements measured downstream the drainage tunnels appear to be reduced in MN4, IN1 stations compared to the horizontal displacements measured in stations located upstream the drainage tunnels (PW3, IN2 upper part of landslide). The settlement (1,9 cm) of the lower parts of landslide MN4, IN1 are smaller compared to the settlement recorded (5.3cm) in stations PW3, IN2.

- The horizontal displacements and settlement measured downstream the drainage tunnels in the area of Agios Demetrios-Arahoa Country Road Landslide appear to be reduced in comparison to the horizontal displacements and settlement measured in stations located upstream the drainage tunnels.

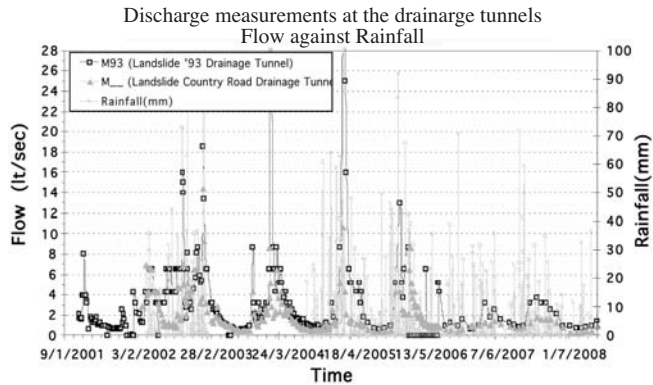
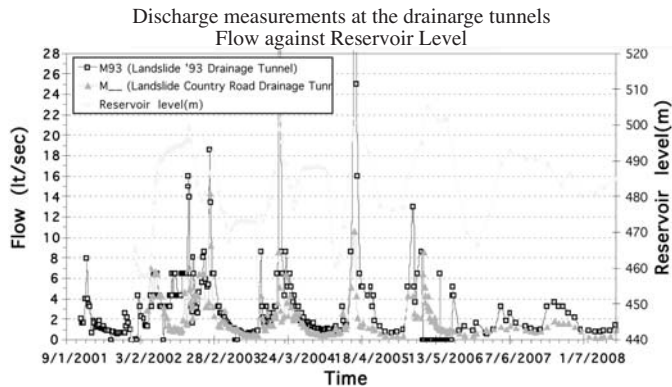
**Fig. 16:** Discharge measurements at the drainage tunnels in the areas of 1993 Landslide, and Country Road Landslide in relation to the rainfall.

**Fig. 17:** Discharge measurements at the drainage tunnels in the areas of 1993 Landslide, and Country Road Landslide in relation to the reservoir level.

In figs. 16, 17 the discharge measurements at the drainage tunnels of: a) Landslide of the left abutment '93 and b) Agios Demetrios-Arahova Country Road Landslide are depicted respectively. It is observed that the discharge at the outlets of these two drainage tunnels depends on the level of rainfall and exhibits immediate response. The discharge of the drainage tunnel within the landslide of the left abutment '93 depends on the reservoir level. It is shown that the discharge of the drainage tunnel within the landslide of the left abutment '93 is increased remarkably when the reservoir water level is above +485m.
