ROCK SLOPE STABILITY PROBLEMS IN NATURAL SIGHTSEEING AREAS - AN EXAMPLE FROM ARVANITIA, NAFPLIO, GREECE

Loupasakis C.¹, Galanakis D.² and Rozos D.³

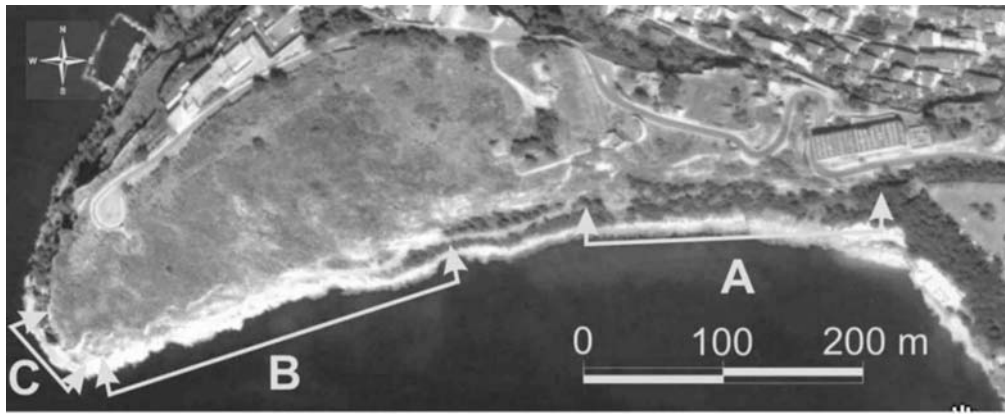
Nafplio - Arvanitia - Section A

Fig 3. Satellite picture (Google Earth) pointing the parts of Arvanitia walkway (A, B and C) constructed along the base of the slopes. The Schmidt stereo diagrams presenting the numerous joint sets intersecting the A, B and C parts of the slopes. The numerous unstable wedges are clearly presented by checking the intersected major planes in the "zone of potential instability" (grey area) (Hocking, 1976; Hoek & Bray, 1981).

The Schmidt stereo-diagrams presented in figure 3 prove that the A, B and C parts of the slopes are intersected by multiple joint sets. Most of the joints appear very high persistence (>20 m), wide spacing (1-2 m), no separation (< 0.1 mm) and lack of weathering. Those parameters explain the high RQD values (reaching up to 80-90%) and justify the also high RMR ratings (75-80) that classify the limestones in the “good” rock mass category (Kolligri, 2008). Based on the before mentioned characteristics of the joints, the wedges formed along the slopes are common and almost always oversized.

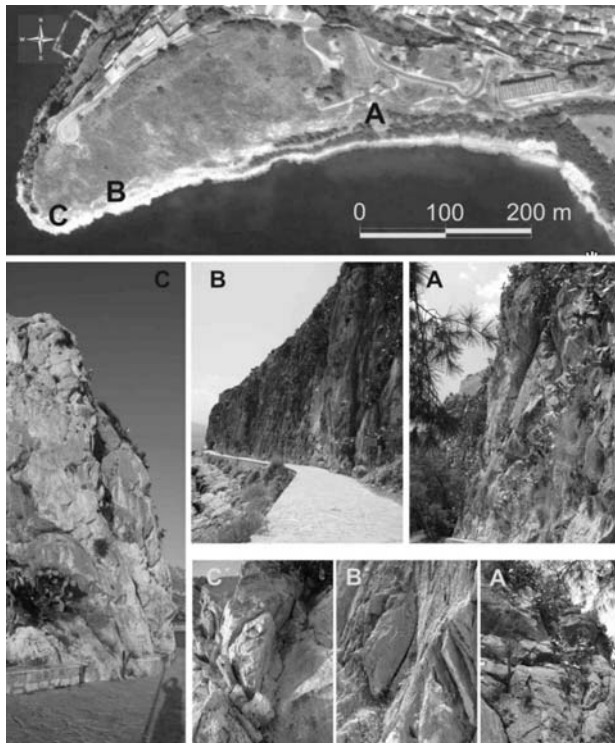
Fig 4. Photos presenting the condition of the rock mass in the before mentioned parts A, B and C of the walkway. Pictures A', B' and C' present focus on main wedges in the corresponding slopes.

and C are constructed attached to the base of the slopes without leaving any space for the installation of any protection measure. Those sections appear serious stability problems, due to the rock mass fracturing, and the disturbance caused by the excavation procedure.

Unfortunately, the above mentioned stability problems require the application of remedial measures causing disturbance to the natural sightseeing character of the site. Indeed, the actions needed to be applied are: a) removal of all overhanging detached rock blocks, using controlled quarrying b) ap-

plication of spot bolting in order to stabilize all the big rock wedges and c) installation of a high strength rockfall protection uniaxial netting along the entire slope (Fig. 7B, C).

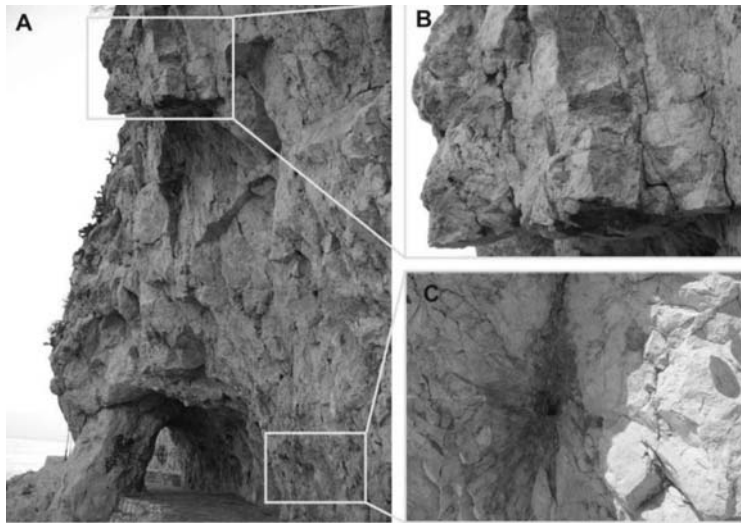
Beside the tectonics, the rock mass condition was affected by unadvised excavation procedure. The lack of any pre-splitting technique during the cutting of the artificial slopes (figure 5c), led to the intensive cracking of their rock mass. The abundance of the overhanging blocks, the height of the slopes (reaching up to 40 m) and the installation of the road on the base of the slopes without keeping any safety distance, cause serious safety issues.

All these problems are even more intensive along section C. Several meters of the walkway are constructed not only attached at the base of the slope, but along overhanging parts. Even a small tunnel was constructed in order to cross a ledge of the rocky slope (fig. 5).

Fig 5.: A) A small tunnel constructed along section C. B) Wedges hanged over the entrance of the tunnel. C) the intense artificial fracturing around a drill used for the installation of explosives.

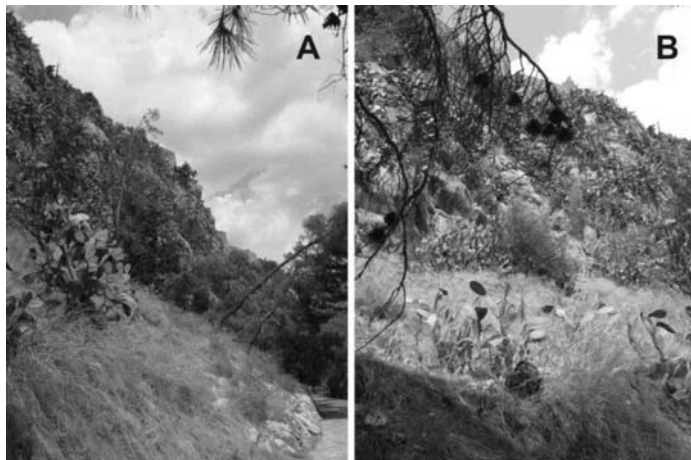
The slopes along the rest of the walkway (except parts A, B and C) manifest the same tectonic fragmentation but they are not disturbed by any excavation procedure. Further more the available space along the base of these slopes, as well as the tree cover, allow the installation of all necessary protection measures without causing any aesthetic destruction to the site (fig. 6).

Fig 6.: Photos taken from the slopes extending between section A and B. The available space allows the installation of camouflaged protection measures.

The selection of the proper protection measures for the slope parts being at a distance longer than ten meters from the walkway can be easily confronted. The available modern protection fences systems (Fig. 7D) could be very effective without causing any aesthetic distraction to the sightseeing site. These fences could be installed along the base of the slopes within the limits of the declivity extending between the slope base and the walkway, and can be camouflaged by planting trees or bushes. Along the western part of the walkway, with the larger available base declivity space, gabion boxes embankments (Fig. 7E) can be installed instead of fences. The installation of these embankments is cheap and they require no maintenance expenses, unless they are damaged.

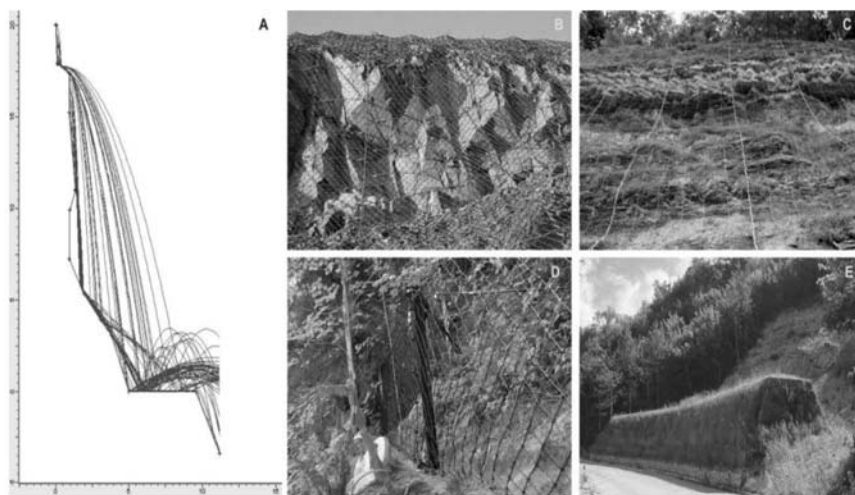
For the selection of the proper support measures of sections A, B and C, besides the stability analyses, rockfall propagation analyses were conducted (Fig. 7A), using the *RocFall* statistical analysis program. These analyses revealed that the spreading of the falling rocks covers the entire road width.

Fig 7.: A) Analysis for the estimation of the rock fall propagation in a typical cross section of the slope, B, C, D and E) typical support and protection measures. Wire nets (B and C), fences (D) and gabion boxes embankments (E).

Alternatively, as the net, causes a visible aesthetic demission, it could be substituted by the installation of a metallic frames shelter, covered on top with wavy sheet iron. Metallic frame constructions could be designed to take over the impact of a rock fall and at the same time their architectural design could make them fit the natural sightseeing setting.

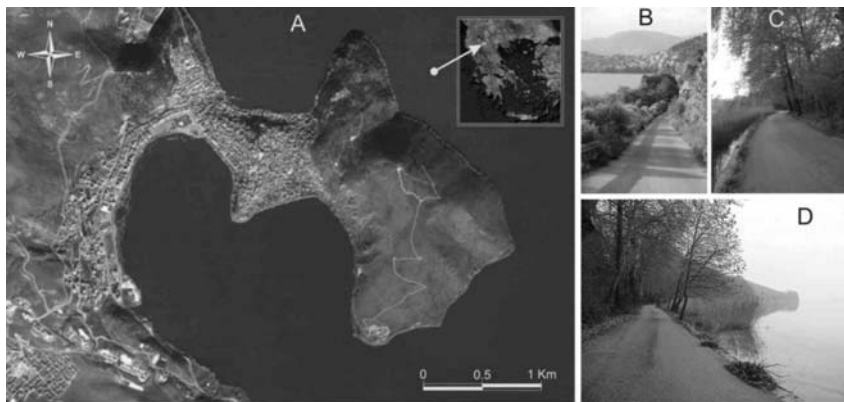
Fig 8.: A) Satellite pictures - taken from Google Earth - pointing the Kastoria peninsula surrounded by the, 8,5 km long, lake walkway, B, C and D) variant views of the walkway sections.

for the installation of proper protection measures, such as metallic fences, sort concrete walls or excavated trapping ditches (Fig. 8C & D). Limited sections with steep slopes (Fig. 8B) can be protected with wire nets, without causing serious aesthetic alteration to the site because of their reduced contribution to the total length of the road. Most of the before mentioned geotechnical problems could have been avoided if during the construction of the road the condition of the rockmass was taken under consideration. For example the road could have been constructed 1m higher in order to give space for a trapping ditch. Also, due to the shallow depth of the lake, limited section could have been constructed over the lake, avoiding the excavations.
