## INVESTIGATION AND MITIGATION OF A FAILURE AT THE TAXIARCHES CANAL OF MORNOS AQUEDUCT

Mourtzas N.D.<sup>1</sup>, Gkiolas A.<sup>2</sup>, Vakiris D.<sup>2</sup> and Soulis V.<sup>3</sup>

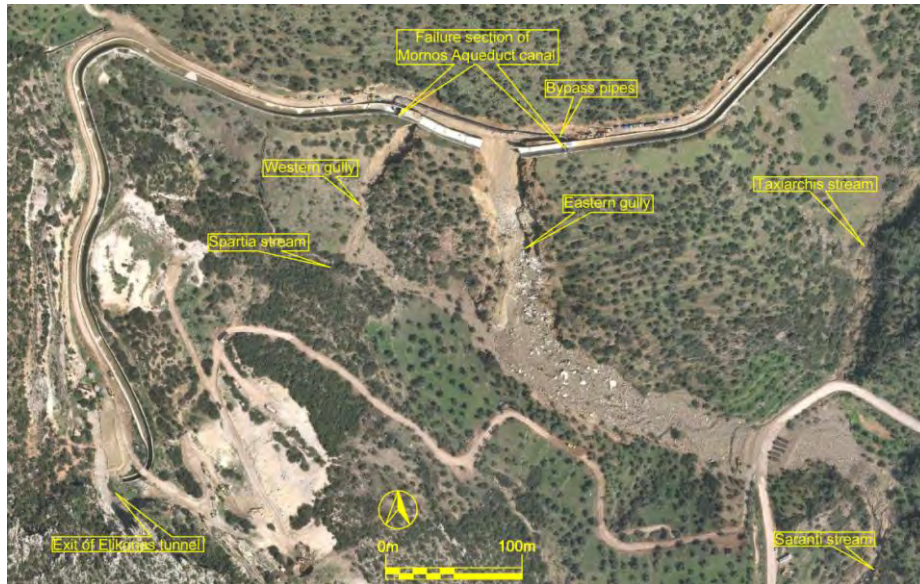
downhill and four segments upstream (2, 3, 4 and 5) and another one downstream (8) tilted and were damaged (Figures 1 and 2). During the final phase of the failure, water discharge dropped from 100 m<sup>3</sup>/sec to 10 m<sup>3</sup>/sec, within a two to three minutes time period, resulting in an estimated outflow volume in the order of 300 to 400 thousand cubic meters. This sudden outflow resulted in erosion of 45.000 m<sup>3</sup> soil material, consisting of fine and coarse grained material of the overthrust zone.

**Figure 1 - Aerial view of the slide area.**

At the area of the slid segments, the subsoil, the surveillance road and part of the cut slope have also slid downhill forming a gully (eastern) with steep high sides, with a length of 150 m, a maximum width of 45 m and depth ranging between 10 m to 18 m. Upstream the main failure area, four canal segments have undergone significant displacements, mainly horizontal towards lower elevations. At the area of the most distant segment a secondary gully (western gully) with steep sides was formed, with a length of 250 m, a maximum width of 18 m and depth ranging from 2 m to 3 m (Figures 1 and 2).

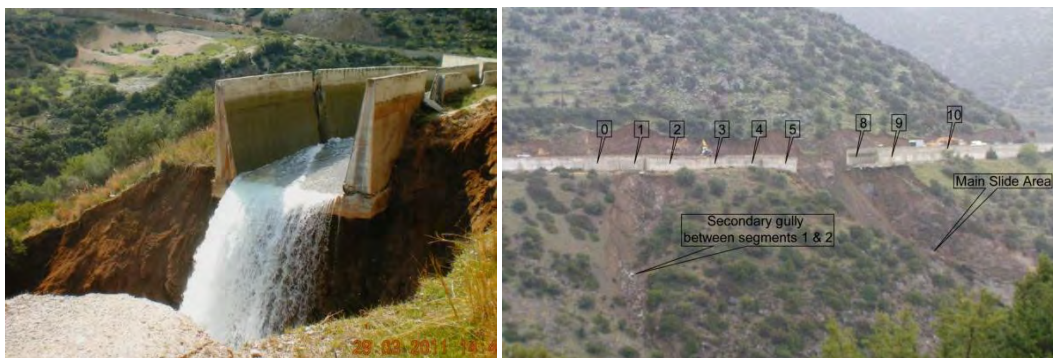
**Figure 2 - Canal segment failure (left), Main slide shortly after occurrence (right).**

The sudden discharge of a great water volume, after the canal failure, created two gullies spaced 75 m apart. The eastern major gully, of a length of 150 m, has a direction of NNW-SSE, maximum width of 45 m and it is 18 m deep (Figures 1 and 3). Its slopes are steep with gradients reaching 80% in the western slope, where friable and vulnerable to erosion calcareous-clayey materials are predominant and 100% in the eastern, where sandstones and conglomerates are developed.

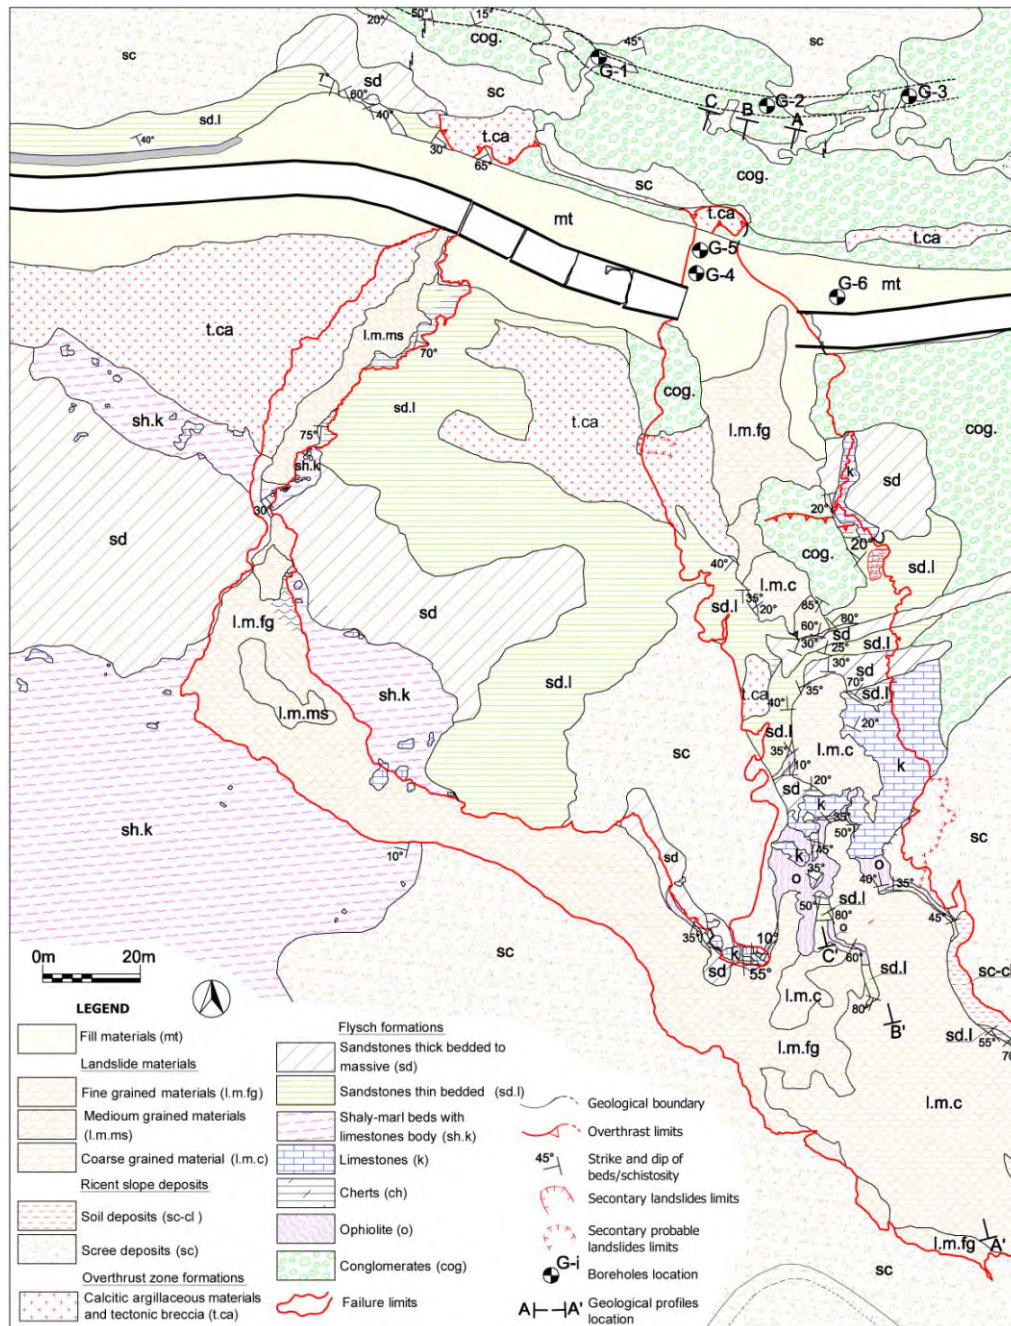
Figure 3 - Geological map of the landslide area.

According to the geological mapping of the failure area (Figures 3 and 4), schists with intercalations of thinly and thickly bedded sandstones are located at the base of the stratigraphic sequence. At their southern boundary show a general dip towards the south (ranging from SE to SW) at angles 50° to 80°. At their northern appearances are dipping towards NNE and NNW at

angles 35° to 40°. The extended limestone body, massive to thickly bedded, with a general dip to NE at angle 20°, follows. The next formation uphill are alternations of thinly to thickly bedded sandstones with a limited schist intercalation, dipping 25° to 35° NE, with thickness of ca.35 m. They are followed by cohesive and massive conglomerates. Tectonic breccia covers the tectonic surfaces. The ash-green coloured schists with limestone intercalations are located at the foot of the western gully, dipping 10° WNW. Thickly and thinly bedded, intensively tectonized sandstones follow, dipping 70° to 75° SW (Figures 3 and 4).

The tectonic depression formed in the overthrust zone was filled with calcareous-clayey, friable, light-yellow material of a thickness of 10m to 12m, as seen on the eastern slope of the eastern gully. Small-scale thrusts, with surfaces dipping mainly to the SE and ESE and secondarily to the NE at angles ranging from 30° to 35°, were mapped along the excavated slopes uphill the failure area, crossing the sandstone and conglomerate bedrock. Their length reaches 50 m, their aperture does not exceed 0.30 m and have been filled with friable calcareous-clayey material. An extended tectonic zone filled with light-yellow calcareous-clayey material, is usually formed at thrusts' ends or at their intersection (Figures 3, 4 and 8).

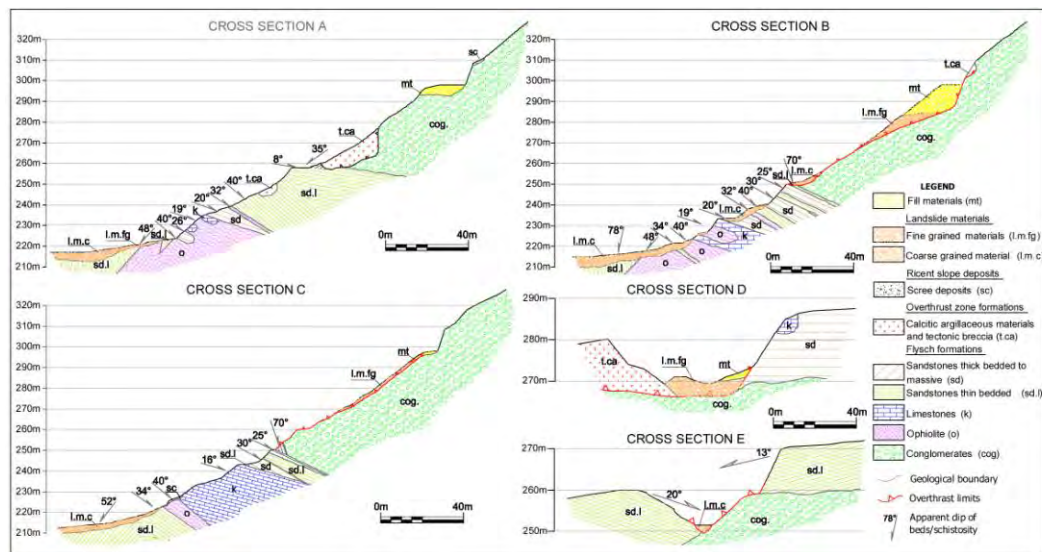
Figure 4 - Geological cross-sections of the landslide area.

The morphological gradients of the relatively steep riverbed can be divided into three sections, which are separated by two scarps, with heights of 9m and 5m, respectively. The first scarp is located in a distance of 70 m from the canal level and the second in a distance of 103 m. The gradients reach 70% in the first section, 37% in the second and 57% in the lower one (Figures 1, 3 and 4).

The western and smaller size gully has a direction of NE-SW, a length of 110 m, a maximum width of 17 m and it is 8 m deep, due to less volume of discharge. The inclinations of its eroded sides are in the order of 100% at the western and 65% at the eastern side slope, while the mean longitudinal gradient of the gully is 65% (Figures 1, 3 and 4).

The flysch formations of the Parnassos-Giona unit comprise the massive bedrock of the landslide area (Figures 3 and 4). The conglomerates of this unit show a high degree of diagenesis and consist of schist, quartz, chert and limestone gravels and cobbles, with a particle size ranging from 0.01 m to 0.10 m, within a quartz, siliceous or carbonic matrix. Sandstone layers consisting of coarse-grained, ash-green coloured, massive sandstone crossed by quartz veins as well as lenticular intercalations of limestones, are interpolated. The green to ash-green coloured schists, with white quartz veins, present an intense microfolding as well as fragmentation and detachment along the schistosity planes.

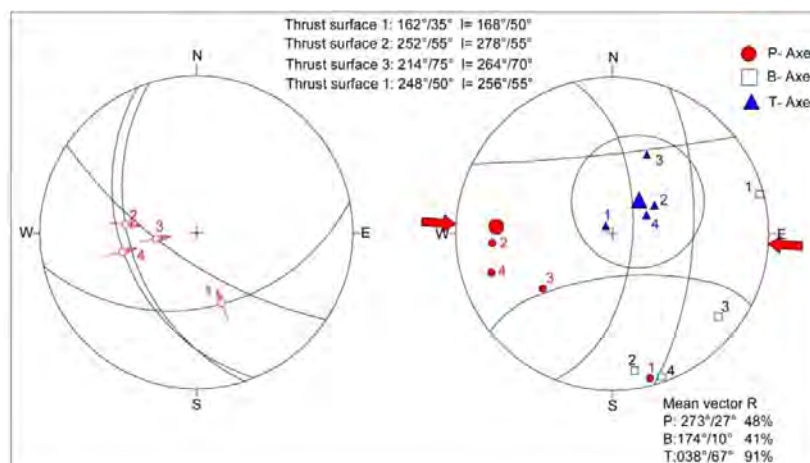
Figure 5 - Kinematic analysis of overthrust.

The kinematic analysis of the overthrust, based on the orientation data (dip direction/dip) of the overthrust plane and the orientation of striations, revealed that this large-scale compressive event took place under a compressive stress regime of WNW-ESE direction (Figure 5).

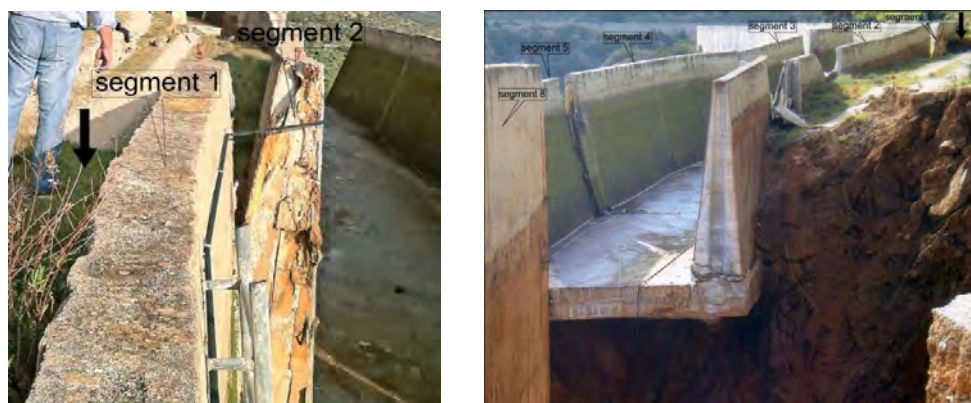
- The soil fracture and the following canal failure is not considered limited in the area of the two slid canal segments (No 6 and 7), but extended throughout the area of all the tilted canal segments (No 2 to 8). Furthermore it is delimited by the overthrust geometry. The western limit of the failure is located in the contact area of segments No 1 and 2, where a soil subsidence on the uphill side of the left canal wall is evident (Figure 6), causing tilting of segment No 2, thus enabling the canal water outflow at the right (downhill) canal wall, resulting in soil erosion and formation of the western (smaller) gully. The northern limit of the failure is related to the geometry of the overthrust.

**Figure 6 - Soil subsidence on the uphill side of the left canal wall between segments 1 and 2 and along the surveillance road.**

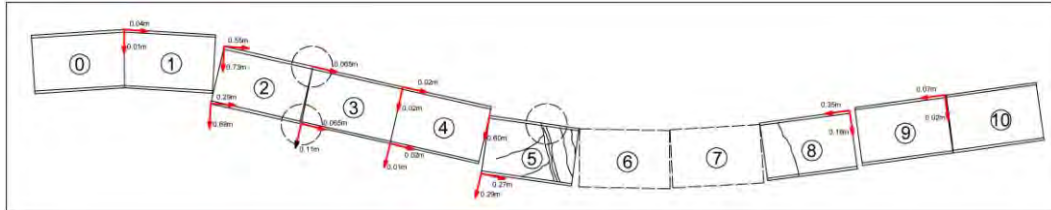
- Based on a detailed recording of the canal segments displacements (Figure 7) and their associated structural damages, it is concluded that the main displacement was perpendicular to the canal (N to S), but also along the canal with direction from segment No 2 towards segment No 5 and 6, along with rotation. The above displacement is considered to occur instantly, resulting in increase of the curvature of the canal with downhill (N to S) direction. The above

kinematics is also confirmed by the fact that all joints between hillside (northern) wall canal segments demonstrate compression failures, while all downhill (southern) wall canal segments are detached (extension).

**Figure 7 - Displacement of canal segments.**

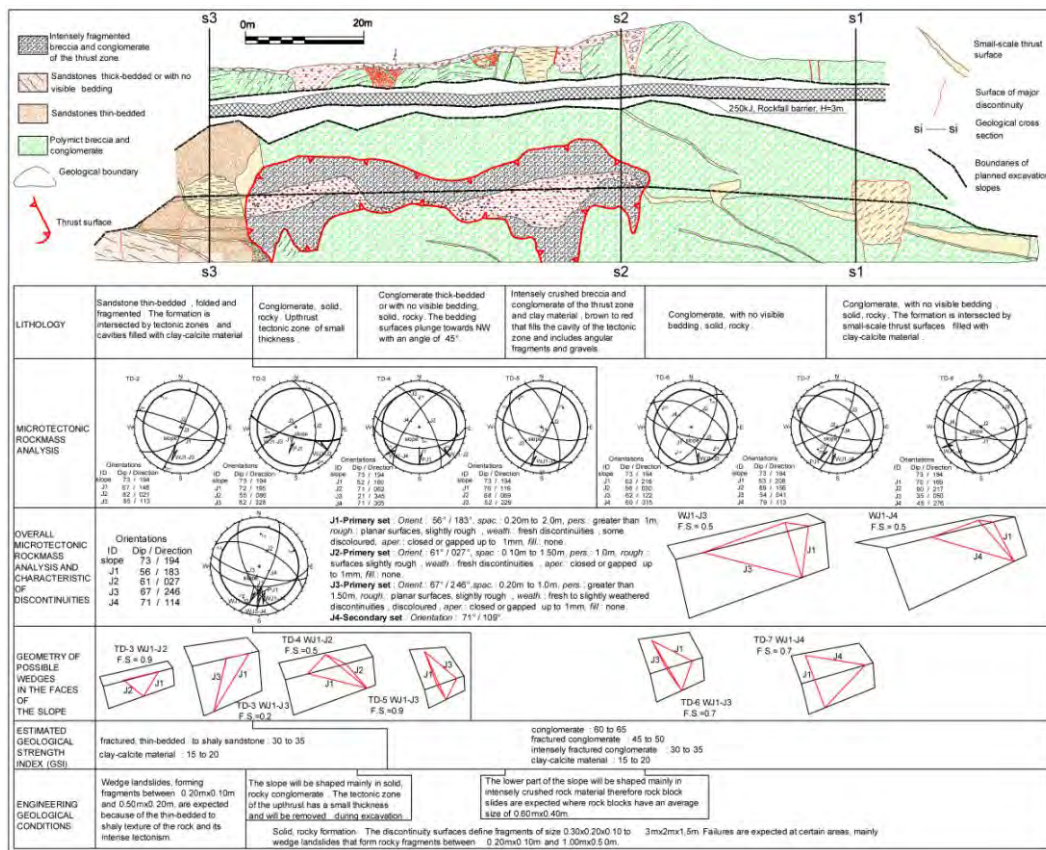
**Figure 8 – Engineering geological mapping of existing slope face.**

The rock mass is crossed by three major and one minor discontinuity sets dipping towards the SSE, NE, SW, and SE at angles ranging from 60° to 70°. According to ISRM (1981), their spacing is characterized as close to very wide (0.10 m up to 2.0 m), their persistence low (greater than 1m up to 1.50m), their surfaces are smooth to slightly rough, planar (VII–VIII), fresh with evidence of oxidation at positions, very tight to open (aperture up to 1mm), without filling material (Figure 8).

Based on the geological mapping of the slope faces, the quantitative description of discontinuities of the rock mass, their stereographic projection in individual rock mass parts and sliding potential failure modes, the geological structure and the engineering geological conditions along the new cut slopes, designed parallel and 5 to 6 m uphill of the existing cut, were estimated (Figures 8 and 9).

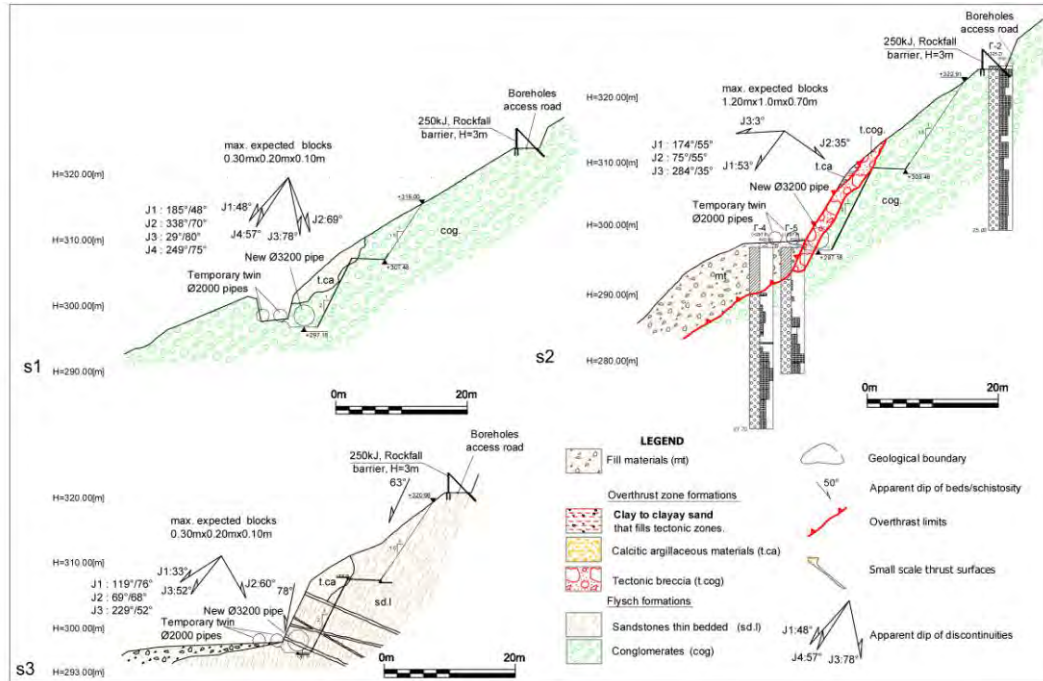
**Figure 9 – Engineering geological cross-sections along the new slope.**

The new slope at its western end was expected to be excavated in sandstones, mainly thinly bedded and fragmented, crossed by three major discontinuity sets. Wedge failures of rock blocks of estimated sizes ranging from 0.20 m x 0.10 m to 0.50 m x 0.20 m were expected, due to the thinly bedded to foliaceous structure and intense fragmentation of the rock mass. Subsequently, the slope was anticipated to be excavated in massive to thickly bedded conglomerates, crossed by

three major and one minor discontinuity sets. Wedge failures of rock blocks of estimated size ranging from 0.20 m x 0.10 m to 1.0 m x 0.50 m, were expected. Rock quality was considered downgraded, mainly in the overthrust area and also in places where the rock mass was crossed by small-scale thrusts and major joints. The development of small-scale cavities filled with clayey and calcareous-clayey material was considered possible (Figures 8 and 9).
