GEOTECHNICAL INVESTIGATION OF THE ROCK SLOPE STABILITY PROBLEMS OCCURRED AT THE FOUNDATIONS OF THE COASTAL BYZANTINE WALL OF KAVALA CITY, GREECE

Key words: *Rock slope stability, rock wedges, Panagia coastal Byzantine wall, Kavala*

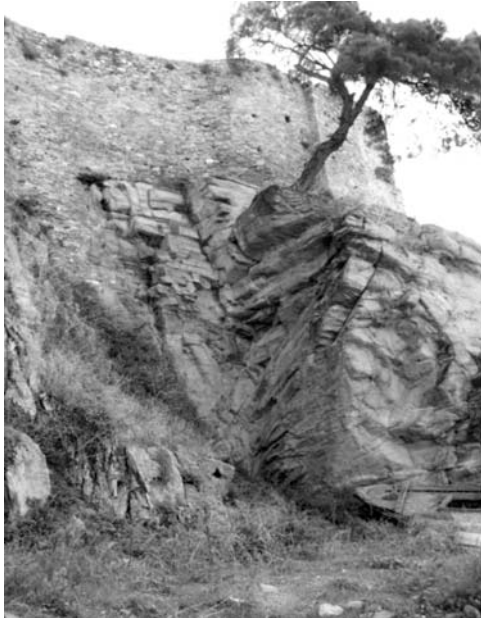
Fig. 2: Location P1. A fault intersects the slope forming a huge rock wedge and a wide fractured zone. The Wall fills the gap between the two sections of the fault.

Stability analyses conducted for the slopes with a dip direction 272°-302°, revealed that joints sets J1 and J2 form rock wedges rising along the slopes. These wedges tend to slide along the axis formed by the intersection of the before mentioned joints, with an angle of 73°. The slopes appearing a dip angle smaller than 73° are safe, as the rock wedges are self supported. On the contrary, the slopes with a larger dip angle are unstable. These wedge slides can threaten the Byzantine Wall only in cases where the foundation of the wall was constructed close to the slope edge. Precisely, in parts where the foundations were constructed in a distance smaller than half the height of the slope (Fig. 5E). Signs of oversized wedges that have already failed are visible in several parts of the slopes (Figs. 2, 4 and 6).

In order to avoid the wedge, plane and toppling failures spot bolting and sub-foundation constructions were proposed. To be more precise, the overhanging blocks could be supported by grouted rock bolts installed in selected locations. The underexcavated parts could be supported by filling the void with reinforced concrete constructions (buttresses, gravity walls etc.) camouflaged by stone coating. As presented in fig. 6, sub-foundation constructions were also applied in the past.

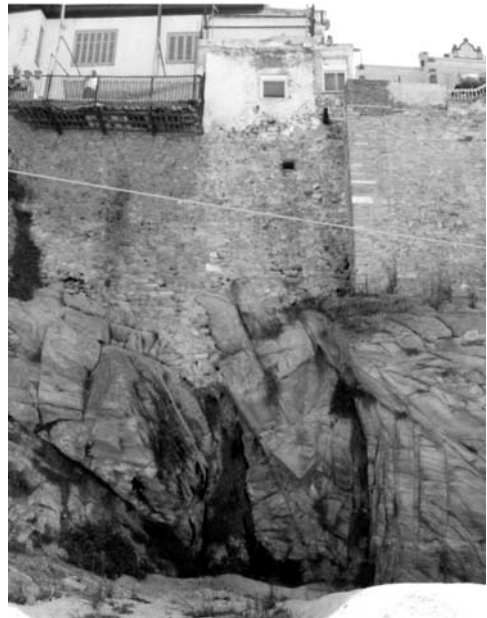
Fig. 3: Location P4. An intensively fractured zone caused by a fault. The wave erosion caused intensive underexcavation to the slope.

the wall was constructed in direct continuity with the slope. Even worse, in some places the wall was constructed forming a bridge across the two sections of the fault (Fig 3 & 5B,C,D). Figures 2 to 5 present typical examples of sections appearing slope stability problems capable of effecting the Byzantine monument.

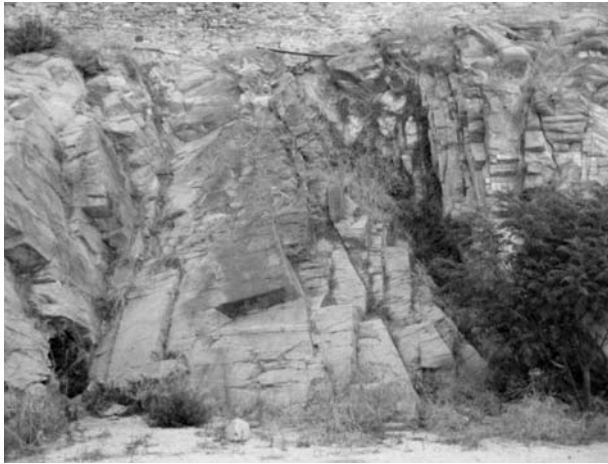
Fig. 4: Location P2. An oversized rock wedge that probably failed during the excavation of the small tunnel appearing at the base of the slope, on the left side of the picture. The extension of the failure could very easily damage the Byzantine wall.

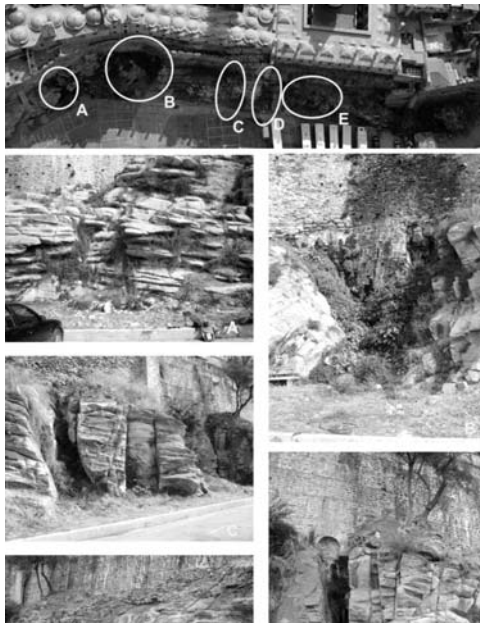
The corresponding analyses conducted for the slopes with a dip direction 202°-216° proved that those slopes are stable; no oversized rock wedges are formed (Fig. 5A). The only stability problems can be expected by the falls of small rock blocks sited along the slope face.

Fig. 5: Part P5. View of the slopes below Imaret monument intersected by the faults presented in the map of Fig. 1. The deterioration of the rock mass along the major tectonic lines cause serious rock slope stability problems threatening the monument. The letters pointing the various unstable locations correspond to the homonymous pictures (5A to 5E).

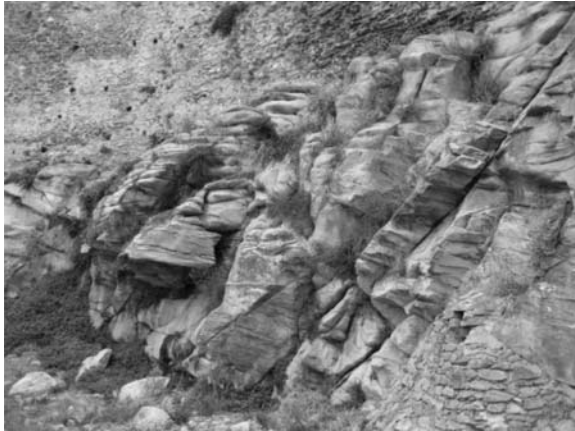
Fig. 6: Part P6. Several rock wedges are formed, to prevent them from sliding the underexcavated rock blocks were sub founded by the use of masonry walls – fills (lower right corner of the picture).

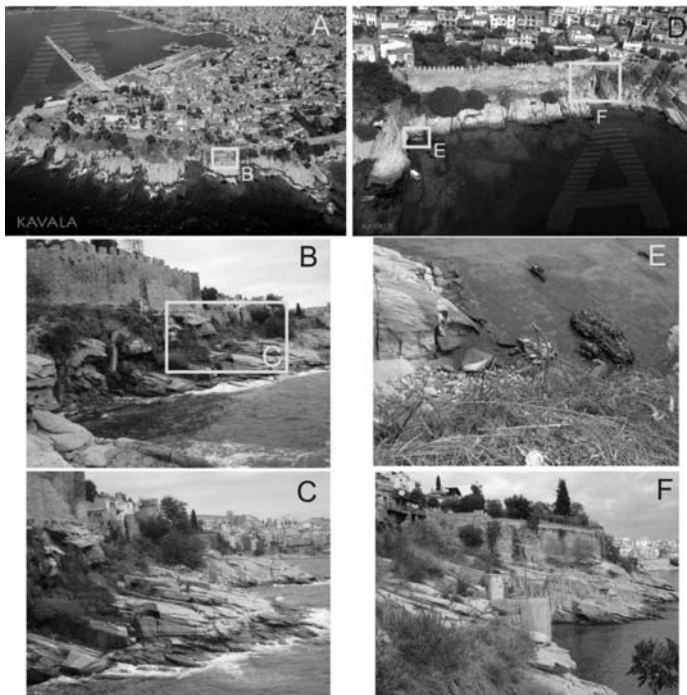
The South-eastern slopes present dip ranging between 45° and 90° and height extending 20 to 30m over the sea level. The lower parts of the slopes are found into the sea, effected by the marine erosion. The longest parts of the Byzantine wall are protected from the marine erosion and from the rock wedge failures as they are founded far from the edge of the slopes. However, along parts where the slopes are intersected by numerous faults, erosion processes have formed small gulfs and the sea has approached the historical construction, putting its foundation in danger (Fig. 7).

Fig. 7: Parts P9 and P10. View of the slopes along the SE part of the peninsula. Along the parts where the slopes are intersected by numerous faults the marine erosion processes have formed small gulfs and the sea has approached the historical construction, putting its foundation in danger. E: A collapsed section of the wall is presented.

Concluding, the slopes sited at the SE part of Panagia peninsula are not prone to rock sliding. On the contrary, toppling is likely to occur. Rock fragments of 2-3meters maximum height could topple, especially in parts where their foot is undercut (Figs. 7, 8). These phenomena could damage the historical monument at those areas where marine erosion has excavated rupture zones reaching to Byzantine wall's foundation.

The marine erosion of the slopes can be effaced by the installation of seawalls. These breakwater structures can be constructed by granite boulders, fitting to the surrounding bedrock and causing the minimum aesthetic distortion to the site. As presented in figure 7, the shallow sea, close to the coastline, allows the installation of the boulders by using barges. Unfortunately, these structures are going to block the small beaches formed along the gulfs. Small piers or narrow passages through the breakwater structures can provide solution to the problem.

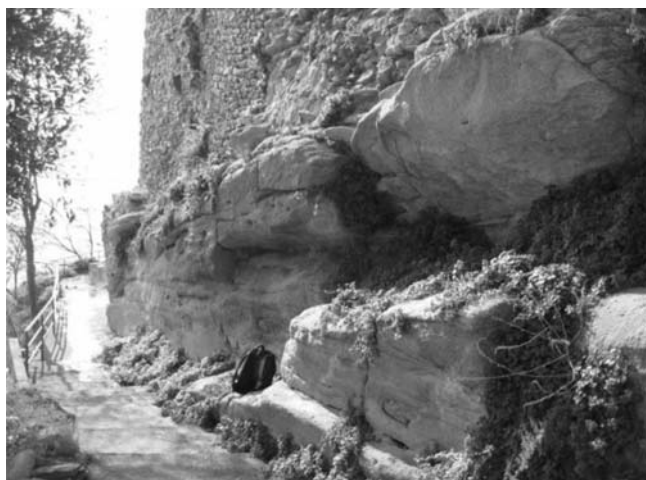
Fig. 8: Part P13. Underexcavated slope along a fault scarp. The wall was founded close to the edge. The toppling or the rupturing of the rock mass could cause extensive damages to the monument.
