Πρακτικά	βου	Συνεδρίου	Μάτος	1992
Δελτ. Ελλ. Γεωλ. Εταιρ.	Τομ.	XXVIII/3	σελ. 581-601	Αθήνα 1993
Bull. Geol. Soc. Greece	Vol.		pag.	Athens

**ENGINEERING GEOLOGY OF SELECTED ABANDONED ANDESITE
QUARRIES, IN IZMIR-TURKEY**

M.Y.KOCA, N.TURK

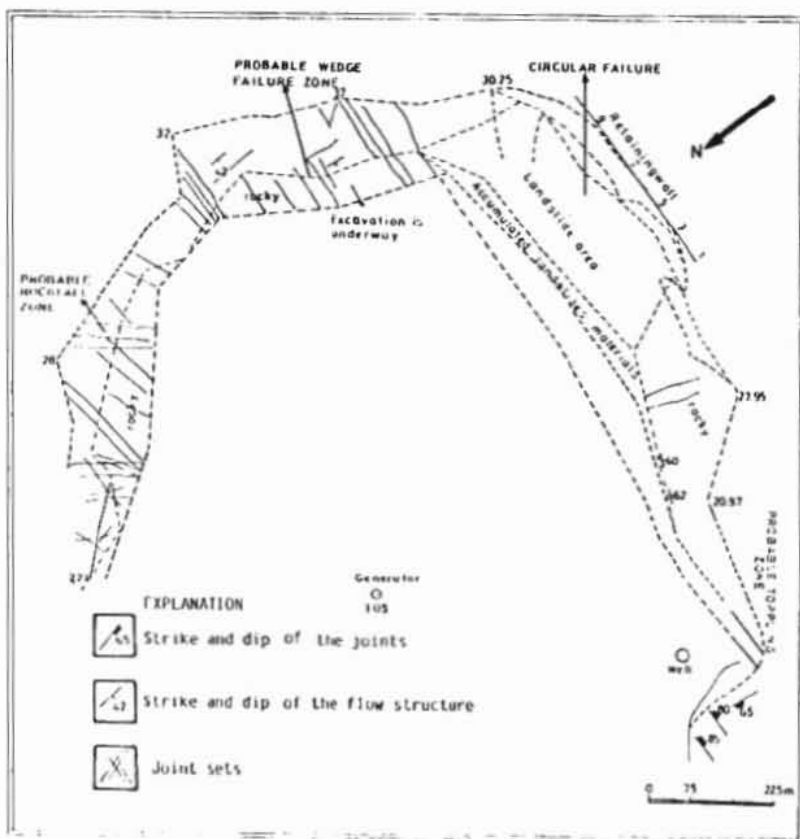
Figure 3. Engineering Geological Map of the Andesite Quarry at Göztepe.

The types of slope failure modes expected in the quarry slopes are shown in Fig-3. Some parts of the slopes were found to be at critical state of stability when this study was carried out. The following measures were recommended for the reinforcement and the protection of the slopes, before any construction is made in the quarry site.

a. **Rock fall zone** : Critical blocks were suggested to be removed. Rock bolting and wiremeshing were recommended to increase the stability of andesite blocks. Additionally, a sand filled corridor (zone) should be left between the toe of the slope and the planned building in order to stop the unprecedented rock falls.

b. **Wedge failure zone** : Slope face angle was suggested to be lowered by blasting and rock bolting of the critical wedges was recommended.

c. Circular sliding zone : The slope angle was suggested to be lowered and a retaining wall was recommended to be built at the toe of the sliding mass.

d. Toppling zone : Andesite blocks prone to toppling, were suggested to be removed by dislodging them.

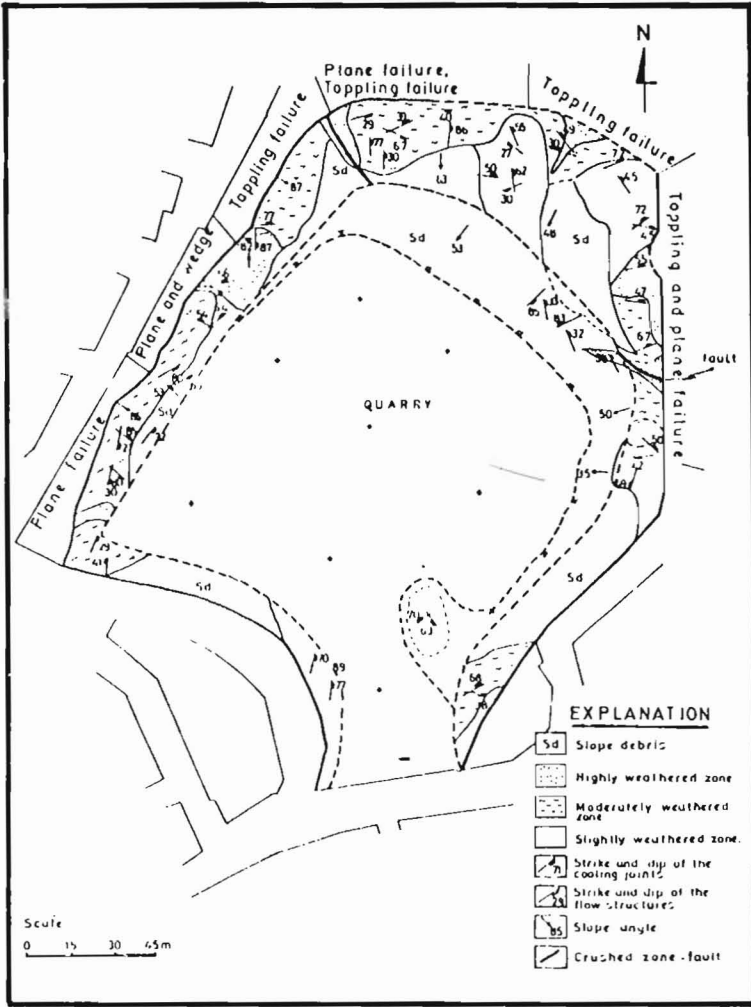
Figure 4. Engineering Geological Map of the Andesite Quarry at Bayraklı.

Engineering geological studies were undertaken to assess the stability of the quarry upon the request made by the Karşıyaka Municipality. Figure 4 shows the engineering geological map of the quarry. The major discontinuity and weathering profile of the quarry slopes are also shown on this map. Andesites are found in varying grades of weathering in the quarry.

There are three types of discontinuities found in the quarry; flow band structures, cooling joints and tectonic joints. The flow band structures are tightly closed, and have rough surfaces and dip at 27^o-30^o to the in and around the quarry. Cooling joints have smooth surfaces and dip at high angles, and are slightly widely open. There is about 1 meter thick shear zone running in SE-NW direction in north of the quarry. The tectonic joints are generally found running parallel to the tectonic crushing zone and rough, clay filled (1-3 cm). Andesites are found to be

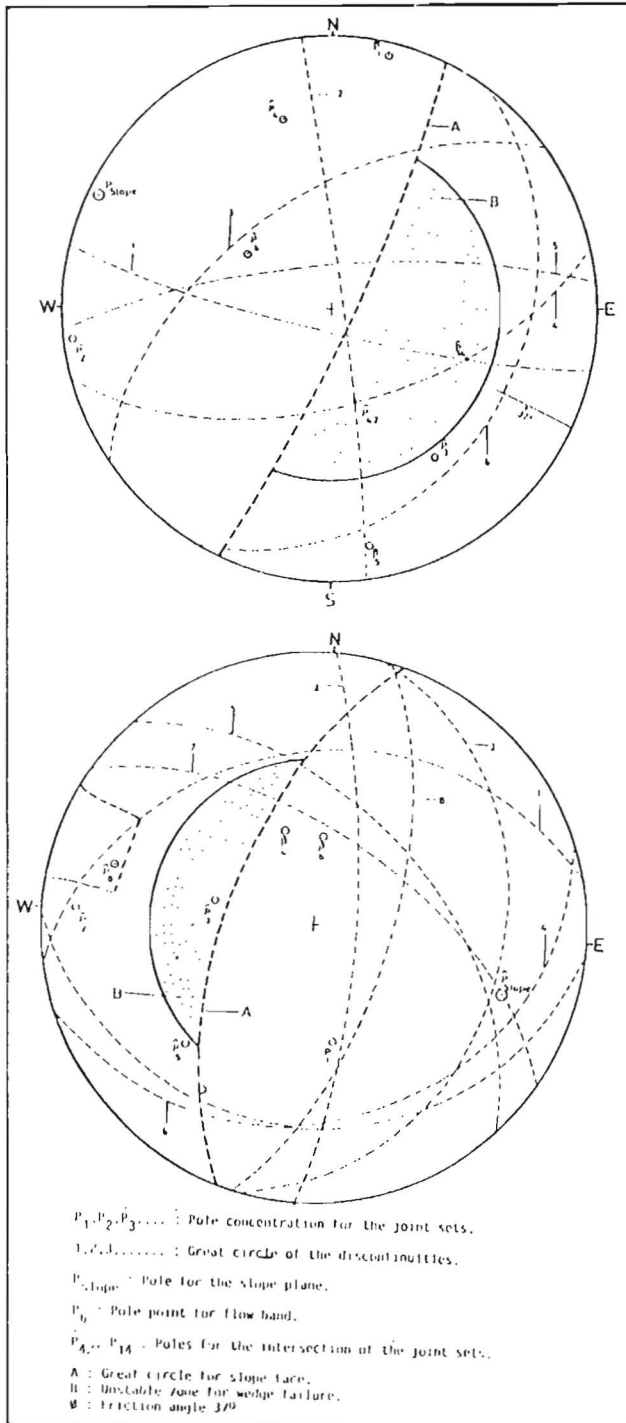
Figure 5-6. The Stability Analysis of the Discontinuity Data of the Western and Northern Slope of the Bayraklı Andesite Quarry.

Detailed discontinuity measurements were carried out along the quarry slopes. Analysis of the discontinuity measurements has shown that mainly toppling, wedge and plane type of rock slope failures are expected around the quarry (Figure-5).

Figure 5 shows the stereonet analysis of the discontinuities measured in the western slopes of the quarry. Surface friction angle of the discontinuities were taken as $\phi = 37^{\circ}$ from the block sliding experiments carried out in the field. This protection indicates that there is a possibility of wedge types failure in this slope. Figure-6 shows stereonet analysis of the discontinuity data obtained from the northern slope of the quarry. Rock falls and toppling type of failures are expected in this part of the quarry. Additionally, the analysis of the discontinuity data obtained from the eastern slope of the quarry indicated that there was not any major discontinuity concentration likely to cause slope failure in this area.

Rock bolting and wiremeshing type of rock slope reinforcement and drainage of the surface water were suggested to increase the stability of slopes. Additionally, a retaining wall was proposed to be built around the quarry to stop falling rock blocks to roll away from the toe of slopes before any construction activity is started in the quarry site.

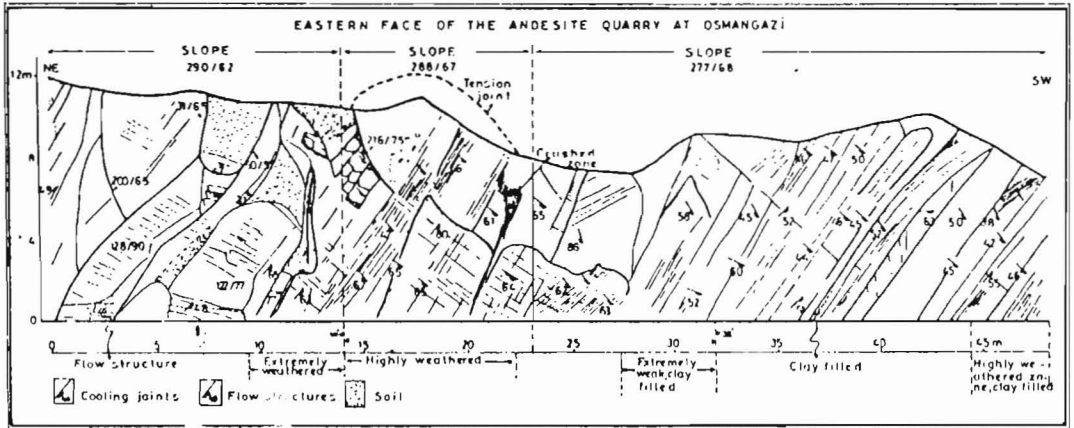
Figure 7. Discontinuity and Weathering Map of the Osmangazi Andesite Quarry.

There are several disused andesite quarries located between Bayraklı and Bornova districts in NE of the Gulf of Izmir. At present, these quarries are located in a scarcely built area and a major motorway is planned passing through these quarries. Figure 7 shows 1/100 scale discontinuity and weathering grade map of the eastern slope of a selected quarry in the area. The mapped part of the quarry is about 50 m long and 12 m high. The slope angle of the quarry face changes along the eastern slope. The stereographic projection and the stability analysis of the discontinuities measured in each section of the eastern slope are carried out separately.

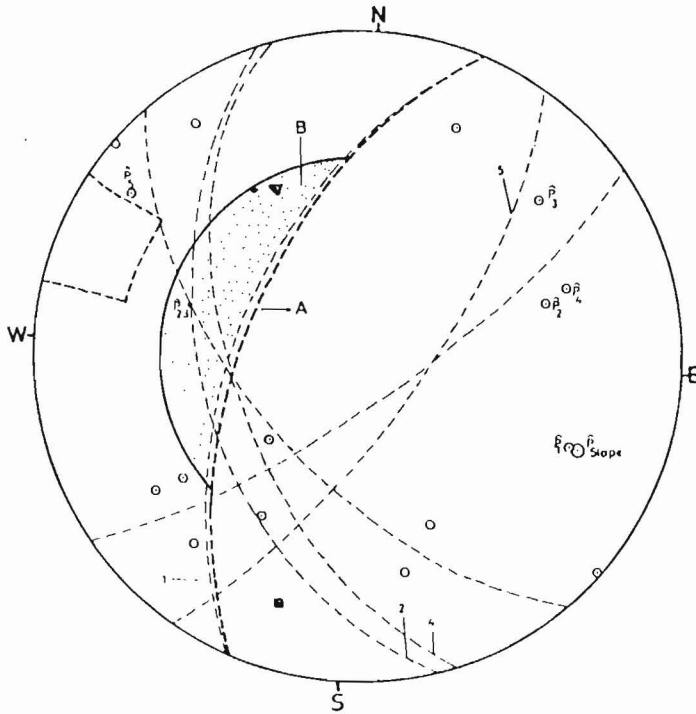
Figure 8. Stability Analysis of the Discontinuity Data of the Osmangazi Andesite Quarry, Using Stereographic Projection Technique.

Section 1 : It is 14 m long and its slope face stands at 290/62. Contour diagrams of the discontinuities are given in Figure-8. Stability analysis of the discontinuities indicates that planer slope failures are likely to take place along the discontinuities dipping at 290/60 and rock falls and toppling of andesite blocks are expected associated with the pole concentration $\hat{P}5$.

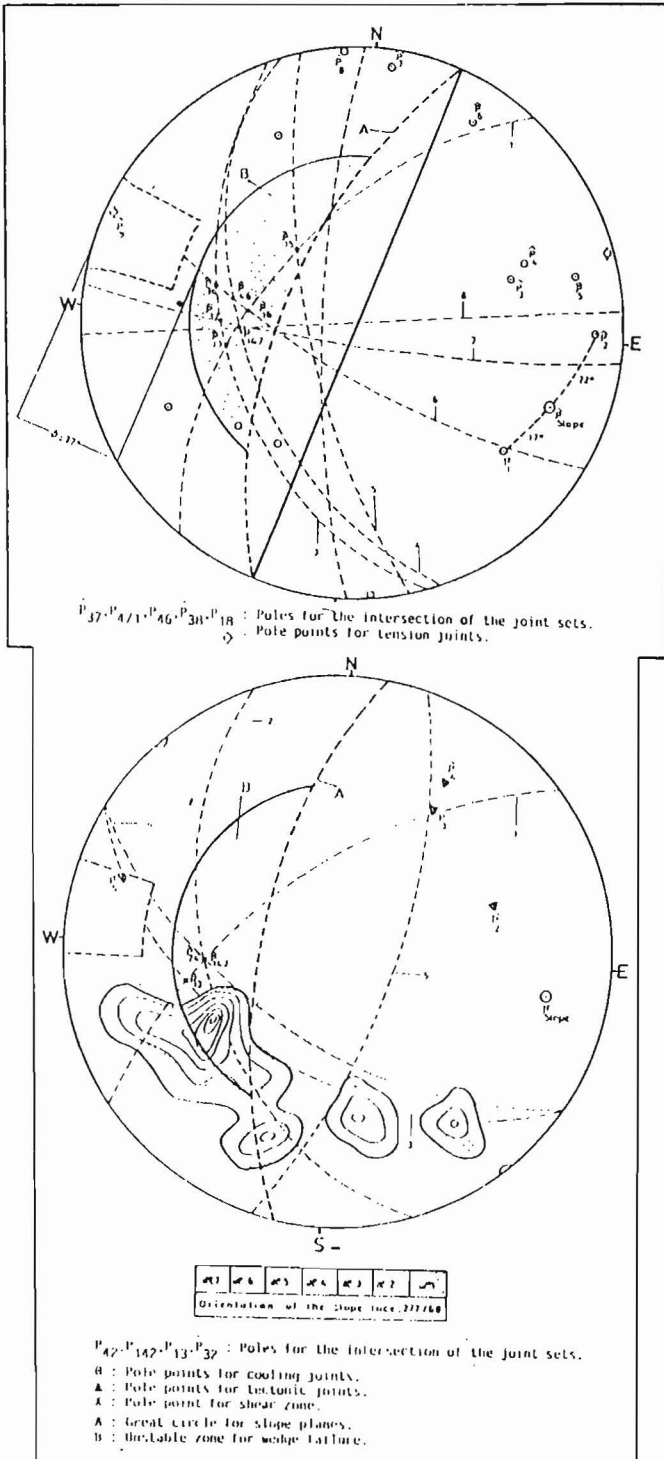
Figure 9-10. Stability Analysis of the Discontinuity Data of the Osmangazi Andesite Quarry, Using Stereographic Projection Technique.

Section 2 : It is 10 m long and highly weathered and its slope face stands at 288/67. The contour diagrams of the discontinuities are shown in Figure 9. Wedge failures are possible over the discontinuity plane represented by the pole $\hat{P}1$. Additionally, rock falls are possible in this section.

Section 3 : It is about 25 m long and its slope face stands at 277/68. The contour diagrams and the great circles of these discontinuities are shown in Figure 10. Rock falls and toppling type of failures are expected associated with the discontinuity 106/72. Additionally, pole $\hat{P}5$ falls into

the toppling envelope indicating possibility of toppling failure associated with this discontinuity.
