## THE ENGINEERING GEOLOGICAL BEHAVIOUR OF DISTURBED AND WEATHERED GNEISS IN SLOPES. THE CASE OF THE “VERTICAL AXIS” OF EGNATIA MOTORWAY, KOMOTINI – NYMFEA, NORTHERN GREECE

Marinos V.<sup>1</sup> and Goricki A.<sup>2</sup>

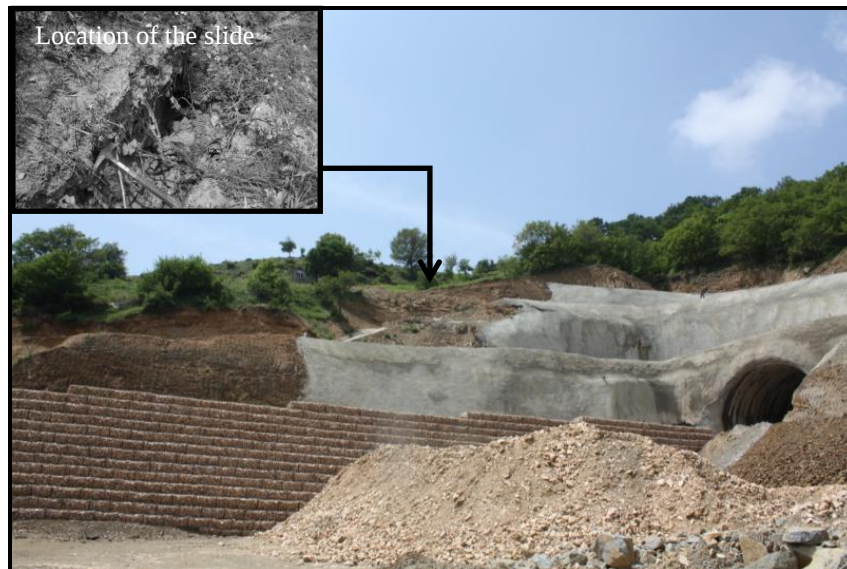
The first case study discusses a slide that occurred close to the entrance portal of Nymfea tunnel (Figure 1). The rock mass in the area is comprised of gneissic schists in the surface and schistosed gneiss in depth. The rock mass is highly to completely weathered at the surface (type V and VII) and becomes moderately weathered (type III) in depth. Six boreholes with inclinometers and piezometers were drilled to investigate the slide. The identification of weak zones, the thickness of the weathered cover in the specific area and the evaluation of inclinometer and piezometer measurements were of primary importance. Taking into consideration the above parameters, it was evaluated that the slide was driven within the weathered zone, occurred after the excavations of the tunnel portal. It started several meters above the cut and ended in the second bench of the excavated cut, developing several cracks in the already applied shotcrete. The weathered zone, other geological features and the tensile cracks are highlighted in the Figure 2. It is highlighted here that sliding could have been also assisted by the weathered schistosity that is favourable dipping with  $30^{\circ}$  towards the slope.

**Figure 1 - View of the entrance portal of Nymfea tunnel. The gabion wall is used here for the stabilization of the whole slope. The slide occurred above the gabion wall.**

The scope of the back analysis is to estimate the geotechnical properties of the completely weathered gneiss (type VII). The slide was driven within the weathered cover, starting several meters above the cut and ending in the second bench of the excavated cut, developing several cracks in the already applied shotcrete after the excavations of the tunnel portal. From the grain size distribution analysis of the completely weathered soil-like geomaterials it is found that the percentage of sand is around 50-70% and of silt and clay around 20-30%. Plasticity index is around 5-7. The shear strength properties that resulted from laboratory tests (cohesion  $c=31\text{ kPa}$  and angle of friction  $\phi=37^\circ$ ) are considered high and not representative for the material within the failure plane. An important parameter that influences the analysis results is the status of the pore water pressure at the time of the failure. The piezometric surface was assumed along the contact of the weathering cover and the more fresh bedrock. Moreover, due to intense raining before the slide and some infiltration within the weathering cover, a  $r_u$  coefficient of 0.25 was considered. It is noted that the weathered cover has some small cohesion since clayey-silty material are present in the mass. The concluded values from the analysis are  $c = 5\text{ kPa}$ ,  $\phi = 28^\circ$ . It is highlighted that the analyses were done for circular and non-circular surfaces. The results from both the analyses were almost similar (0.998 for the non-circular and 1.029 for the circular surface with the Janbu-corrected method). The actual sliding surface seemed to be the non-circular one as it resulted from the tension cracks, the depth of the bedrock and the cracks in the shotcrete above the portal cut.

The solutions to stabilize the entrance portal cut of Nymfea tunnel can be categorised in two alternative solutions.

- Measures within the area of the failed rock mass by supporting with a pattern of pre-stressed anchors or removing the failed material.
- Measures at the bottom of the failed rock mass by retaining measures. Support the failed material at the lower to those focused to secure the road from further slides with the construction of passive measures.

Due to the large area and the great depth of the slide it was found, that retaining measures are the economic way to stabilise the slope. Reinforced concrete walls with pre-stressed anchors were combined with the Cut&Cover structure of the tunnel portal and constructed from the road level.

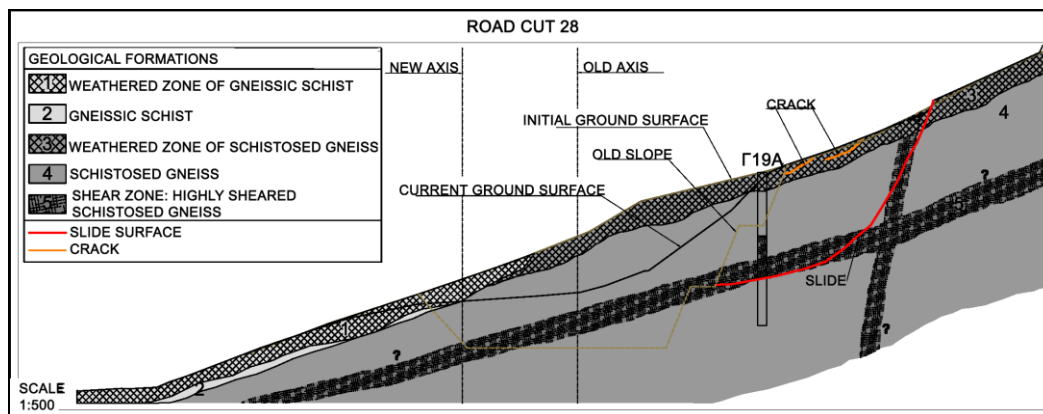
**Figure 4 - Geological section along the slide of the road cut O28 (Case Study 2).**

In this case study, the sliding occurred along two shear zones, consisting of foliated gneiss that resembles almost to sandy-clayey soil material after its tectonic disturbance. The first shear zone forms the scarp of the slide, and the second - the main sliding surface – is almost parallel to the slope surface. Although the geotechnical parameters of the surrounded gneissic rock mass (type III,  $\gamma = 25\text{ kN/m}^3$ ,  $\sigma_{ci}=35\text{ MPa}$ ,  $\text{GSI}= 25\text{-}35$ ,  $c= 100\text{ kPa}$  and  $\phi= 30^\circ$ ) were incorporated in the analyses, the critical parameters are the ones of the shear zones. The piezometric surface has been found in a depth of 13m due to the fracturing of the rock mass. The concluded values from the analysis are  $c = 50\text{ kPa}$ ,  $\phi = 23^\circ$ . Similarly to case study 1, the analyses were done for circular and non-circular surfaces. Although the sliding surface fits better (geometry of shear zones, location of surface cracks on the cut and the natural slope, depth of movement) to a non-circular surface, the results were similar (0.999 for the non-circular and 1.015 for the circular surface).
