## PALAEOTECTONIC ENVIRONMENT AND LANDSLIDE PHENOMENA IN THE AREA OF MALAKASA, GREECE

Mourtzas N.D.<sup>1</sup> and Sotiropoulos E.<sup>2</sup>

### Abstract

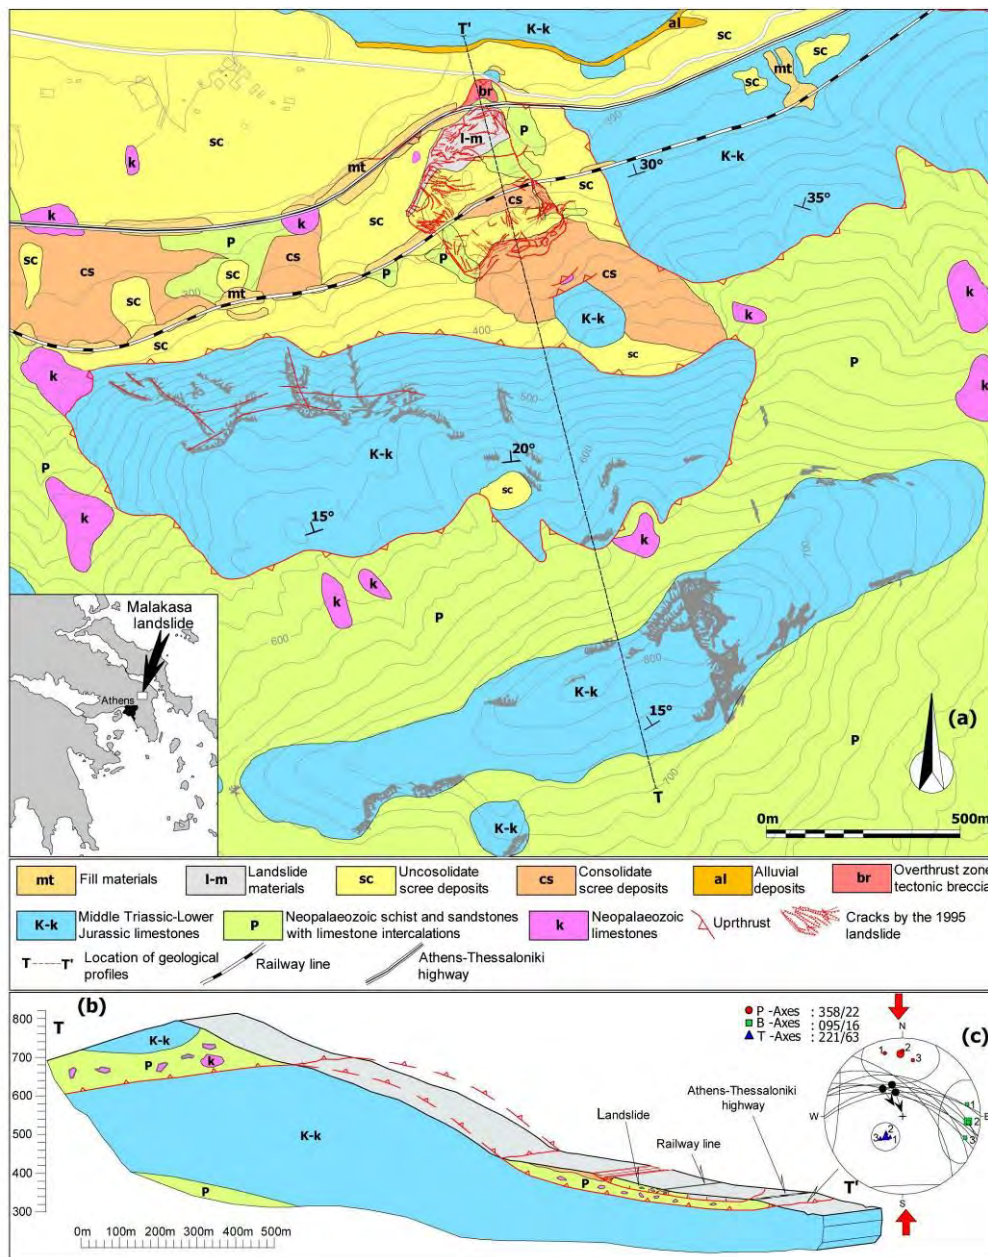
**Figure 1 - (a) Location map of Malakasa landslide (b) Detailed geological map of the NE slope of Mt Parnitha in the wider area of Malakasa landslide (c) Geological cross-section along the longitudinal axes of the north-east slope of Mt Parnitha (d) Up-thrust surface data and palaeostress mechanism analysis.**

The thrust of the neopalaeozoic formations to the Triassic limestones constitutes the main palaeotectonic structure of the landslide area. This large-scale tectonic movement took place during the first orogenetic phase and affected the wider area. It caused strong foliation of the geological formations, with the strike of the main fold axis being NNW-SSE, and the generation of tangential forces that pushed the schist-sandstones towards a SE direction over the carbonate formations of the Sub-Pelagonian geotectonic unit. The following erosion removed significant parts of the tectonically overlying schist-sandstone formations and revealed the younger underlying carbonate bedrock in the form of a “tectonic window”. Also, the erosion caused the fragmentation of the nappes into klippe which lay on the Triassic substratum. The Malakasa landslide occurred in one of these klippe (Figures 1 and 2).

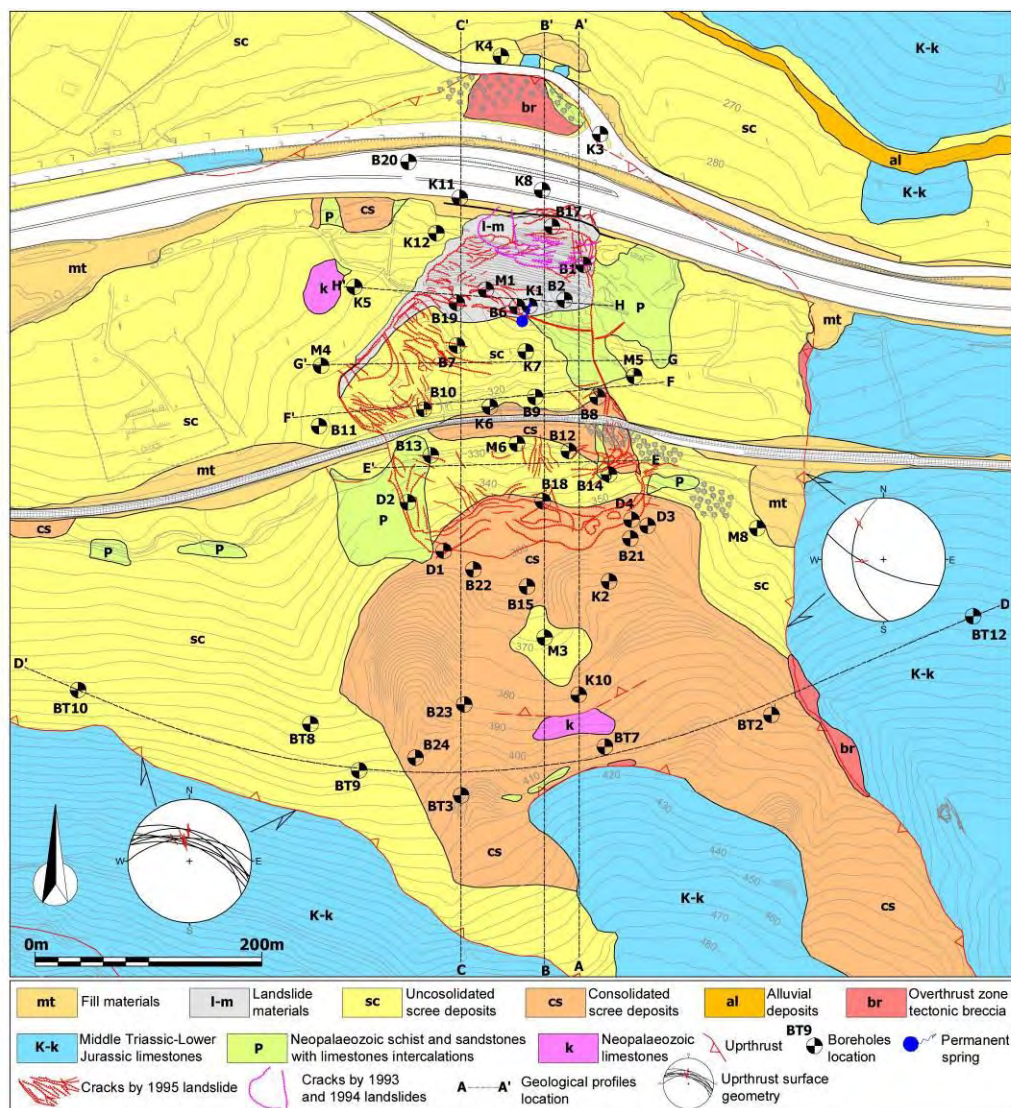
Figure 2 - Detailed geological map of Malakasa landslide.

The total number of cracks recorded on the sliding mass surface was 114 and the sequential measurements of their position and size did not give clear results for the direction and magnitude of the movement. The variations of their size did not seem to come from factors related to the soil mass movement but they can be attributed to conditions that affect the soil surface. However, the presence, density, and orientation of the cracks on the landslide surface provide significant evidence about the movement of the soil mass (Figures 2 and 5).

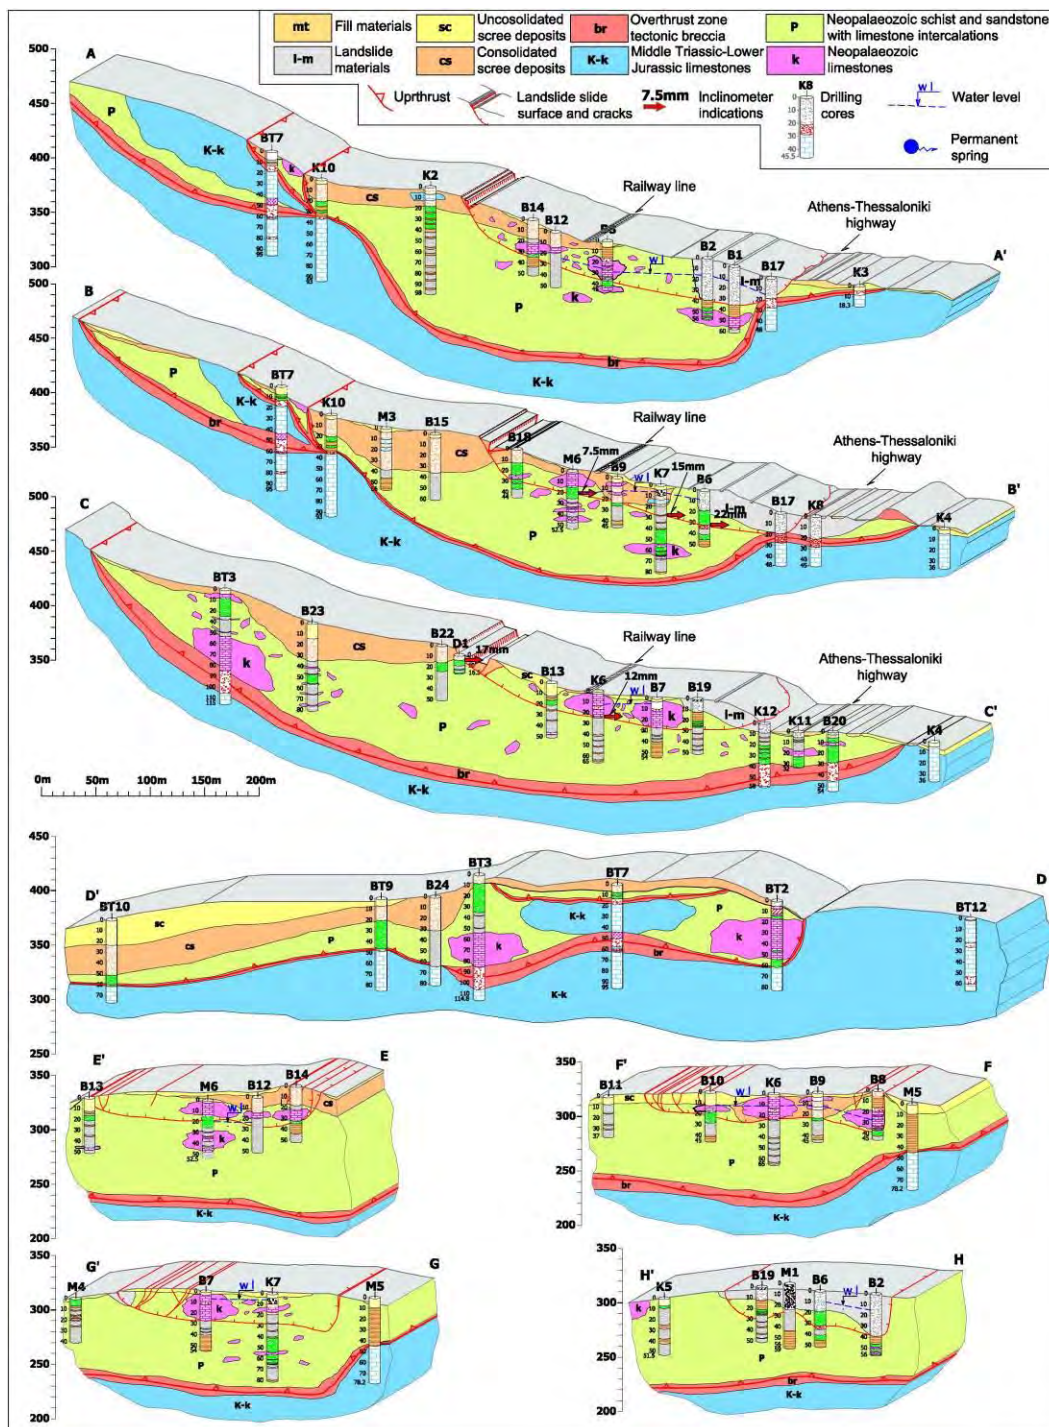
Figure 3 - Geological cross-section of Malakasa landslide.

The landslide presents classic tensile cracks at the head, with almost vertical walls and vertical displacement of few meters. These cracks turned into trench gaps, after the mass movement, being 15m to 30m wide and 15m deep. At its sides, the landslide is clearly defined by continual cracks which revealed the failure surface with characteristic glide lines to the direction of the movement. There is, also, intense ground elevation at the landslide toe and multiple failure surfaces, extremely smooth and with glide lines, in different levels (Figure 3).

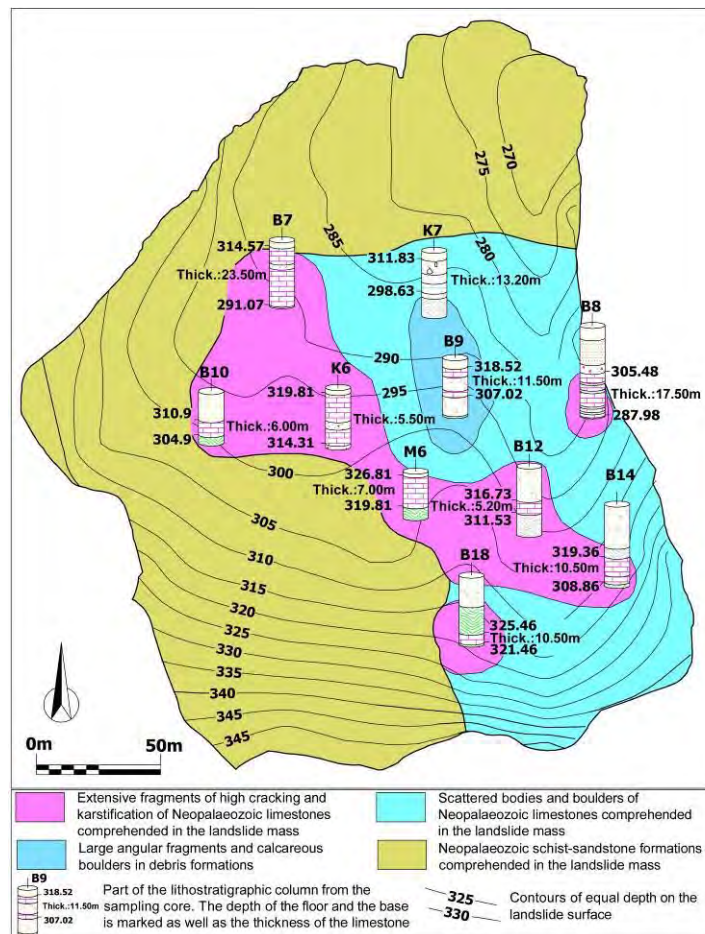
**Figure 4 - Dispersion map of the limestone bodies in the mass of the landslide.**

The limestone bodies are thinly bedded with intense folding and medium to high fragmentation and karstification. The discontinuities and karstic voids of the rock mass are filled by green clays and clayey sands. The largest proportion of RQD index values is between 0% and 20%. At least three large limestone bodies are contained in the schist-sandstone mass. The first one is about 40m thick and can be found in the western section of the up-thrusted mass, 170m upwards and NE of the landslide head. The second is about 35m thick and it is located 200m upwards and to the north of the landslide head. Finally, the third is located in the central section of the landslide, having NW-SE direction, extends up to a depth of 3m, and has a length of 195m and maximum width of 70m. Its thickness reaches 24m in its NW end, 5 to 7m in the most extended central section, and 10m in its SE end, while its volume is estimated at 216,000 m<sup>3</sup>. The two smaller limestone bodies, in the north-eastern and southern sides of the main section, are about 25 to 30m long and are having a thickness of 10 and 17m respectively, while their total volume is estimated at 33,000 m<sup>3</sup> (Figure 4).

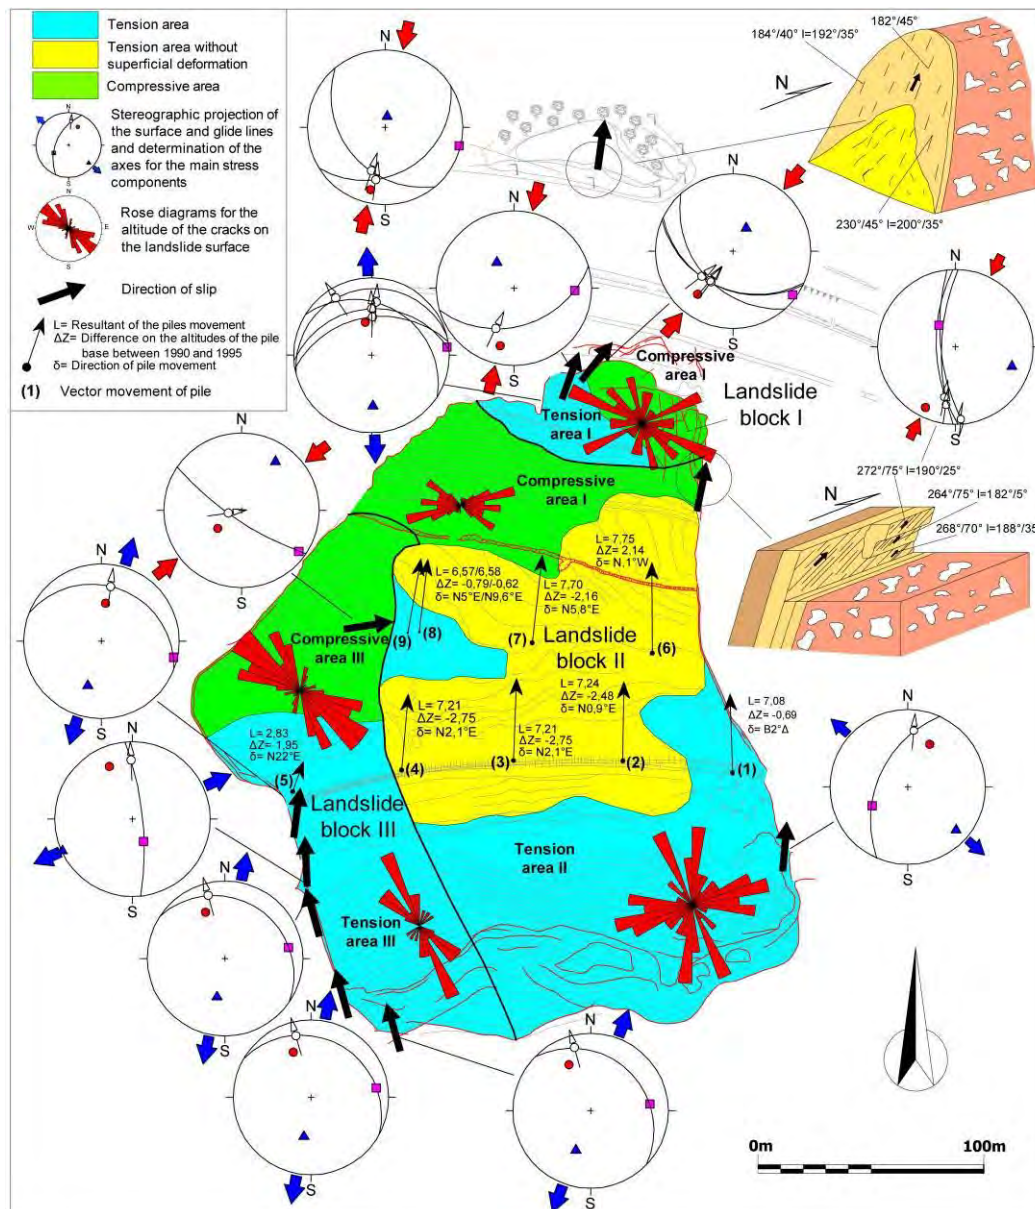
According to the geometric data of the movement, the tension and compression zones of the landslide, the orientation of the tensile and compressive axes, and the direction of the movement, in every location, are determined (Figure 5). An extended tension zone was determined at the SE side and the central section of the landslide mass, upwards and downwards the railway line. At its north section, failure surface dips to the NW and glide lines have NNE direction and NW-SE orientation of the tension axis (Tension area II). At the NE side of the landslide, movement took place on a surface dipping to the ESE, glide lines with NNE and NE direction, determining a zone of compressive events with orientation of the compressive axis to the NE-SW (Compressive area II). At least two older slip planes, with striations that have the same orientation as the recent ones, were determined at the sequential planes of the calc-crust, at the SE end of the compressive area II. At the SW section of the landslide, upwards the railway line, a tension zone was determined with tension axis orientation N-S and mass movement to the NNW at the most southern part, to the North at the middle part, and to the NNE when approaching the railway line (Tension area III). A compression zone by sequential compressive cracks was determined immediately downwards the morphological crest, which has planes with SW inclination and glide lines to the ENE (Compressive area III).

In conclusion, tension area (I) with compressive area (I), tension area (II) with compressive area (II), and tension area (II) with compressive area (III) define three different soil blocks of the unstable mass (Figure 5).

Figure 5 - Kinematic analysis of the landslide.

Two areas with distinct kinematic can be clearly defined by the movement vectors. The area which includes the western section of the landslide is defined by the poles 14 (5) and 5 (8) and the western boundary of the sliding mass (Figure 5). This section has been moved by 2.83m to the NE. The eastern section of the landslide shows its maximum movement at the central part, from 7.21m up to 7.75m, reducing at 6.57m up to 7.08m in its western and eastern margin. On the other hand, the eastern section of the landslide is divided, considering the direction of movement, into the western part, to the west of the poles 12 (3) and 6 (7) with a movement direction to the NNE, and the eastern part with a movement direction to the NNW (Figure 5).

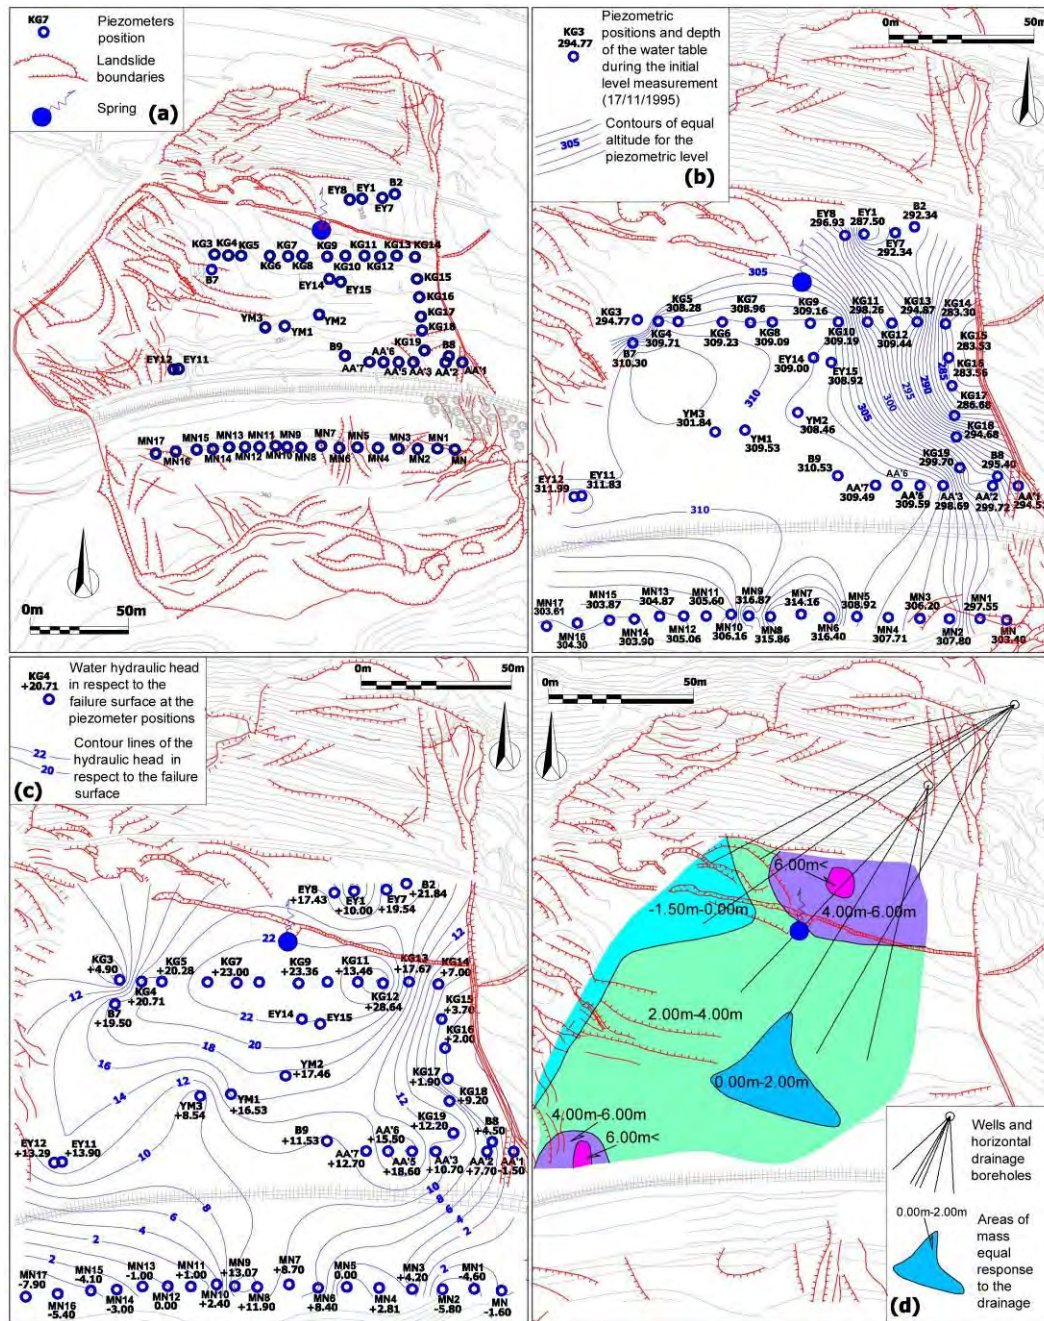
The spread of the Triassic and Neopalaeozoic limestone phases of the Parnitha Mt. favors the development of a rich karstic underground water potential. The spring at the landslide mass, in the altitude of +313 and with constant flow of 1.5m<sup>3</sup>/h to 2m<sup>3</sup>/h, is an overflow spring and gushes out at the contact between the entrapped, highly cracked, karstic, Palaeozoic, calcareous blocks and the impermeable schist-sandstone bedrock. Also, the discharge of high quantities of water during the winter, at the wider spring area and the slope upwards the railway line, shows the existence of a significant, unsteady, hydraulic load in the landslide mass, whose volume depends on the rainfall (Figure 2). The underground karstic aquifer is developed in the central section of the landslide, between the elevation contour lines of +335, at the railway line area, and +310, at the drainage cemented trench. From the piezometer measurements in 42 vertical drillings, distributed in three parallel to the motorway axis branches and a conjunctive vertical branch, arises that the groundwater table varies between 2.00 and 35.11 meters from the surface (Figure 6a). In the central and most extended section of the aquiferous zone, the piezometric level ranges between +305 and +310 and reduces sharp to the NW in +282 and smoothly to the South in +304, displaying a small mean hydraulic gradient of 5° to the North (Figure 6b).

The groundwater in the central section of the landslide mass forms a significant hydraulic head above the failure surface with a volume of 500.000m<sup>3</sup>. The distribution of the hydraulic head is not uniform, so there are four distinct areas which are recognized. At the northern section of the aquiferous zone, the hydraulic head is over 20m, at the central section is between 10m and 20m, at the southern and the eastern sections is between 0m and 10m, while at the southern and eastern margins the piezometric surface is lower than the failure surface (Figure 6c).

**Figure 6 - Maps of groundwater conditions in the Malakasa landslide. (a) Distribution of Casagrande type piezometers in the landslide mass. (b) Piezometric map of Malakasa landslide. (c) Potentially groundwater pressures on the slide rupture surface. (d) Response in the draining at the different locations in the slide mass by placing horizontal drains**

The response to the drainage was different from place to place. The western side of the central section of the landslide showed degradation of the piezometric level between 0m and 9m, while at the rest of the western side the piezometric level increased up to 1.5m. Consequently, there is a clear discrimination into two areas, one of increased ground water capacity, high hydraulic head, increased discharge volumes and quick recharge, at the central section of the aquifer zone, and one area of decreased respective hydraulic parameters at the eastern and northern borders (Figure 6d).

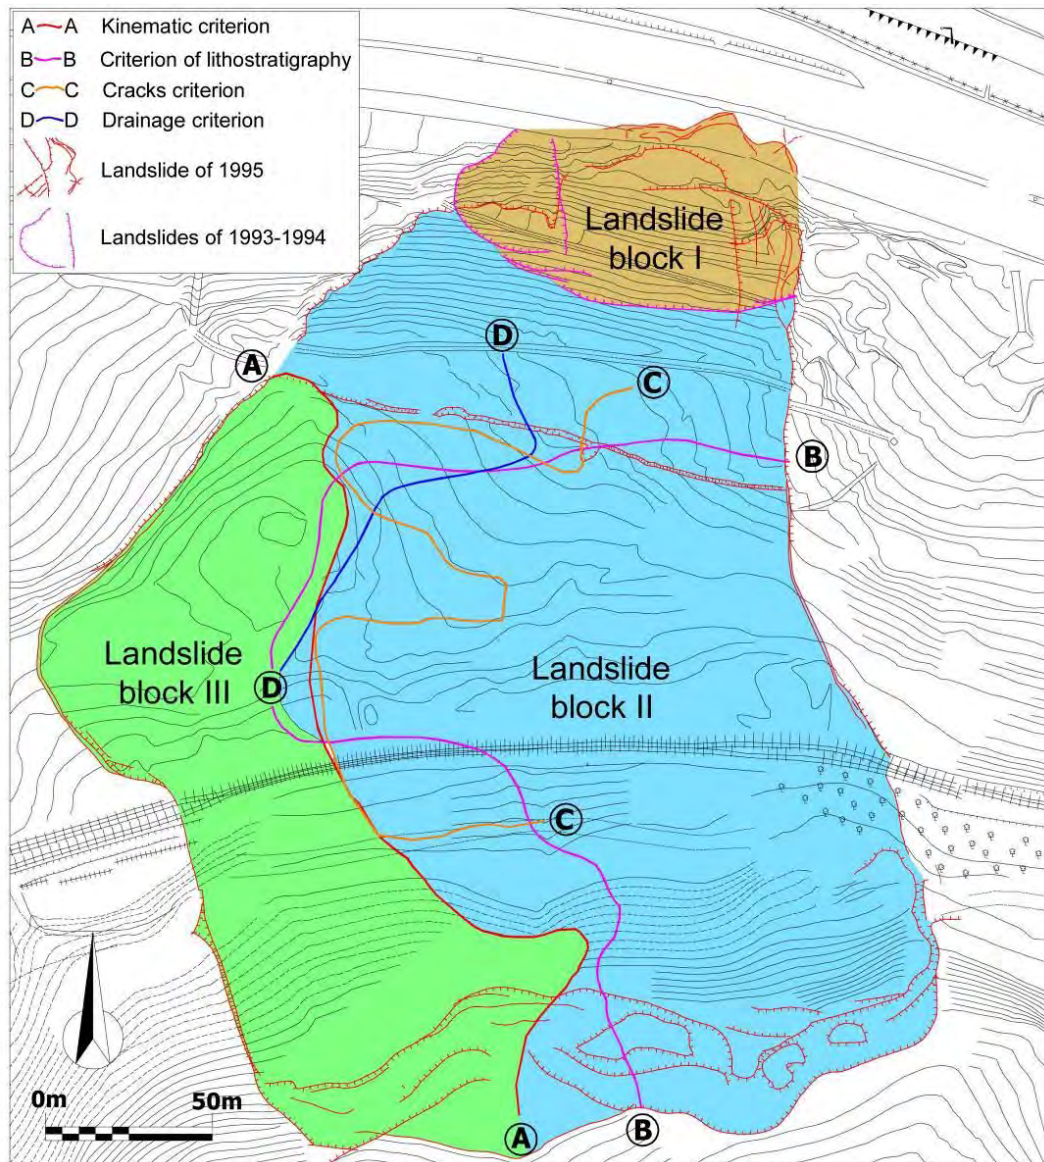
The landslide mass was separated into two distinct blocks: (i) to the eastern, and most extended block, with estimated volume of 993,000 m<sup>3</sup>, where the significantly folded and fractured, permeable calcareous mass of estimated volume 250,000 m<sup>3</sup> develops on the tectonically stressed and impermeable schist-sandstone mass and (ii) to the longitudinal western block of limited extend, with estimated volume 225,000 m<sup>3</sup>, where there are, exclusively, soil layers with increased permeability (Figure 7). The eastern block moved totally and independently, in respect to the western one, at NNE up to NE direction, with total horizontal movement of 7m and vertical movement of 2.50m. The tension and compressive cracks at the head and toe of the slope, respectively, accumulated at the periphery of the sliding mass and were totally absent from the central section due to its rigid nature. The western part of the sliding mass made up a distinct soil mass with independent spatial and temporal resultant movement to the North, total horizontal movement of 3m and vertical movement of 2m. The differential movement of 4m between the two fragments was covered through the numerous and dispersed cracks of the western section. The southern part of the eastern block seems to be an independent block which has boundaries that coincides with the failure of 1994. This soil block, with estimated volume of 63,000 m<sup>3</sup>, moved in NW up to NNW direction with clockwise sliding component, pushed by the upward section of the landslide (Figure 7).

From the discharge of the horizontal drainage drillings, which perforate the sliding mass radically in order to unload it, the great potential of the calcareous aquifer was determined, with the discharge flows being over 100 times than the one of the western section (Figure 7). The sequential older failure surfaces, which were determined to the NE end of the landslide and in

**Figure 7 - Delineation criteria of the soil blocks which form the landslide mass.**

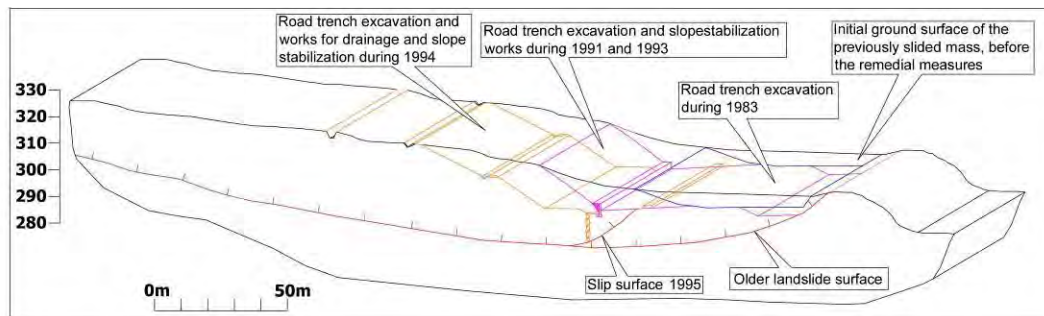
The gradual loss of support, caused by the sequential excavations in the slope toe made in a length of 110m, 155m in width and varied depth between 5m and 16m, in combination with the increased hydraulic head of the upward mass, was one of the most important factors for the landslide occurrence (Figure 8).

**Figure 8 - Representation of the different excavation stages for the figuration of the National Highway at the landslide toe.**
