CHARACTERIZATION AND CAUSES OF BUILDING STONE DECAY AT THE ARTEMIS TEMPLE, BRAURON, E. ATTICA, GREECE

Tsipoura-Vlachou M.¹, and Michopoulos K.¹

Abstract

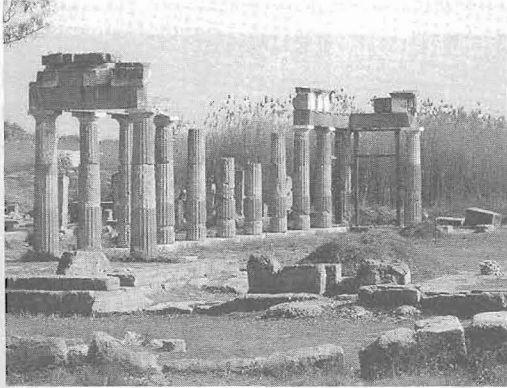
Figure 1 - View of the monument remains

2. Strong colour alteration- calcareous crust formation: observed in many column pieces having deep grey colour, instead of whitish-grey to beige colour of the new column pieces, used at the restoration, (Figs 1, 3, 14)

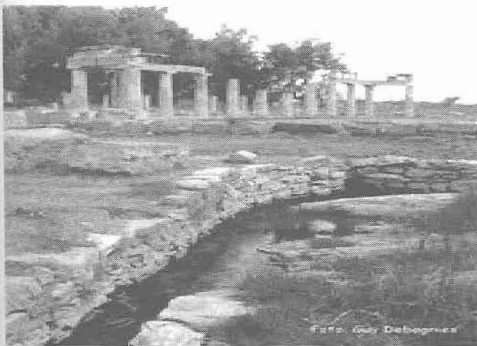
Figure 3 - The temple and Erasinos river

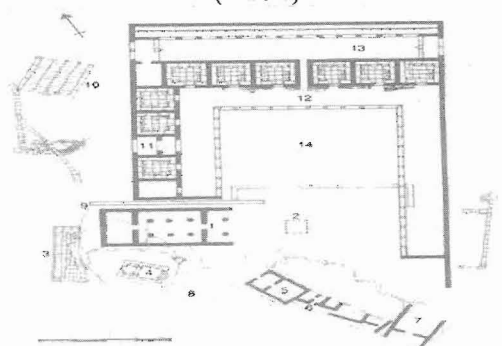
Figure 4 - Plan of Artemis Temple area. 1. Temple, 5. Iphigeneia heroon, 6. Iphigeneia tomb, 7. Sacred house, 12. Stoa 14. Courtyard

- From the building stones used for the construction of a. the Π shaped Portico b. the connected rooms and c. the sacred house, the alter and the tomb of Iphigenia, (Fig. 4).
- From the sandstone layers of the above-mentioned upper-Miocene formation where the ancient quarries were (figure 4). They are located in a near by hill 500m away from the temple, at northeast and the quarry traces are well preserved, (Buras 1967)

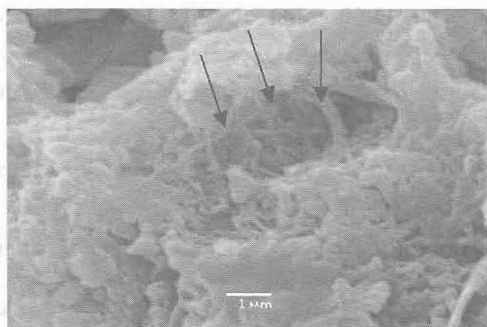
Figure 8 - Micromorphisms development in pores

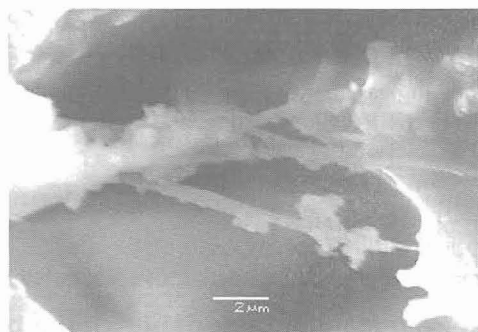
Figure 9 - Tiny crystals of halite

SEM analysis: Initial coarse calcite cement crystals are locally dissolute and secondary recrystallized calcite is formed. The locally presence of germs was observed. They have developed between the grains where the cement is dissolute (Fig. 8) and are bound to the grains. Tiny salt (NaCl) are developed in voids and pores creating bridges between grains (Fig. 9). Zircon also was found as isolated grains or constituent in rock fragments.

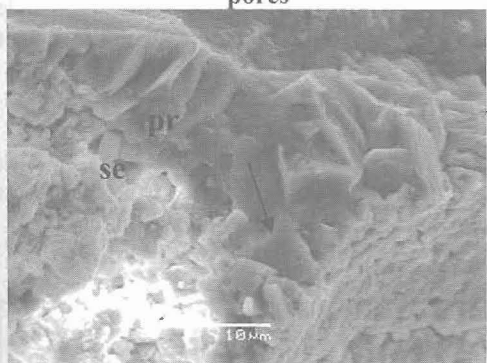
Figure 10 - Secondary calcite cement crystals (se), displaying coarser crystals than the primary calcite cement (pr), with dissolution pits (arrow)

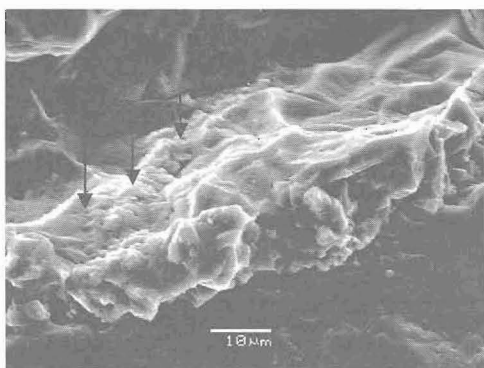
Figure 11 - Dissolution patterns and pits (arrow) on calcite cement, due to solution attack

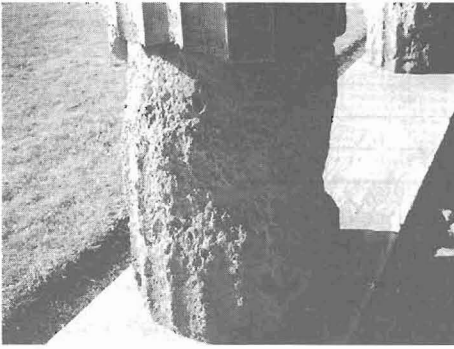
1. Pitting corrosion to cavitation erosion of graduated degree: the presence of vugs and cavities, large enough, approximately of 1-4 cm mean diameter, is very extensive, (Figs 12, 13, 16, 17, 18, 19). These vugs that were observed on many different pieces of the columns, seem to have diminished not only the durability, but also the good appearance of the monument, (Figs 13, 14, 15). When the cavities are getting enlarged they are connected by “bridges” (narrow areas of rock), (figure 13). Eventually bigger pieces are loosening and the result is a complete alteration of the original grooves and progressively of the shape of the column pieces (Figs 12, 13).

A close inspection of the building stones indicates that in the restored monument pieces of stone found in situ and other new pieces display different degree of decay. For example in figure 12, the lower part of the column, characterized by great material loose was found in situ, whereas the upper part is a new piece. The different stage of deterioration between the weathered source rock and the decayed building stone is quite obvious in figures 22, 23, 24 and 25. In the pair of figures 22-23 and 24-25 under the same magnification, rock samples from the quarries and samples of the building stones that correspond to the same lithotype, I and III, are compared. The degree of decay of the building stones is obvious. The calcareous cement is been partly dissolute. Pits, pores and vugs have developed. Progressive dissolution of cement leads to the formation of bigger pores and cavities. These cavities may be connected by narrow areas as “bridges” (Fig. 13), which progressively will be diminished. That gradually results to grain loose and material removal. The concave surfaces occupied previously by grains are obvious (Fig. 25).

Figure 12 - Honeycomb decay of bottom column piece of type I sandstone, and shape alteration

The three sandstone lithotypes are cemented by calcite. This is a feeble characteristic since acid water attack results easily to calcite dissolution, (Fig. 20). Vulnerability of stone to certain decay forms, as soluble minerals, is highly controlled by microstructural and mechanical characteristics of the stone (Leith, *et al.* 1996). When the cementing material is loose through solution, the mechanical properties of the stone are diminished. That results in rapid disintegration of the clasts. The consequence is the development of honeycomb forms, which is a usual decay form of sandstones, (Fig. 12).

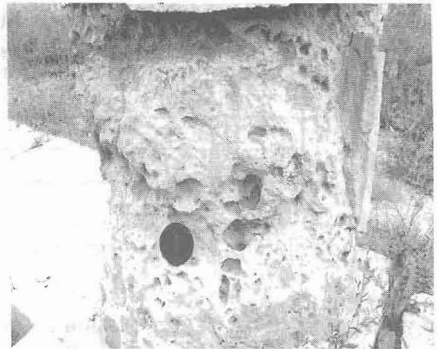
Calcareous crust was also observed on the column pieces, which were in contact to the capital, constructed of white Penteli marble, (Figs 13, 14).

Figure 13 - Severe decay of bottom column piece constructed of type III sandstone and shape alteration

Rock properties controlling the effects of acid rainwater or/and pore water include mineralogical composition and permeability. The later is again controlled by porosity, more particularly by pore size distribution. The three sandstone types display mean to high porosity. On this basis they are considered of poor quality for building material. The role of pore size distribution is clearly indicated in the decay patterns of sandstone type III, which displays the most intense decay problems compared to the other two types, while its mineralogical composition is similar to that of type I. With increasing porosity the attacking solution waters are able to penetrate deep into the rock. During dry periods of evaporation the salt solution are drawn by capillary action toward the surface, where precipitation may cause the development of a resistant crust over the deteriorated interior, (Figs 13, 15, 16).

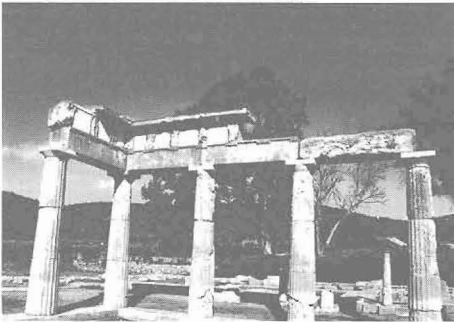
a whitish-grey sandstone found in situ and b: beige (light brown) sandstone cut from the nearby quarry. These two stone materials show different degree of corrosion. The former (Figs 14, 16) displays strong cavity corrosion and colour alteration (calcareous crust), while the latter displays pit and cavity corrosion of a lower degree (Figs 14, 17).

Figure 14 - Different degree of decay on capitals and Calcareous crust development

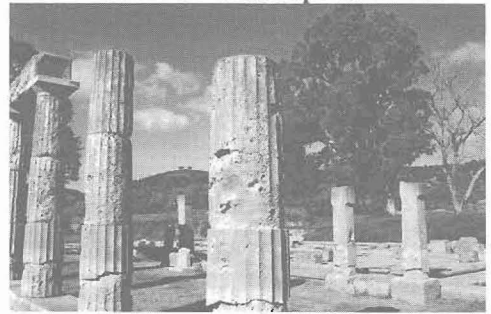
The more intense decay problems appear on the portico columns, (Figs 12, 13, 14, 15). The sandstone of the columns seems to be strongly deteriorated. The different types of decay can be summarized

Figure 15 - Different degree of decay on column pieces

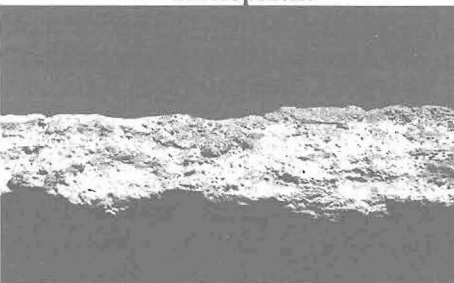
Figure 16 - Capital constructed by lithotype I illustrating high vuggy decay, shape alteration- material loss and crust development

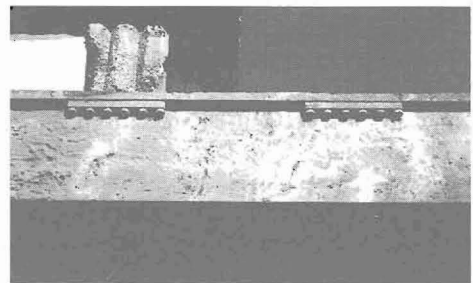
Figure 17 - capital constructed by lithotype II illustrating vuggy decay and color alteration

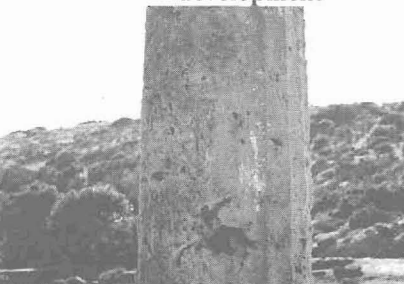
Figure 18 - Intence decay form on sandstone type III

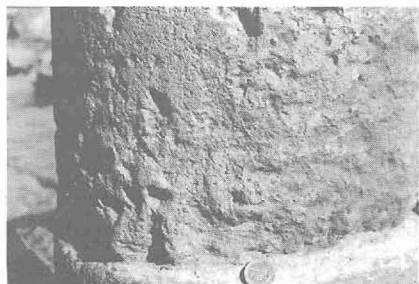
Figure 19 - decay form on sandstone type I

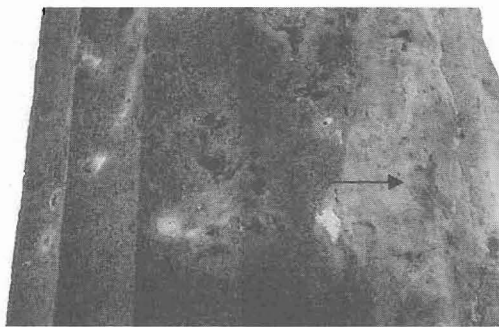
Figure 20 - Cavities and calcareous crust on column piece (arrow)

well as along cracks, (Webley *et al.* 1963, Winnkler 1966). Since the stones have been covered by mud for a substantial period of time and are still influenced by the periodical presence of the water, the development of communities is expected (Michopoulos 2005), (Figs 20, 21) and has considerable impact on stone decay.

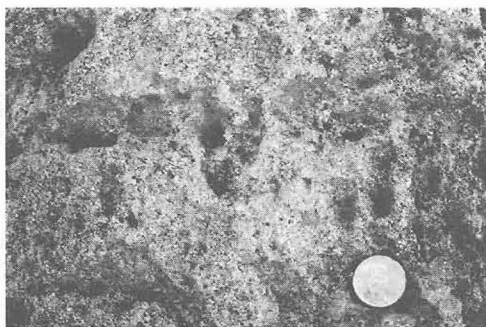
Figure 21 - Development of calcareous crust (white areas)

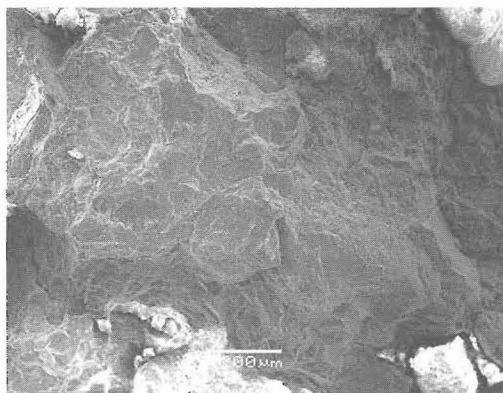
Figure 22 - lithotype I-quarry

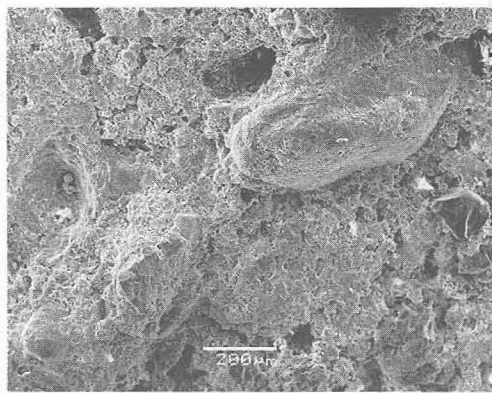
Figure 23 - lithotype type I-monument

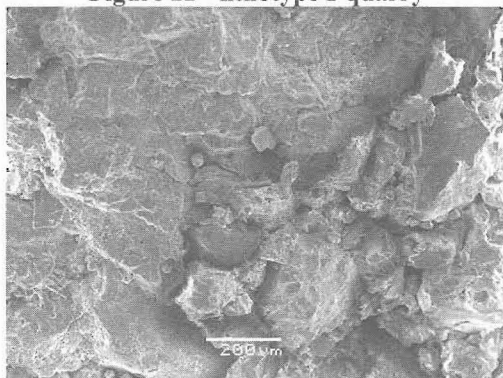
Figure 24 - lithotype III-quarry

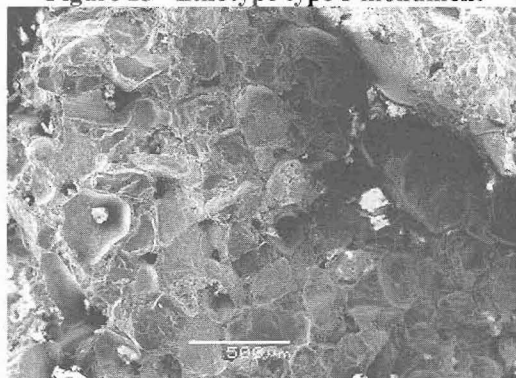
Figure 25 - Litho type III-monument

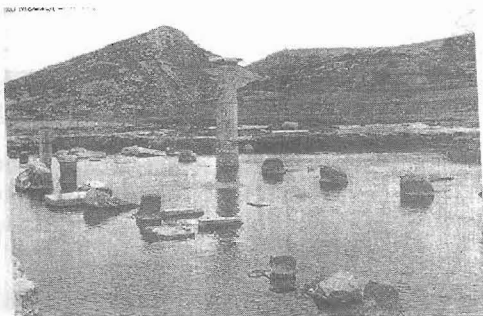
Although Erasinos is a small river, it is flooding after strong and intense rainfalls. (Figs 26, 27). Then the waters caring along mineral materials as bed load or in suspension, cover all the area of the monument, (Fig. 16), for considerable period, until the waters withdraw. The water drainage area of Erasinos is large enough including locations as Attica Road, Venizelos airport, Marcopoulo city. Rainwaters and Municipal wastewater treatment from the above areas are driven into the bedload of Erasinos. This might be a possible pollution source for the river waters that reinforce the ion and bio content. Running water picks up ions on its way downstream or loses ions by absorption to clay particles. The flow through stone pores and narrow channels gives the water enough time to reach near equilibrium condition quickly in the presence of calcium carbonate in the stones. The ion content of groundwater is subject to extreme variation depending on both the source rock and the length of travel; groundwater is generally high in Ca, Mg, SO₄, Cl, and Fe. Saline groundwater that usually indicates invasion of corrosive marine water cannot be excluded even in the present since distance from the shore is short and wetlands partly and periodically exist. Soluble salts are considered to be the key-deteriorating factor of building materials in the case of monuments and historic buildings (Arnold 1989). During salt crystallization pressure crystallization occurs within the pores of rocks, and degree of weathering is depends on the degree of salt saturation of the solution and the pore size (Benavente *et al.* 1999).

Figure 26 - Brauron monument before the restoration works (photo by Bouras 1967)

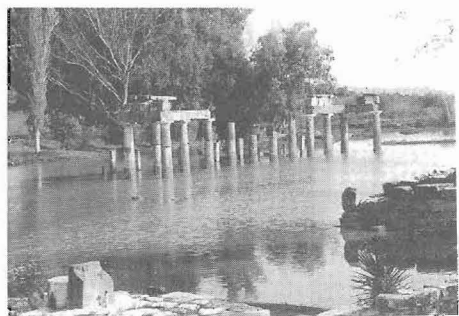
Figure 27 - Brauron monument (26/11/2005) Erasinos flooded after strong rainfalls

Unfortunately flood controls are not sufficient and the phenomenon goes on for centuries, increasing the stone decay by the river or/and seawaters. In addition, the columns side mainly of the new stones, facing toward northeast are affected by marine aerosol and display stronger decay degree due to salt crystallization. The rate of decay is at its greatest when the cycling of the crystallization–hydration cycles is relatively infrequent. It is the length of this ‘drying’ period that apparently has the greatest influence on the rate of decay and could explain the significant difference in the rate of decay between different stone pieces. (Colston *et al.* 2001).
