THE FLUVIAL ACTION OF THE KARLA BASIN STREAMS IN A NATURAL AND MAN – MADE ENVIRONMENT

Abstract

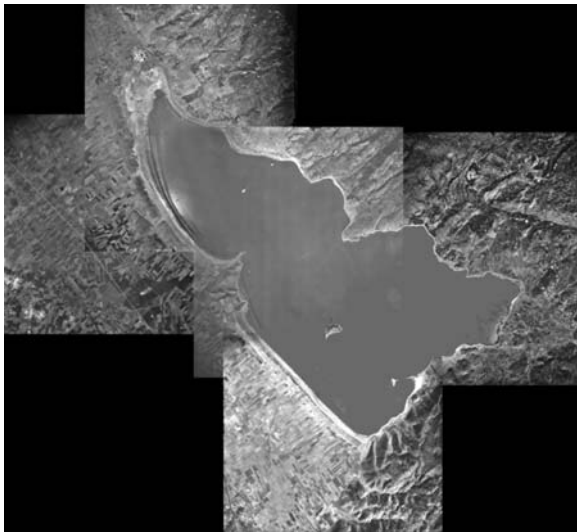
Fig. 2: Aerial photos of the year 1945, illustrating former Lake Karla (Moumou, 2007).

During the Middle Neolithic age, the level of the lake was over 50m (Apostolopoulou – Kakavogianni, 1979), reaching a maximum water level of 64m a.s.l. during the Mycenaean Age (Grundmann, 1937; Gallis, 1989; Palikaridou, 1998). Also, it is known that the water levels in 1921 and 1953 reached 50.10m and 45.85m, respectively (Ananiadis 1956; Palikaridou, 1998). Finally, through the use of aerial photos taken in 1945 the water surface of the former Lake Karla was calculated at 78.35 km² (Fig. 2).

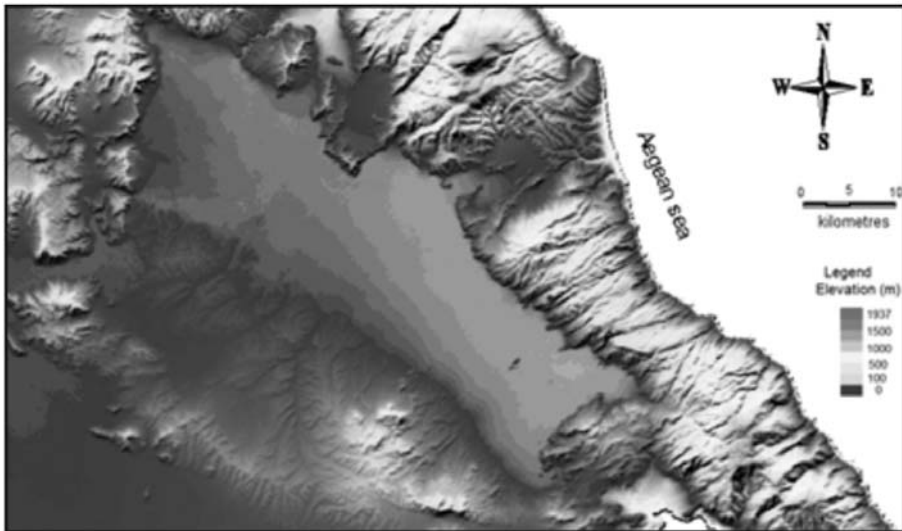
Fig. 3: Digital elevation model (DEM) of the studied area.

A terrain analysis was performed in order to study the morphology of the lower part of the basin. The vertical accuracy of the HMGS topographic maps was not suitable for the study of these low relief areas. Thus, a DEM derived from the SRTM data (Shuttle Radar Topography Mission) was used. (Fig. 3)

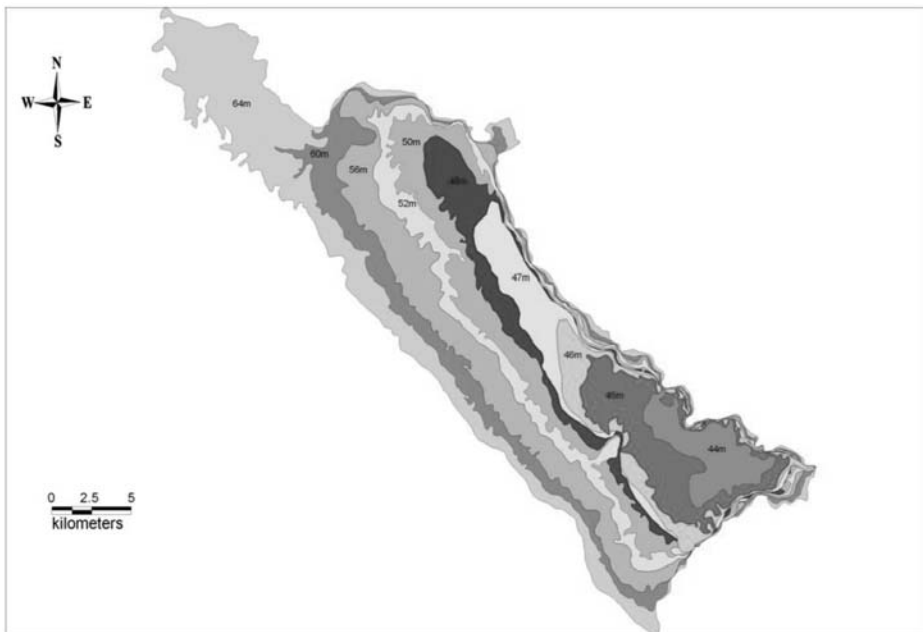
Fig. 4: Stages of shoreline migration derived from the terrain analysis of DEM data.

In order to correlate the upstream erosion rates and the channel's morphological changes with the lowered base level of the drained lake, it was necessary to know the location of the lake's shorelines and their fluctuations. Therefore, with the use of the elevation model for the absolute elevations of 44m, 45m, 46m, 47m, 48m, 50m, 52m, 56m, 60m, and 64m, a restoration of the water surface and the water volume of Lake Karla was attempted (Fig. 4, 5, Table 2).

The study of the shoreline's location obtained from the elevation model showed a large migration to the basin's center due to the constant drop in the lake's water level. On the western side of the basin, with regard to the total lowering of the lake's water level, a displacement of 4.5km was estimated. On the opposite side of the basin (SE) the displacement was estimated at 1.6km, while in the eastern part the average displacement was only 500m. These displacements have greatly affected the fluvial – erosional action of streams located in that area.

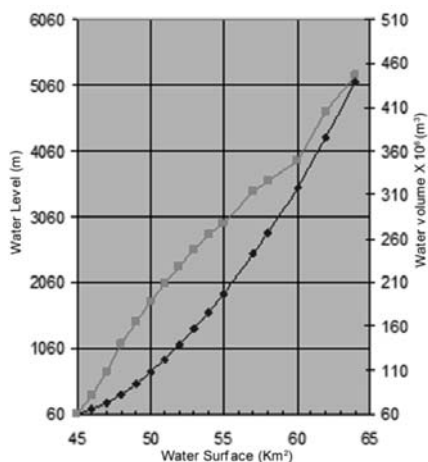
Fig. 5: Plot diagram of water level - water surface and water volume – water surface.

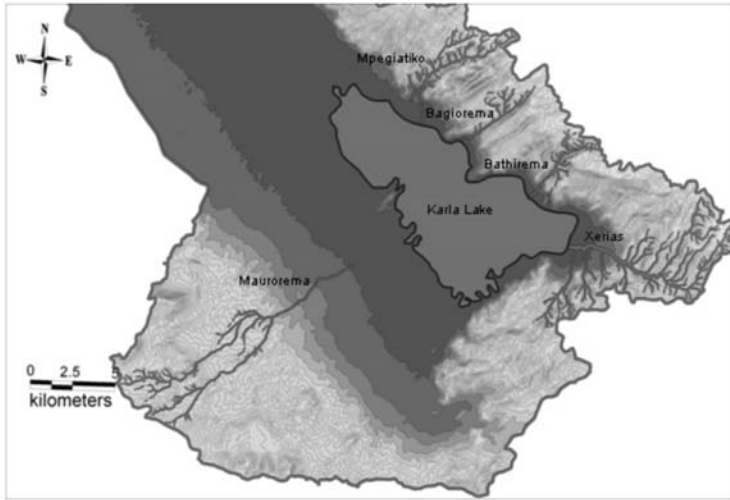
Fig. 6: Regional setting of the five main channels that were selected for the field study.

Following the aforementioned criteria, the study focused on five main channels of the following flumes: Mpegiatiko, Bagiorema, Bathirema, Xerias and Maurorema (Fig. 6)

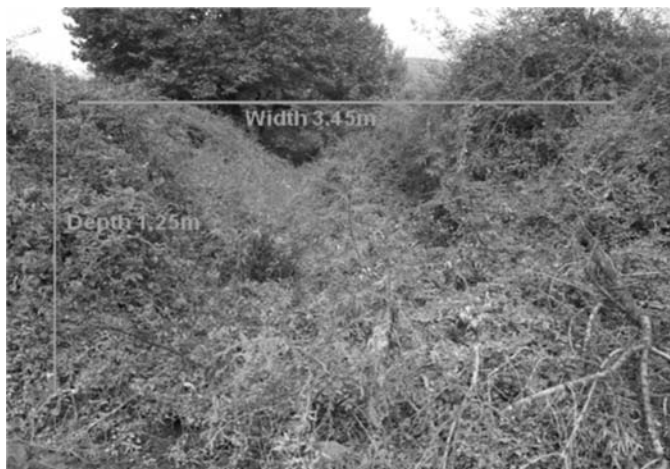
Fig. 7: Photo of Mpegiatiko stream showing the dense vegetation inside the channel bed.

The field study performed on the stream of Mpegiatiko showed that it is a seasonal flow stream, whose interior presents a wide channel bed with dense vegetation. No erosion was measured in the channel, apart from some incidents in the past. (Fig. 7) As the results from the morphological profile of the studied channel segment showed, the average slope is 2.8%.

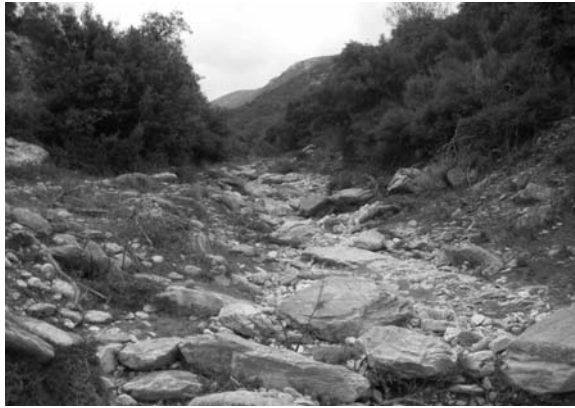
Fig. 8: Bed river of Bagiorema stream with the prevailing coarse-grained materials.

The field study for this stream showed that it is a seasonal flow stream, presenting a small hydrological basin. The coarse-grained materials of the river bed have been a restraining factor in the erosive processes (Fig. 8). The morphological profile showed that the average slope of the Bagiorema studied channel segment amounts to 6.6%.

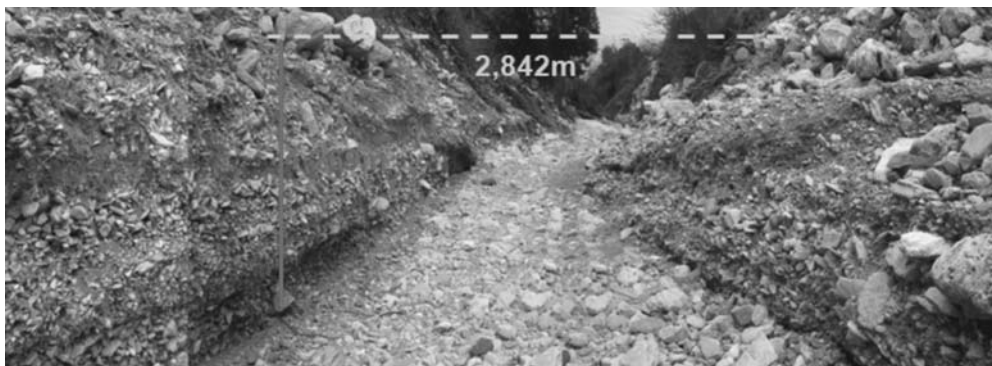
Fig. 9: Photo of Bathurema stream showing the coarse grain size of the alluvial deposits.

The field study for the stream of Bathirema showed that it is a seasonal flow stream. The various incidents of erosion measured are older stream terraces unrelated to the recent changes in the area after the drainage of the lake. A restraining factor in the erosive processes, despite the large slope of the streambed, has been the coarse grain size of the alluvial deposits on the channel bed, and the short period of time that has elapsed since the base level change (Fig. 9). The morphological profile

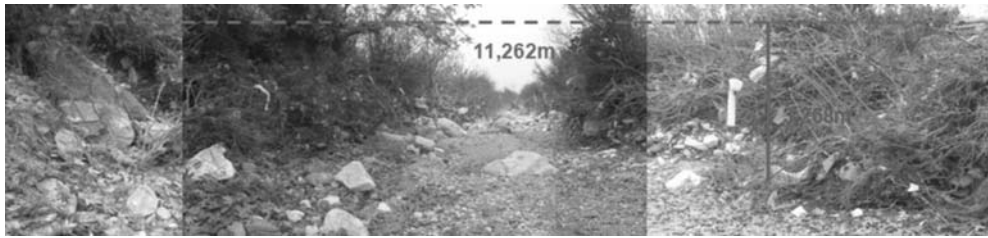
Fig. 10: Photo of Xerias stream. No erosion has been observed.

The field study undertaken for the stream Xerias showed that it is a stream with a large hydrological basin and high peaks in flow discharges. The stream flow in combination with the gentle channel slopes allowed a shortage of the streambed's alluvial sediments (coarse-grained materials close to the apex and sandy sediments further downstream). The final change of the base level after the drainage of the lake shifted the coarse bedload further downwards (Fig. 10). Finally, the processing of the morphological profile gave us an average slope channel segment of 1.8% for Xerias.

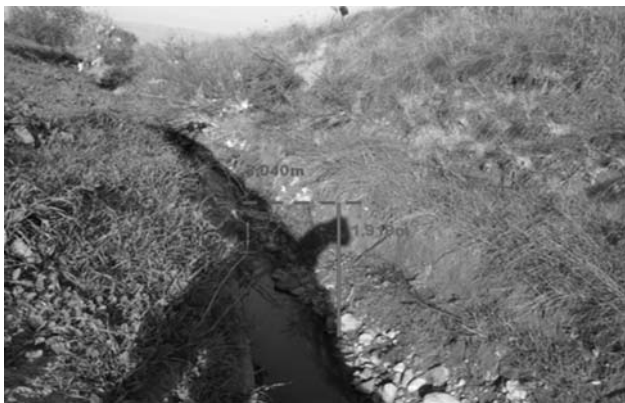
Fig. 11: Photo of Maurorema stream showing the V - type erosion inside the channel.

In the field study of the stream of Maurorema the characteristic V-type erosion was measured inside the channel, which is recent and related to the drained Lake Karla (Fig. 11). The last flood event in combination with the gentle slope of the channel segment and the fine-grained bottom are responsible for the upstream erosion and the formation of a new graded channel profile. The average slope of the studied channel segment is 1.15%.
