PRELIMINARY RESULTS REGARDING THE ROCK FALLS OF DECEMBER 17, 2009 AT TEMPI, GREECE

Christaras B.¹, Papathanassiou G.¹, Vouvalidis K.², Pavlides S.¹

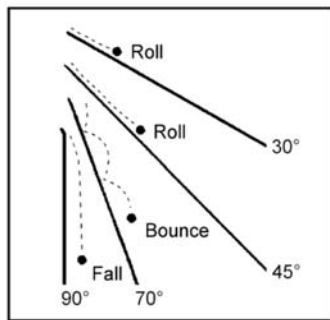
Fig. 1: The three most important modes of motion (from Dorren 2003).

After the rock has been detached it descends the slope in different modes of motion mainly depending the mean slope gradient. The three most important modes of motion (Fig.1) are freefall through the air, bouncing on the slope surface and rolling over the slope surface (Dorren, 2003).

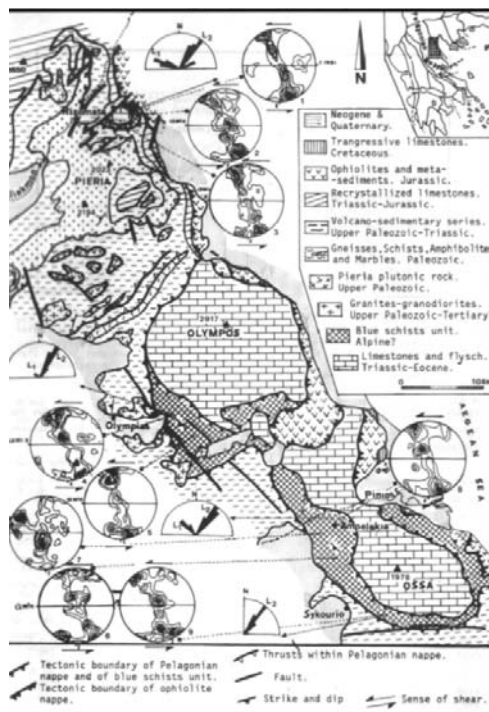
Fig. 4: Geological map of the Olympos Ossa window (from Kiliias et al., 1991). The rock falls area is located in Ambelakia – Ossa unit.

The area of study is located in the inner part of Pinios straits (Tempi valley) between the Mounts of Olympus and Ossa. It is located within the Pelagonian zone (Aubuin 1959, Mountrakis 1984) between the geological masses of the Olympus and Ossa Mounts. The structural sequence in the Mt. Olympus region of the Pelagonian zone, from top to bottom, comprises (Schmitt 1983, Schermer 1993): (A) the *ophiolite unit*, consisting of ophiolitic igneous rocks, in coherent thrust sheets and serpentinite-matrix melange, overlain by limestone; (B) the *Infrapierien unit*, gneiss and schist overlain by metasedimentary and metavolcanic rocks and Triassic-Jurassic neritic carbonate rocks; (C) the *Pierien unit*, Paleozoic granitic gneiss overlain by a thin metaclastic sequence and Triassic- Jurassic neritic carbonate rocks; (D) the *Ambelakia unit*, continental margin carbonate and quartzofeldspathic sedimentary rocks, and basic to intermediate volcanic rocks of uncertain age; and (E) the *Olympos unit*, Triassic and Lower Cretaceous to Eocene neritic carbonate rocks overlain by Eocene flysch (Godfriaux 1968, Schmitt 1983). The rock falls area is placed in Ambelakia Unit (Fig. 4).

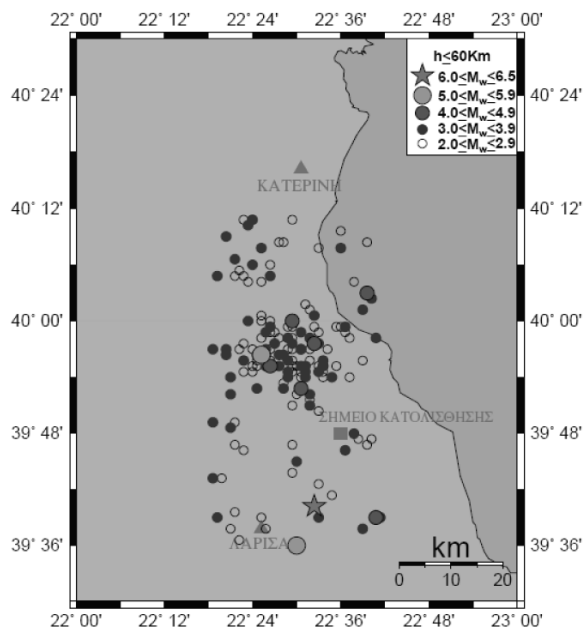
Fig. 5: Map showing the distribution of earthquake epicenters.

Therefore, historical seismicity information of the area was collected regarding the instrumental period in order to examine the occurrence of earthquakes capable to generate rockfalls within the area of Tempi. As it can be seen on Table 1, many events of magnitude $M > 4$ occurred in the vicinity of study area (fig. 5), thus the parameter of active tectonic should be taken into account during the construction of remedial measures.

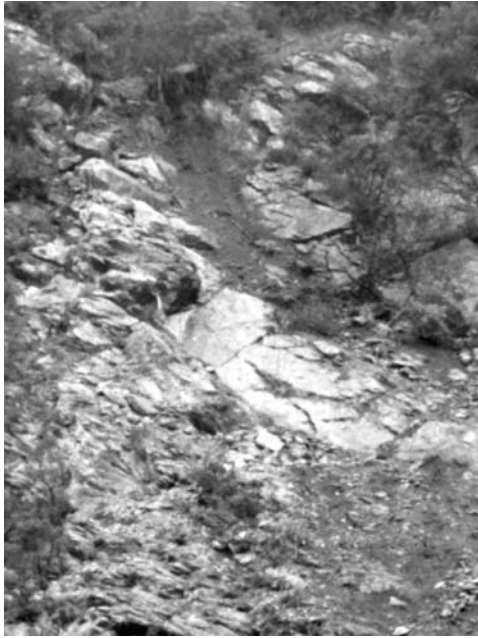
Fig. 6: The initiation of the slope failure originated as sliding along the joint 350/47.

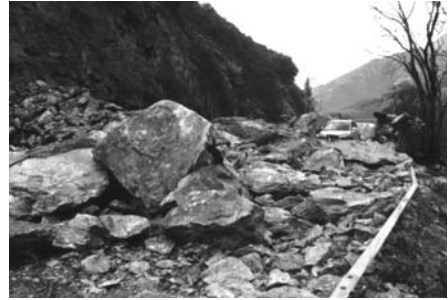
Fig. 7: Boulders on the road.

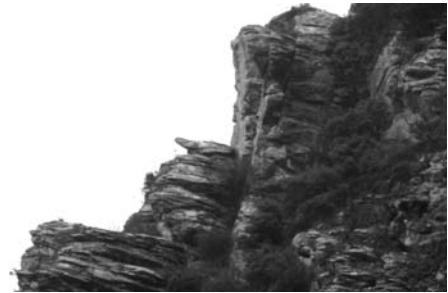
Fig. 8: Bedding 110/10 and fault 20/80.

Three main tectonic systems are found in the area, given in Table 2. In the area where the failure was generated most unstable conditions of rock slopes are related to planar weaknesses. Wedge failures most likely where line of intersection of two fracture planes dips $< \phi$ and daylight in slope. The studied failure started by the sliding of a big block along the joint 350/47 (Fig. 6) which activated and drifted smaller geomaterials, down slope, toward the road (Fig. 7). The bedding of the crystalline limestone is $110/10$ (Fig. 8). The related stability analysis of the slope is given in Fig. 9.

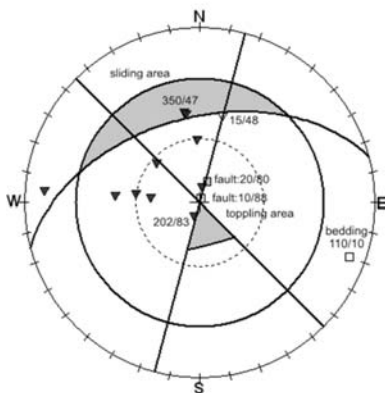
Tempi discontinuities at the slope of failure			
Discontinuity	Structure	Dip direction	Dip
1	large joint	350	47
2	large joint	277	60
3	fault	20	80
4	large joint	351	48
5	fault	10	88
6	bedding	110	10
7	large joint	357	61
8	large joint	8	83
9	large joint	15	48
10	large joint	311	63
11	large joint	274	12
12	large joint	275	67
13	large joint	202	83
14	large joint	274	50

Fig. 9: Stereographic projection of the planes mapped on the rock slope in order to estimate the sliding potential.

According to Fig. 9, joint 350/47, corresponded to the field observed sliding surface, is limited included in the sliding area of stability analysis diagram, confirming the limited stability of the slope. This block was retaining in situ, for long time, as joint surfaces are not, usually, totally open, but some small retaining "bridges", remain inside the rock-mass and keep the stone parts together. Another joint, with data: 15/48, also gives limited safety conditions, even for dry con-

dition, found on the boundary line of the sliding area. Furthermore, another joint, with data: 202/83, is found, on the boundary line of the toppling area of the diagram of Fig. 9. The above data give the impression of a slope with limited general stability, which could decrease in heavy rain conditions, as happened in the studied case.
