EVALUATING THE TRIGGERING FACTORS OF THE ROCK FALLS OF 16TH AND 21ST DECEMBER 2009 IN NEA FOKEA, CHALKIDIKI, NORTHERN GREECE

Christaras B.¹, Syrides G.¹, Papathanassiou G.¹, Chatzipetros A.¹,
Mavromatis T. ¹, Pavlides Sp.¹

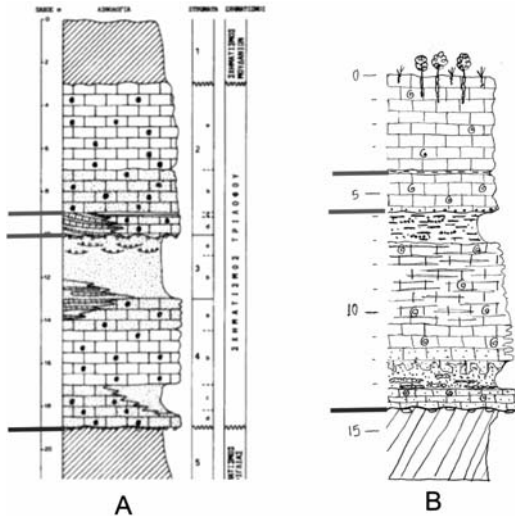
Fig. 2: A) Stratigraphic column of the sediments in Nea Fokea – Athytos area (Syrides 1990) and b) stratigraphic column of the study area.

A stratigraphic column (Fig 2a) for the sediments exposed in the area of Nea Fokea – Athytos villages is given by Syrides (1990),

The stratigraphy (fig 2b) of the sediments along the rock falls is very similar with that (fig 2a) of Syrides (1990) for the wider area, while differences are observed due to the lateral changes of the various beds.

From a stratigraphic point of view, three “weak horizons” of low strength are defined in this column (fig 2b); a thin layer of grey-whitish cohesive clay (bed 2c) pointed as grey line, a second layer of reddish-brown sandy loam (bed 3) (red line depicts the contact between 2 and c beds) and a third layer defined as the contact (violet line) between the base of the Trilophos Fm limestone and the Triglia Fm red beds.

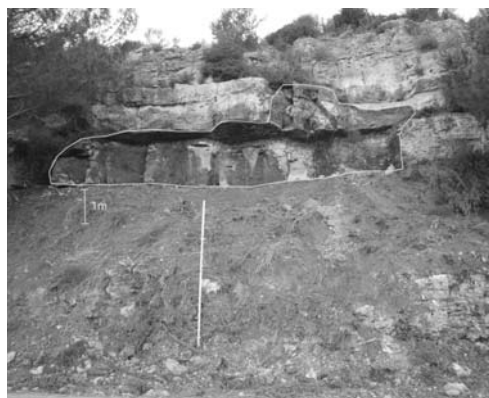
Fig. 3: Source area of the rock falls occurred on December 16, 2009.

More specifically, on Wednesday, December 16 at 21:30, two large size boulders of 6-8 m³ detached from a height of 8 m and fell onto the road. This rock fall event forced the local authorities to temporarily close the road for few hours in order to remove the fallen blocks and construct a new protective metal barrier along the steep slope of the road cut.

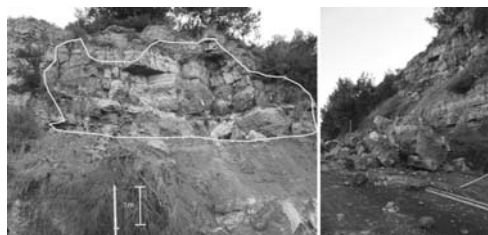
Fig. 4: Source area of the December 21, 2009 rock falls.

However, few days later, on Monday morning of December 21st, a larger scale slope failure happened. As shown in figure 4, boulders with volume ranging from 2 to 15m³ fell on the road from a height of 10 meters, causing the permanent closure of the country road. A few hours after the second slope failure, a field survey took place in order to examine the rock falls and evaluate the triggering factors.

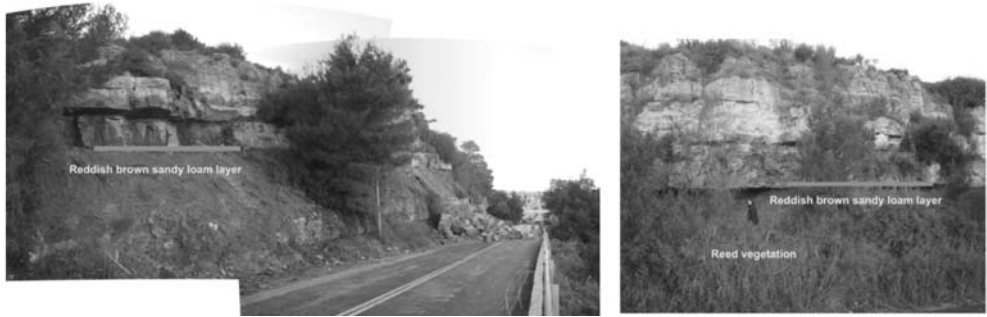
Fig. 7. The layer of reddish-brown sandy loam is slowly washed out by the percolating water from the overlying limestone (note the beginning of undercutting). The water favors thick reed vegetation. It is a matter of time this slow process to undercut the limestone causing a rockfall in this place in the future.

It is remarkable that within the limestone numerous vertical cracks allow the percolating water to pass downwards, but the intercalation of reddish-brown sandy layer (bed 3) between the limestone beds causes the drying up of the water from the superimposed limestone along this contact. As a result, thick reed vegetation appears along and below the contact. It is also remarkable that this bed of reddish sandy loam prevents water from percolating in the lower strata, resulting to the dryness of contact between the base of the limestone (Trilophos Fm.) and the top of the red beds (Triglia Fm.).

the unstable conditions that were created these specific two days (16th and 21st of December 2009), thus concluding that in both cases the rock falls were generated by the undercut of the reddish brown sandy loam bed.
