## MINEROLOGICAL AND PHYSICO-CHEMICAL PROPERTIES OF THE BUILDING MATERIALS OF KOULE CASTLE, HERAKLION, CRETE

### Abstract

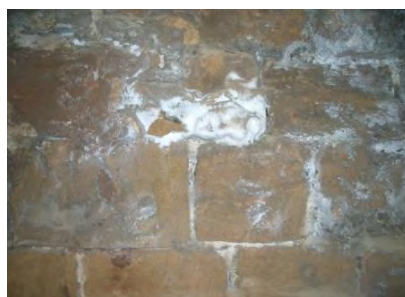
**Figure 2 - Salt efflorescence on the external wall of Koule Castle, Heraklion, Crete.**

Five core samples of rocks and masonry mortars have been extracted by the 13th Municipality of Byzantine Antiquities from different parts of the monument (Table 1). The core samples consist of three rock + mortar specimens and two rock specimens. Various analyses were carried out, in order to determine their physical and technical characteristics as well as their deterioration state. The rock specimens present in their majority salt efflorescence (Fig.2) due to the sea water that enters the Castle.

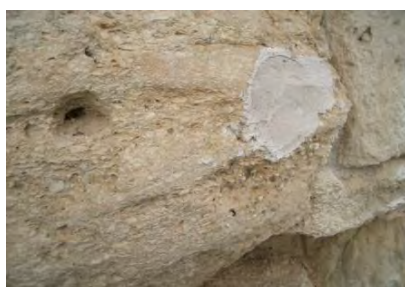
**Figure 3 - Sampling position of a building stone from the internal wall of Koule Castle. The drill hole was covered with a non compatible mortar.**

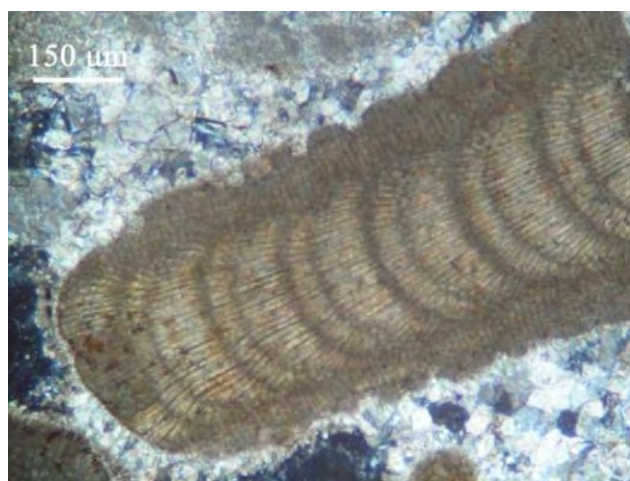
**Figure 4 - Thin section photograph of bioclastic limestone. ⊥ pollars (specimen 1).**

The building stones of Koule Castle are sedimentary rocks, excavated nearby the harbor of Heraklion, where the monument was constructed. In their majority, they are bioclastic limestones with various marine fossils (Fig.4), micritic breccias (Fig.5) and micritic conglomerate limestones. Dolomitic limestones exist only in the pavement of the Castle.
