Extreme terrain deformation in an uncontrolled waste disposal plant in Andros Island.

Key words: Uncontrolled waste disposal plant, extreme rainfall, terrain deformation, Andros Island.

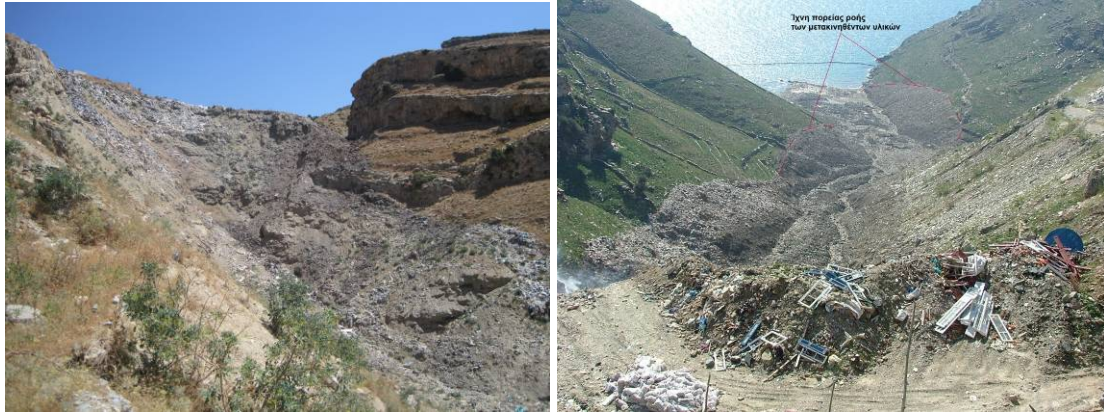
Figure 1 a. View of the newly formed steep slopes, b. View of the waste material flow.

Distinctive geomorphologic changes have been recorded either as a consequence of human activities or as a consequence of extreme natural events, such as heavy rainfall and seismic activity (Burton et al. 1978; Price et al. 2011). Concerning human activities, large scale anthropogenic landscape changes have been recorded after extensive mining activity or urban waste disposal practises (Kerle 2002). These activities could be thought as the main topographic change agents that often lead to the occurrence of extensive catastrophic events. The present study describes such extreme terrain deformations encountered in an uncontrolled waste disposal in the island of Andros, Greece. The current plant has operated for decades using as recipient the natural valley of the nearby stream delimiting the peninsula. A huge slope failure occurred after an extreme rainfall episode, over 70mm, in February of 2011 causing extensive destruction of the site. Massive quantities of waste material (over 35.000 m³) were swept away by the running waters and ended in the adjust stream. The displacement of the waste masses formed very steep slopes at the disposal material cone, forming highly unstable slopes (fig 1a). The extreme flows of the masses were identified by the trace left by the movement along the slope of the stream (fig 1b).

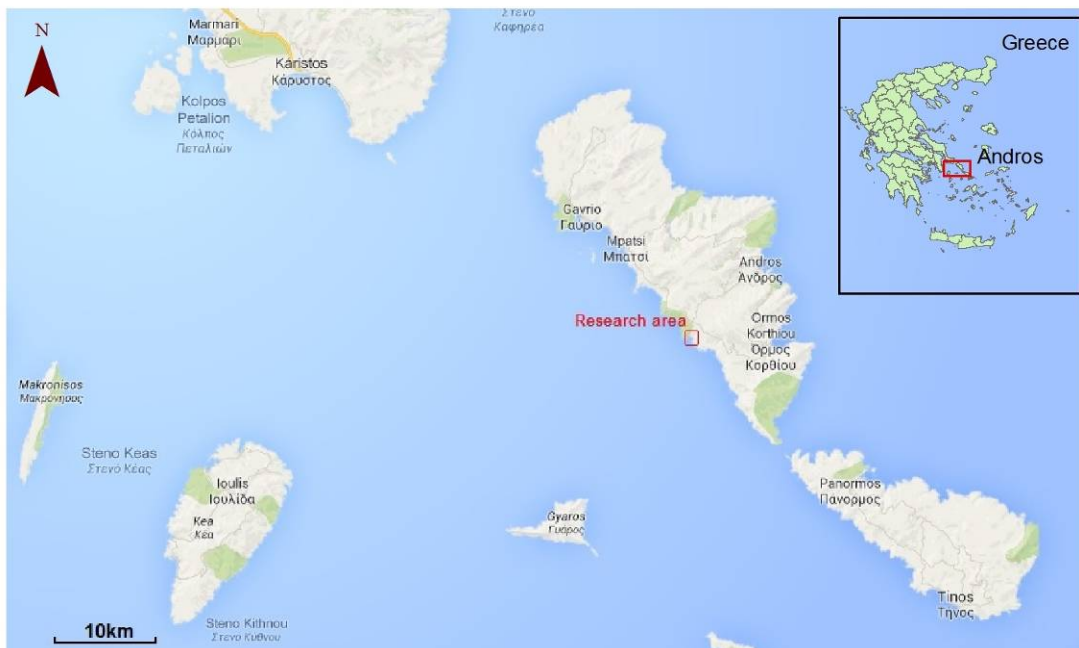
Figure 2 The study area

The waste disposal plant is located in the island of Andros at the Strofilas peninsula and served the needs of residents of the municipalities of Andros, Korthiou, Idrousa, and also local communities over 32 years. Andros is the northernmost island of the Greek Cyclades archipelago, approximately 10 km south east of Euboea, and about 3 km north of Tinos (fig 2).

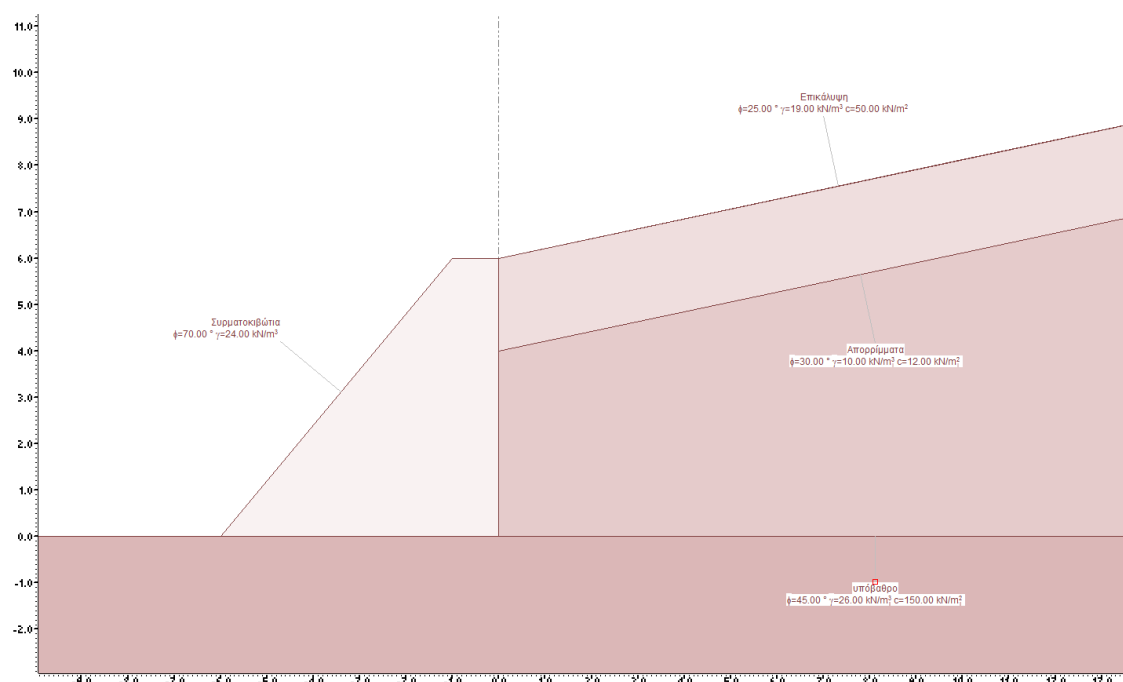
To select the location of the retaining wall it was necessary to satisfy three (3) conditions: First of all, the retaining wall must be founded on the bedrock. Secondly, the retaining wall should be founded in a place with no debris material since if present the construction of its foundation may cause instability problems and finally the retaining wall should be founded in a place upstream to avoid taking additional measures for potential runoff problems. According to these, the optimum position for the foundation of the retaining wall was located approximately 150m from the shoreline, with 4m height and foundation width 3m. Note that, addition 1.5 - 2m of height will be needed for coating materials that will cover the surface. The retaining wall should be manufactured with galvanized gabion to prevent their oxidation. To test the stability of the proposed retaining wall several runs have been executed using the computational package Larix a program for geotechnical analyses based on classic methods (fig 6).

Figure 6 The geometry of the retaining wall resolved using the computational package Larix.

- Construction of a retaining wall within the stream in order to allow secure configuration of the volume of waste repository.
- Lowering the deposition cone and safely transport the waste masses in place that will be formed after the construction of the retaining wall. The masses behind the wall should be formed with a slope less or equal to 1:3.
- Removal of the waste masses from the seaside.
- Topping the waste repository with specific soil layers and geosynthetics.

Larix estimates the safety factor for sliding by formulating the global equilibrium forces acting on a slice according to the well known methods of Janbu (Janbu 1954; Janbu et al. 1956; Janbu 1957) and Krey (Krey 1936). The analyses were carried out using both, Janbu and Krey methods, taking into account the worst height scenario (6m) and the most conservative mechanical parameters (Tab 1).

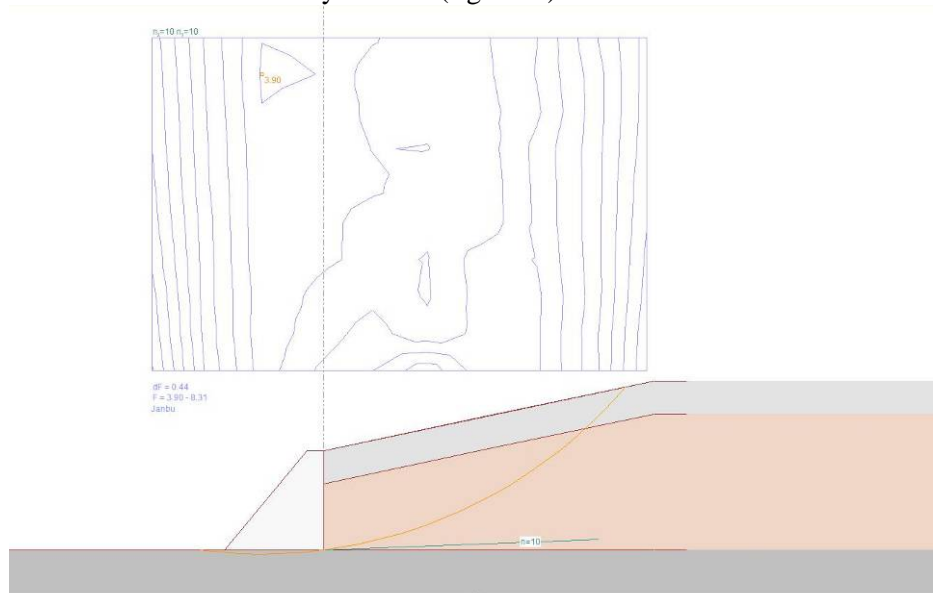
The outcomes of the analysis indicated that the proposed retaining wall will not exhibit any stability problems and is safe. The minimal safety factors were estimated to be 3.9 for the Janbu method and 4.2 for the Krey method (fig 7 – 8).

Figure 7 The results of stability analysis implementing Janbu method.

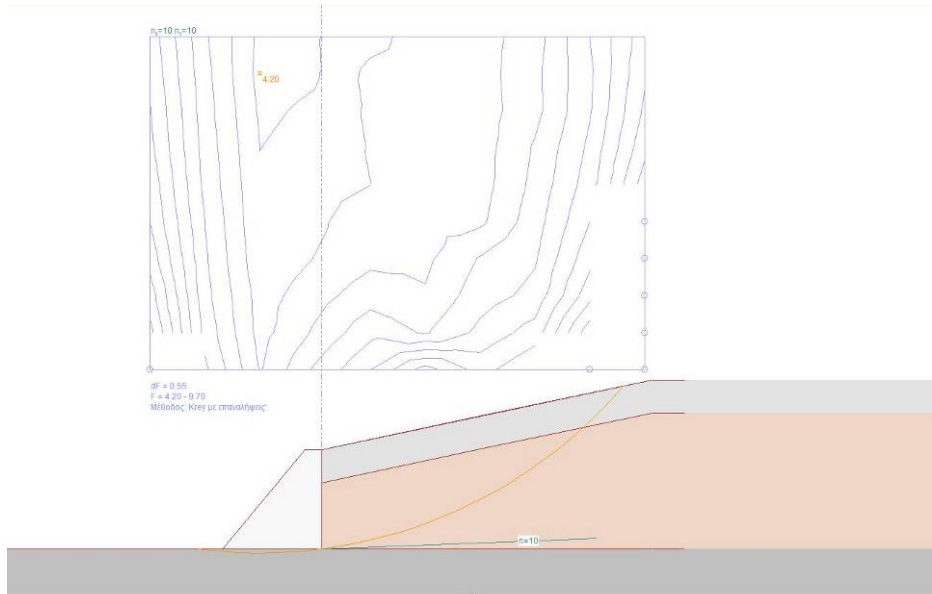
Figure 8 The results of stability analysis implementing Krey method.

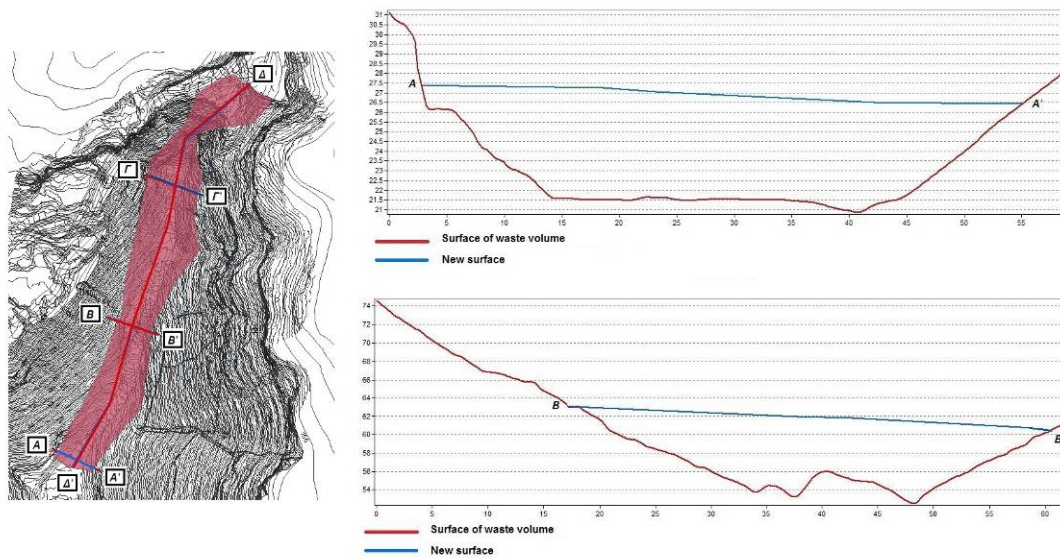
In order to eliminate any risk and to avoid another failure the remodeling of the entire volume of waste is necessary by creating a new repository with gentle slopes. More specifically, it is suggested to safely transport the waste masses along the riverbed and form new slopes less or equal to 1:3. Figure 9 and 10 illustrate the suggested new surface along with four (4) surface profiles that show the post – event surface of the waste volume and the new suggested surface.

Figure 9 The suggested new surface profiles a –b

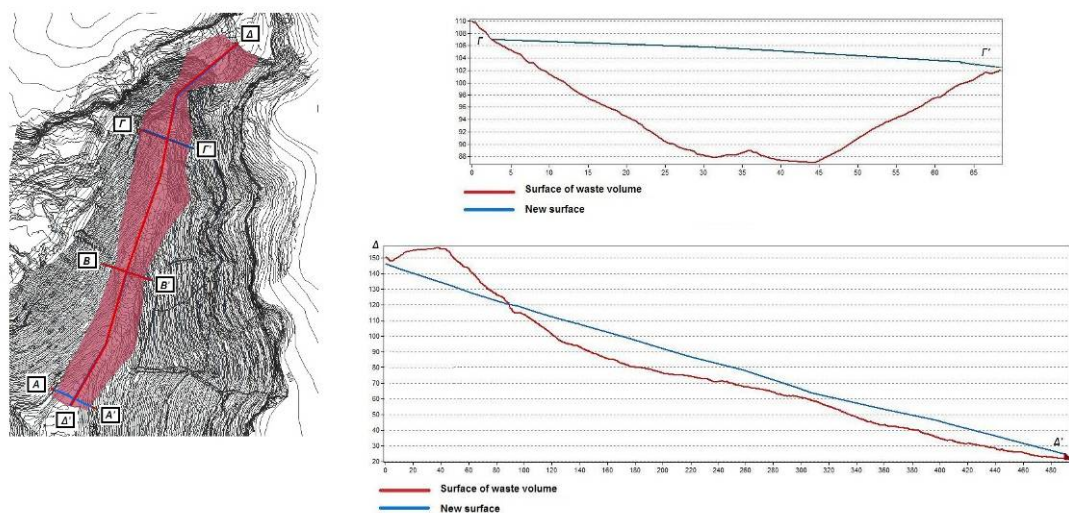
Figure 10 The suggested new surface profiles c –d
