# PRESERVATION OF VILLAGES CONSTRUCTED ON SLIDING AREAS – A CASE STUDY FROM KARDITSA PREFECTURE, GREECE

Loupasakis C.<sup>1</sup>, and Karfakis J.<sup>1</sup>

<sup>1</sup> Institute of Geology and Mineral Exploration, Engineering Geology Department, Messoghion,  
Avenue 70, 11527, Athens, Greece, cloupas@igme.gr, johnkarfakis@igme.gr

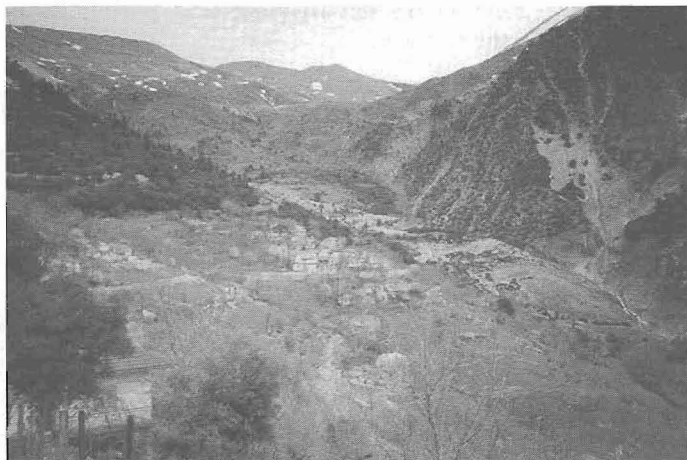
Petroxori village is constructed on the east slope of Karaves hill (south Pindos) on an altitude of 1100 m. The dip angles of the slopes at the proximity of the village are 40° to 50° (Fig. 1). Because of the intensive inclination of the slopes, the area occupied by the village was formed in terraces.

**Figure 1 - A panoramic view of the Petroxori village**

Figure 1 proves that those phenomena were well understood by the old residents of the village, because, despite their initial attempts (Fig. 6), they finally stopped constructing buildings along the zone occupied by the debris materials. In that picture is clearly presented that the majority of the houses were constructed on the north-eastern and the south-western parts of the village; occupied by the flysch formations and the limestones, respectively. On the contrary, the central section of the village was finally used for cultivation. However, the latest owners of the properties ignored the experience of the past and reconstructed houses on the unstable areas (Fig. 5).

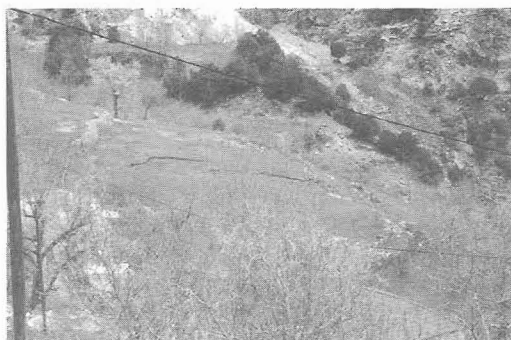
Based on their mechanism, those landslides can be characterized as rotational slides (Varnes 1978) (Fig. 2). They act independently, affecting the terraces, and although they all have the same preparatory causal factors, each one was activated independently.

**Figure 2 - Rotational slides affecting the terraces**

- Reconstruction of the retaining walls of the terraces by using gabions. Gabion walls are flexible and they can take over considerable deformations caused by foundation's settlement or by sliding movements without failing. Note that, the old dry stone retaining walls of the terraces deteriorate intensively when deserted. So, the majority of them require reconstruction.

- Tree planting of the terraces. The root strength mechanical effect combined with the gabion walls can reduce, or even more efface, the surface ruptures occurrence in the majority of the terraces.

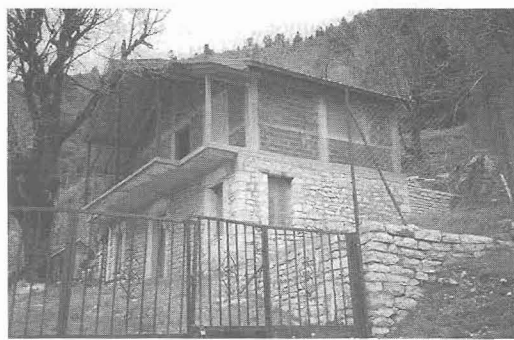
**Figure 3 – Reconstruction and extension of an old house**

According to the same reporting method (WP/WLI 1994), the triggering causal factors of those landslides are, regarding the physical processes, the prolonged high precipitation and, regarding the man made processes, the loading of slopes or their crests and the uncontrolled flow of the surface water through the village (natural irrigation and water leakage from services). The loading of the slope was succeeded by the construction and lately the reconstruction and the extension of buildings (Fig. 3) and the uncontrolled flow of the surface water through the village (Fig. 4) was caused by lack of drainage network.

- Prohibition of the extension of buildings. The construction of additional floors increases the loads of the slopes' crests and triggers the ruptures. Note that, at the moment, those phenomena are confined within the limits of the debris materials. But because of the poor mechanical characteristics of the flysch and the unfavourable dip direction of the limestones' bedding the construction of additional floors must be reconsider all over the village. Further more, the owners of the houses founded along the debris materials must be informed for the unstable conditions of the area in order to prevent them from reconstructing their houses. In those cases it is better to exchange their building sites with other sites, provided by the state, in one of the stable sections of the village.

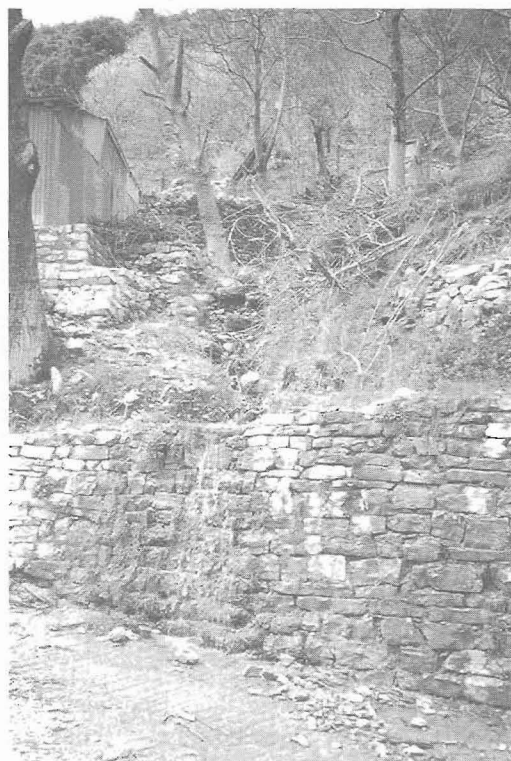
**Figure 4 - Uncontrolled flow of the surface water through the village**

- Construction of surface drains in order to divert water from flowing onto the sliding area (collecting ditches and pipes). Note that, because of the morphology the majority of the surface water precipitating within the limits of the village flows through the sliding area. So the construction of surface drains can reduce the effects of the main triggering causal factor, the prolonged high precipitation.

- Asphalt or concert paving of the roads. The drain network of the roads must be connected with the proposed surface drains extending all over the village. By means of that procedure the roads can work as horizontal barriers of the flowing water and they can help towards the wiser organising of the drain network.

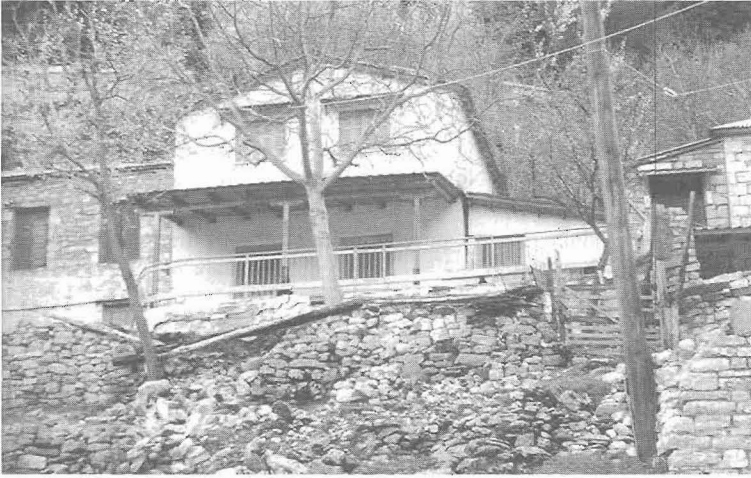
Each failure was triggered by a different combination of triggering causal factors. Except from the prolonged high precipitation that affected all the slopes, all the other factors acted in relation to the local conditions of each slope. For example, the slope presented in figure 5 failed during a year of prolonged high precipitation (2006) because of the increasing loading of its crest caused by the reconstruction and the extension of the house. On the contrary, the slope presented in figure 2, although it is completely unloaded, failed because of the excessive natural irrigation caused by the uncontrolled flow of surface water through the field.

**Figure 5 - A typical example of slope that failed during a year with prolonged high precipitation because of the increased loading of its crest. The landslide caused extended damages to the house**

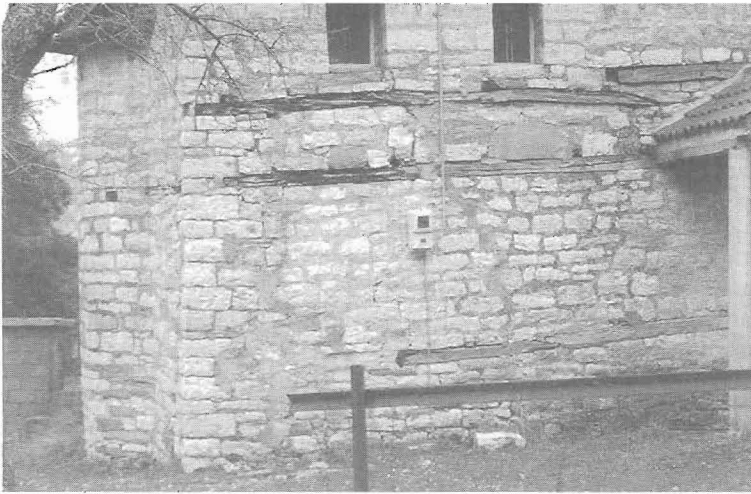
**Figure 6 – Old damages on the church of saint Paraskevy caused by surface ruptures. The church was founded on the debris materials**
