## EARTHQUAKE-INDUCED ROCKFALLS IN SANTOMERI VILLAGE, WESTERN GREECE

**Key words:** Earthquake-induced rock fall, rock fall analysis, Achaia, Western Greece

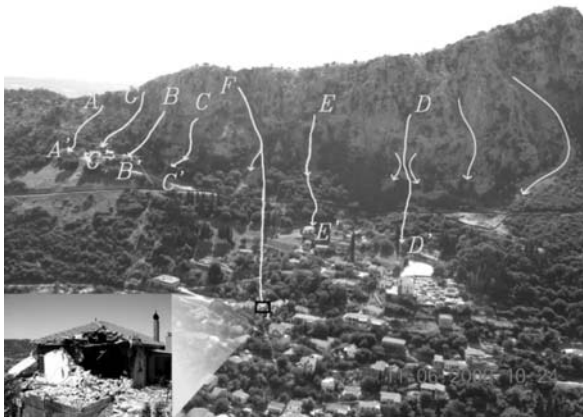
**Fig. 5:** Locations of the analysed Rockfall traverses. The location of a house destroyed by the rockfall is also shown.

Rock fall statistical analyses were performed in seven (7) traverses. The selection of the traverses was based on field observations concerning the traces of the major rockfall events and on the fallen rock recordings. Table 2 gives information about traverse length, average slope gradient and slope height. The location of each traverse correlated with the observed rockfall rock fall courses are also shown in Fig.5.
