## The Morphotectonic Units of Ikaria Island – Contribution in the Natural Hazards Research

### THE MORPHOTECTONIC UNITS OF IKARIA ISLAND – CONTRIBUTION IN THE NATURAL HAZARDS RESEARCH

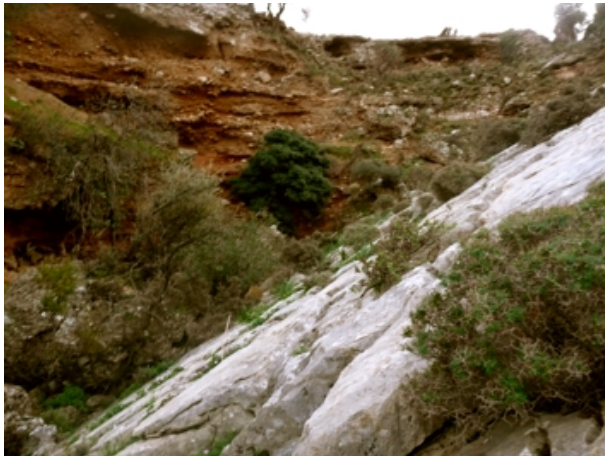
Figure 7. The upper detachment fault surface (30/105), which separates the Pliocene conglomerates from the marbles of the blue schist unit. As it seems the marble is jointed and strongly brecciated (cataclasite zone). Near coastal road, about 7 km from St. Kiri-kos to Fanari.

zone moved to the brittle, upper parts of the crust and today is juxtaposed with the lower of the two main extensional detachment faults (Fig. 2) of the island (Kumerics et al. 2005). The other one, is not connected with an underlying ductile shear zone and separates the blueschist unit from the Pliocene conglomerates. There are some places along the SE coastal zone of the island, where we can recognize the low-angle fault surface (Fig. 7), but there are, also, some others where the detachment accompanied by a cataclastic zone. The most of the smaller scale faults of the island are localized at the central part, and rarely at the area between St. Kirikos and Fanari, cutting the upper blue schist unit (see Fig. 2). The main fault direction is around E-W, but NE-SW and NW-SE (and rarely other) directions also occur. All these faults seem to be related with the lower detachment fault, representing the "upper plate" brittle extensional deformation, showing (according to Kumerics et al 2005) a top-to-the-NNE displacement of the hanging wall.

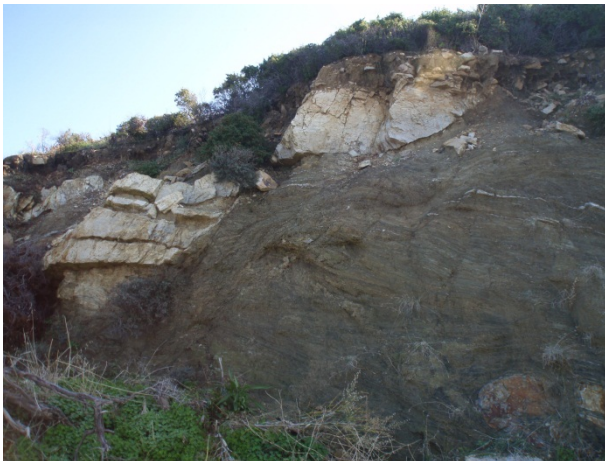
Figure 8. NNE dipping normal fault near Evdilos, cutting the blueschist unit.

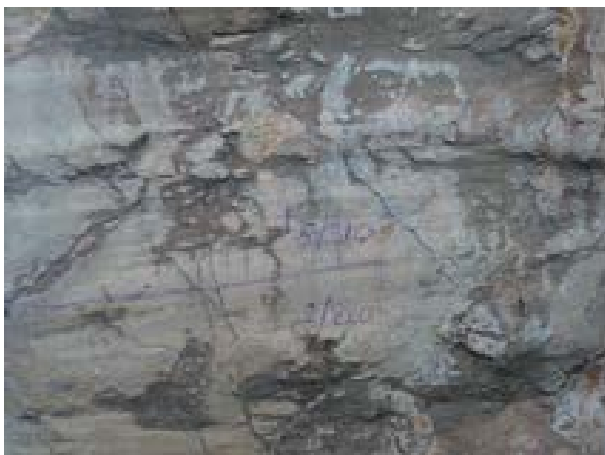
Figure 9. NE-SW dextral strike-slip fault at the SE coastal zone of the Island.

NE- or NW-striking strike-slip faults also occur in the island, like the one presenting in Fig. 9. These faults either represent transfer faults linking different segments of normal faults, connected with the Upper Miocene – Upper Pleistocene extensional tectonics, or must be related with the Quaternary transpressional regime, described, for the major area, by Lykousis et al 1995, from submarine data.

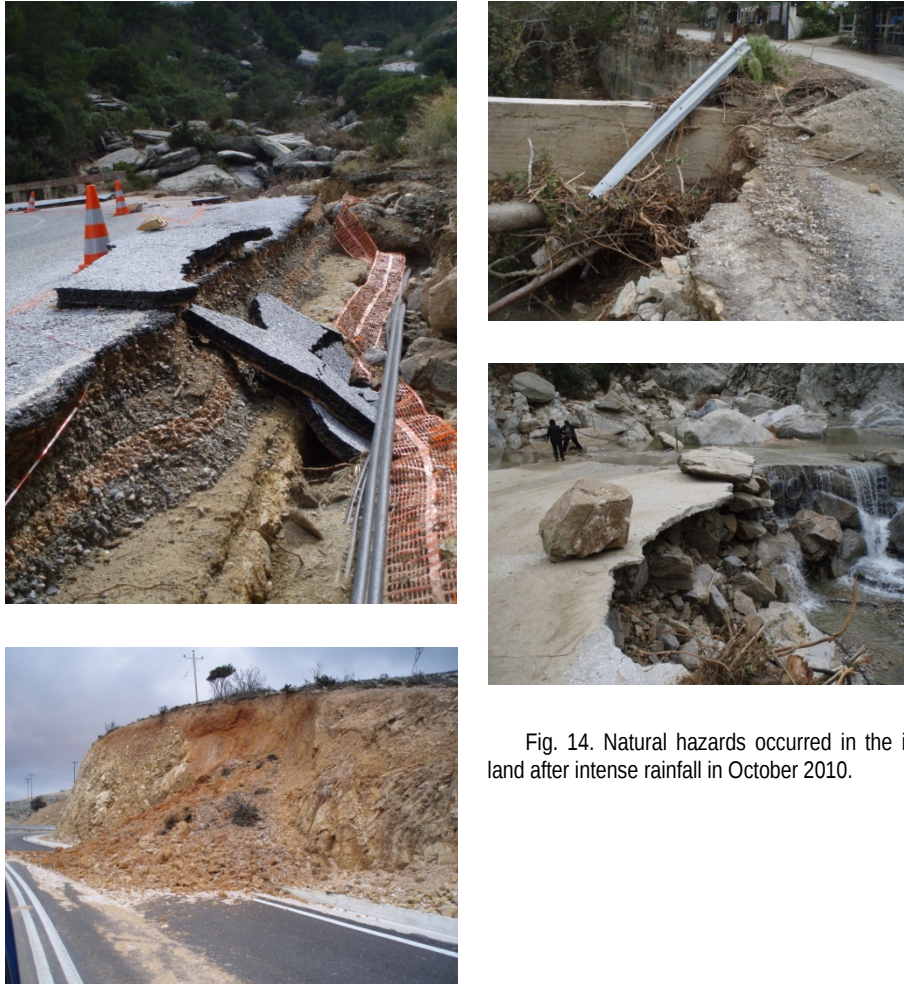
Fig. 14. Natural hazards occurred in the island after intense rainfall in October 2010.

Many natural hazards such as land slides, rockfalls, soil erosion, floods, relief changes and coastline changes occur in many sites of Ikaria island after intense rainfalls (Fig. 14). The catastrophic phenomena have as a result the downgrading of the human and natural environment. The impacts are more intent at the southern part, where the drainage basins slopes are

higher as well as the erosion rate. Drainage basins such as that of Halaris which is of an extent surface, while the downstream area is characterized by high slopes, the surface flow is enhanced and as a result the erosion rate is accelerated. Morphotectonic characteristics in combination with the human interventions control the occurrence, the location and the intensity of the natural hazards. The Natural hazards research may be systematized through the definition of the morphotectonic units. Modelling in addition with the human impact results, the
