PRELIMINARY RESULTS OF INVESTIGATIONS OF POSSIBLE GROUND DEFORMATION STRUCTURES IN THE EARLY CHRISTIAN BASILICA, ANCIENT LECHAION HARBOUR, CORINTH, GREECE

Abstract

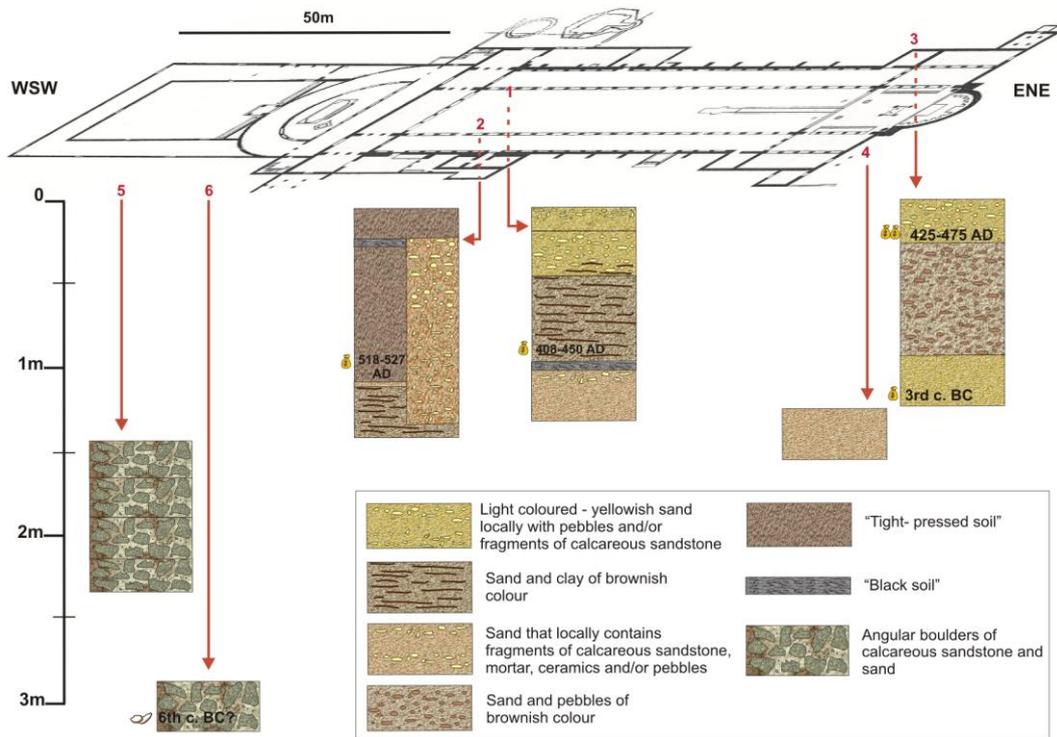
The subsurface lithostratigraphy of the Basilica presented in Figure 2, represents a synthesis of the stratigraphic data described by Pallas during original site excavations (1956 to 1965). Trial trenching (Pallas 1959, 1960, 1965) was carried out at various sites in the Basilica floor (trenches 1 and 2) and surrounding locations (3, 4, 5 and 6). The ground on which the temple was founded can be observed at ~ 1 m below the floor of the Basilica (trenches 1, 2, 3, 4). It is composed of sand that at locations (trench 2) contains clay intercalations and fragments of calcareous sandstone (trench 1), representing the preparation ground for the Basilica construction works (Pallas 1960, 1965). This foundation horizon, having a minimum thickness of ~ 0.5 m is dated to the 3rd century BC according to coins found on trial trench 3. The stratigraphy that overlies the foundation horizon represents the artificial fill used during the works of levelling the floor of the Basilica (Pallas 1960, 1965). This levelling horizon is composed of sand and pebbles as observed in trial trenches 1, 2 and 3. In trench 1 the upper parts include lithic fragments, while in trench 2 it contains fragments of ceramics and mortar. Contrasting dates from coins dating from 408-450 AD (trench 1) to 518-527 AD (trench 2) and 425-475 AD (trench 3) are also indicative of the artificial nature of this levelling horizon. Finally, a layer of angular calcareous sandstone boulders mixed with sand was recorded in trenches 5 and 6 located to the SW of the Basilica extending from 1.45m below the ground surface. It represents an artificial layer possibly related to early harbour installations (Pallas 1959). Although the continuation of this layer under the Basilica is unknown, its existence is indicative of artificial fills extending to a depth of 3m.

Summarising, the subsurface stratigraphy of the Basilica could be characterised as an artificial fill composed mainly of sand and pebbles with occasional intercalations of clay, lithic and ceramic fragments and mortar. This fill extends to a depth of at least 1.50m below the Basilica floor. As suggested by the existence of a layer of boulders at 3m depth located to the SW of the Basilica, the artificial nature of the subsurface stratigraphy possibly extends to a depth of 3m.

Figure 2 – Trial trenches stratigraphy within the Basilica (1, 2) and in surrounding locations (3, 4, 5 and 6) according to Pallas (1959, 1960 and 1965).

Correlation between the stratigraphy described by Pallas (1959, 1960, and 1965) and the geophysical survey provides a better understanding of the subsurface lithostratigraphy on which the Early Christian Basilica was founded. The foundation ground horizon of the construction according to the trial trenches is located approximately 1m below the Basilica floor and is composed mainly of sand with local intercalations of clay. This horizon relates well with the horizon identified at the western part of the central aisle GPR profile (profile 7) extending at ~1m depth. The conductivity contour maps appear to be in agreement with the stratigraphy described by Pallas (1965) in trial trenches 1 and 2 - that is sand with local clay intercalations.

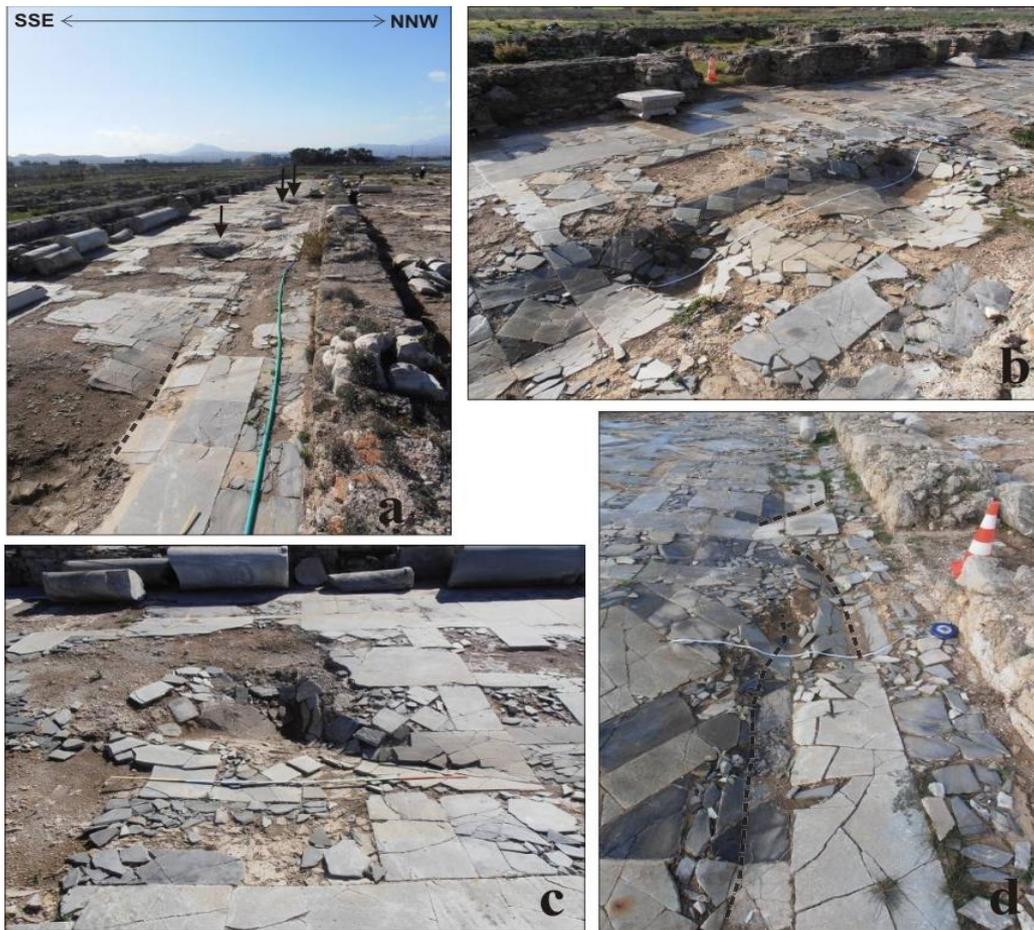
Recent restoration works carried out on the Early Christian Basilica brought to the surface the decorated floor of the temple. Numerous depressions were recorded in the southern aisle, of circular and linear geometry, concentrated mainly at the northern end of the aisle striking in a general E-W direction (Figure 3a), with dimensions varying from 0.45x0.33m and 0.12m depth to 1.80x1.33m and 0.4m depth for the circular depressions (Figure 3b) while the linear depressions (Figure 3d) have a variable depth ranging from 0.05 to 0.12m. It has to be noted that some of these linear structures are in contact with the depressions (Figure 3c). In the central aisle, where the floor is not preserved in a good condition, scattered linear and circular depressions were recorded along with linear and circular buckling structures. Their distribution does not suggest any general trend besides clustering recorded in the central part and near the limit with the southern aisle. The northern aisle remained covered with gravel and soil and was not possible to identify surface ground deformation structures.

Figure 3 – Depressions recorded on the southern aisle of the Early Christian Basilica.

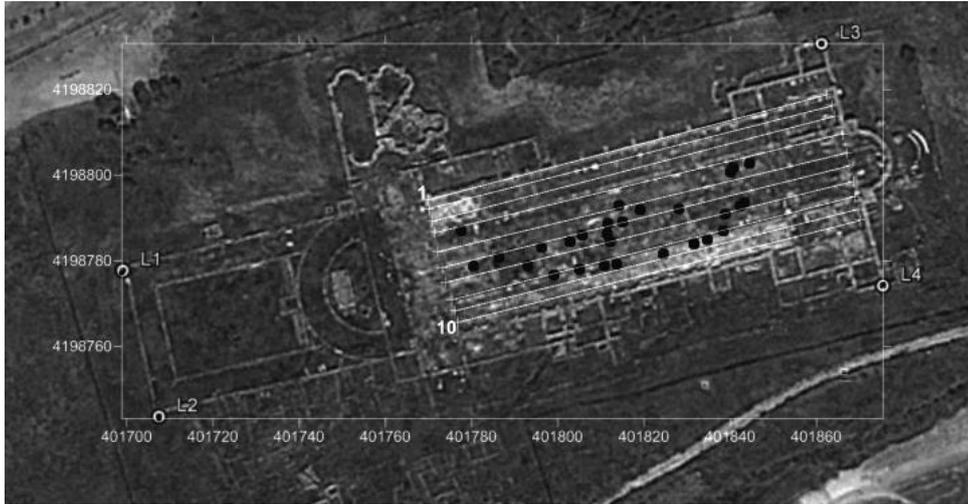
Since the study area is an archaeological site and special laws apply for its protection, a non-invasive approach with respect to the monument was applied (Wolf et al., 2006). After authorisation by the 25th Ephorate of Byzantine Antiquities in Corinth, a geophysical survey was carried out in the Basilica. GPR profiling along with electromagnetic measurements giving the apparent conductivity of the ground in two depths was performed in an attempt to examine the subsurface structure, its possible relation to the surface structures observed and to identify the triggering mechanism (Wolf et al., 2006, Maurya et al., 2006). All geophysical measurements were positioned with Differential GPS system (LEICA GPS 1200). The survey included 10 profiles of GPR using MALA system with shielded antenna 250MHz, and electromagnetic measurements using GF Instruments “CMD2” conductivity meter (compatible with Geonics EM-31) with two setups, “low” for 1.5m depth and “high” for 3.0m depth of detection, positioned by differential global positioning system (Figure 4). Both geophysical methods are affected by the conductivity of underground formations that is dependent upon the compaction, grain size, permeability and saline water intrusion of the sediments and have been used successfully in the past for imaging liquefaction features (Liu and Li., 2001, Al-Shukri et al., 2006, Maurya et al., 2006, Wolf et al., 2006).

Figure 4 – Location of profiles (lines) and major deformation structures (dots) based on Google Earth Imagery.

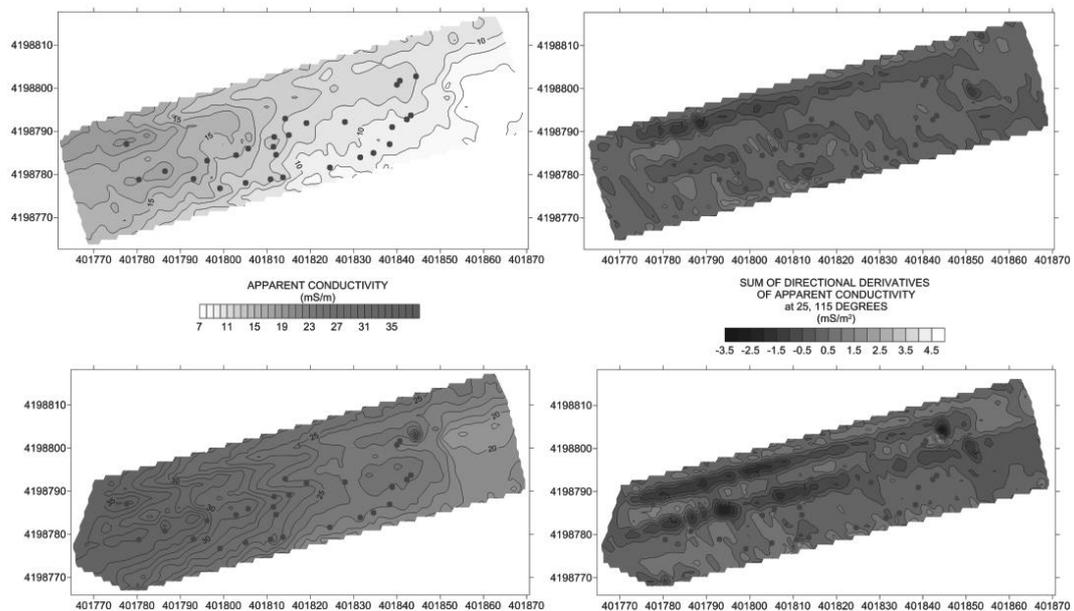
The cumulative apparent conductivity distribution to the two depth levels (1.5m and 3.0m) is presented in Figure 5. Generally the apparent conductivity is increasing gradually from east to west suggesting at the western part higher permeability and/or higher percentages of fine-grained deposits in comparison to the eastern part where lower permeability and/or higher percentages of coarse-grained deposits are expected.

Figure 5 – Left: Apparent conductivity distribution, Right: Sum of directional derivatives of apparent conductivity distribution, in two depth levels, (1.5m top maps and 3.0m bottom maps). Blue dots indicate major ground deformation structures.

Tight circular contours indicate areas of possible liquefaction vent locations (Wolf et al., 2006). These are better discernible on the 3m depth level but only a few correlate well with the surface deformation structures. The contours at the eastern part of the temple and more specifically under the sanctuary of the Basilica are indicative of a potential anthropogenic structure. In addition to the general apparent conductivity distribution, “linear” like and continuous disturbances of the contours are observed under the northern aisle and the northern part of the central aisle of the temple, striking in a direction parallel to the Basilica. In order to enhance the effect of this latter observation the directional derivatives of the apparent conductivity in two directions, 25° and 115°, parallel/vertical to the walls of Basilica was calculated, and the sum for the two depth levels was produced (Figure 5). It seems that two linear structures-zones exist under the northern aisle and the northern part of the central aisle of the temple, striking in a direction parallel to the Basilica. Both resistive structures are clearly documented on the 3m depth map and although the structure-zone under the northern aisle also appears in all of its length in the 1.5m depth map, the structure-zone under the central aisle appears fragmented in two parts. Since the northern aisle structure has been detected by both setups it is suggested that it is located near the surface, while the central aisle structure is possibly located at a depth under but near 1.5m.

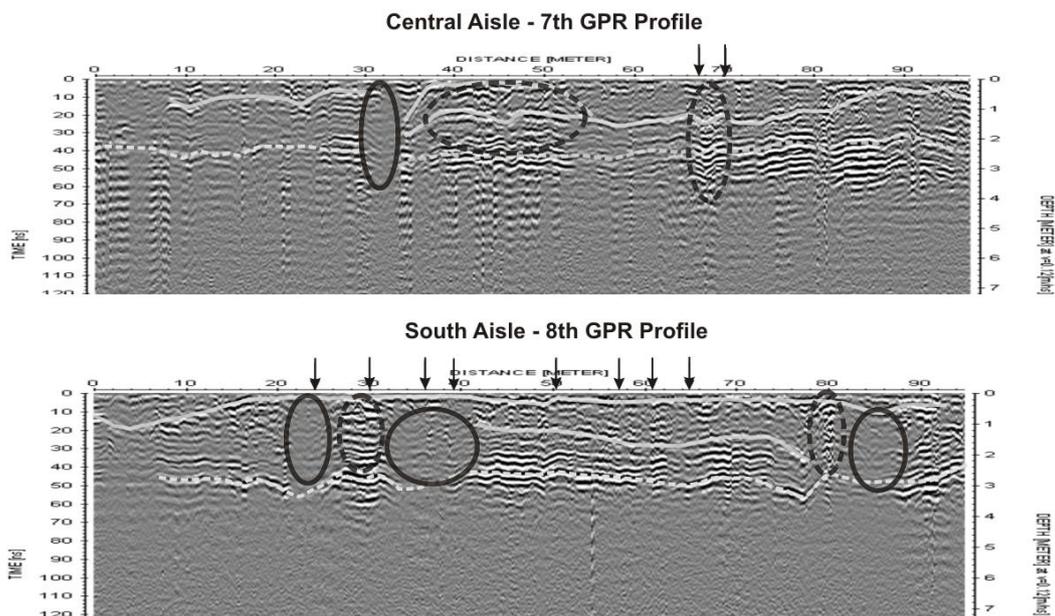
The GPR profiles provided the opportunity to investigate the lithology/stratigraphy, geometry and deformation of the Basilica sandy substratum to a depth of 6m (suggested velocity 0.12m/ns). The GPR processing steps were a) subtract mean, b) move start time (statics), c) manual gain, d) band-pass frequency filtering, e) background removal and f) deconvolution. In Figure 6, two indicative GPR profiles are presented with interpretation depicting interfaces between different formations (solid and dashed lines) or local features being related either to coarse material (dashed line circles) or fine material (solid line circles). Distinct surface depressions observed along the GPR profiles are indicated by arrows.

Figure 6 - GPR profiles with interpretation (interfaces with lines, local features with circles). The arrows show positions of observed depressions.

The stratigraphy presents a complex reflection profile with heterogeneities involving coarse grained laminated stratum that dominates the upper 3m of the profile and an underlying fine grained structureless stratum that could correspond to the saline water table (Figure 6). In the

upper 2m of the profile two interfaces have been recognised (solid lines) and another interface has been identified at approximately 3m depth representing a strong reflection signal horizon (dashed line). The profiles are considered to be in agreement with the conductivity contour maps indicating, coarser stratum at the eastern parts of the substratum up to a depth of 3m indicated by strong reflection signals that gradually fade westward.

The GPR profiles are indicative of substratum ground deformation that at locations could relate to liquefaction processes, (Maurya et al., 2006). The upper stratum presents convolutions especially in the upper horizons, indicative of plastic deformation. Sharp vertical discontinuities of weak signal have been identified across the coarse grained laminated stratum (host sediment), indicative of conductive areas permeable to saline water probably related to sand vents (solid line circles), Dimensions vary from 0.5m to 5m and extend clearly down to a depth of 3m suggesting liquefied sediment source below 3m depth. In addition, laminations of the coarse grained material dip towards the centre of these sharp vertical discontinuities exhibiting a concave up geometry. This concave up geometry is in conformity to surface depressions, indicative of the downward settlement of the sediments after release of pressure, (Takahama et al., 2000). For profile 8 in the south aisle and profile 7 for the central aisle the correlation of the surface depressions with the substratum discontinuities has been possible, indicative of their direct association. For the profiles of the north aisle correlation has not been possible since the floor remains artificially covered by gravel and soil and surface depressions have not been recorded.

The GPR profiles have provided indications that could support ground liquefaction and information on its characteristics (Maurya et al., 2006). The existence of numerous sharp vertical discontinuities in the upper 3m of the profiles with dimensions that range from 0.5m to 5m characterised by weak reflection signals are indicative of sand vents. This indication is further supported by the geometry observed in the lateral margins of the vents, where the host sediment presents laminations dipping towards the centre of the vents that in combination with concave-up geometry observed in the upper parts of the vents, is indicative of the sediment settlement (draw – in process) (Takahama et al., 2000). The sand vents and observed geometry have been successfully correlated with the surface linear and circular depressions. Since the sand vents discontinuities

appear to fade out below ~3m, a liquefaction sediment source below ~3m depth is suggested. Special care has to be taken for the two linear structures-zones under the northern aisle and the northern part of the central aisle of the temple, striking in a direction parallel to the Basilica that have been detected by electromagnetic measurements. These zones in depths between 1.0 - 2.5m consisted of coarse material have to be interpreted and be considered if they relate to the liquefaction phenomenon.
