ARHAEOLOGICAL EVIDENCE FOR SEISMIC ACTIVITY IN BUTRINTI (SW ALBANIA) AND NEOTECTONICS OF THE AREA.

S. PAVLIDES[1], S.KOCIU[2], P.MUKELLI[3], A. HYSENI[3], N. ZOUROS[1].

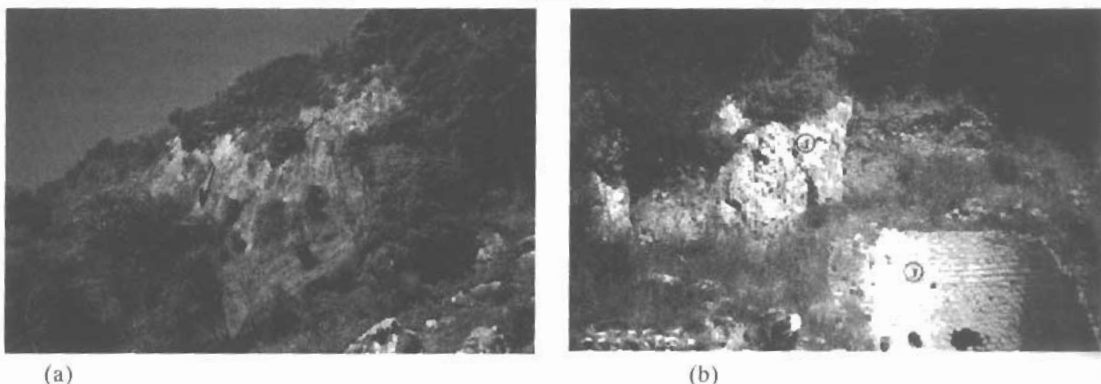
Fig. 4. Left (a) : ENE-WSW striking fault surfaces (contact between basement limestone and recent deposits)
inside the archaeological site, that is the eastward extension of the fault scarp of figure 6. Arrows indicate the
slip vector (striae direction of dip-slip to oblique-slip fault). Right (b) : The same fault surface some meters
eastward : 1, fault plane; 2, historical (post-Roman) scree; 3, ruins of a Roman building.

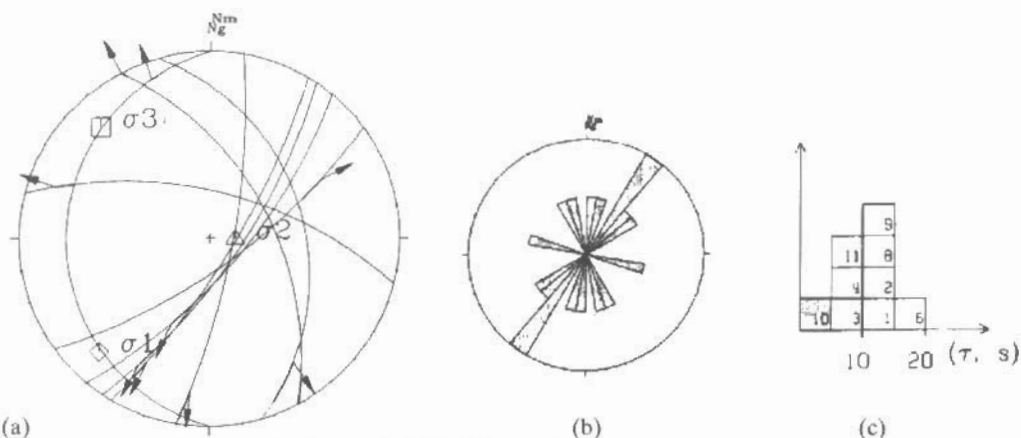
Representative striated faults (as curves with arrows) of the broader Butrinti region are shown on figure 5. In our analysis the "the best mean tensor" (Carey & Brunier 1974) and "conditioned square minima" (Caputo & Caputo 1988) methods have been applied. They give the three principal axes of the stress (or strain) field, as well as some index with the mean standard deviation or angular deviations, which indicate the reliability of the results. The few analysed measurements from the Butrint E-W to ENE-WSW striking normal fault inside the archaeological site indicate a NNW-SSE trending horizontal σ_3 (minimum) stress axis (local extensional re-gime), while the representative data from the broader area (regional stress regime) show typical strike-slip domain, where: σ_1 : Az 224^0 / Dip 100^0; σ_2 : Az 92^0 / Dip 75^0; σ_3 : Az 316^0 / Dip 11^0 .

Fig. 5. Stress analysis on the Butrint main NNE-SSW trending right-lateral fault. a) stereographic projection (lower hemisphere) of the measured striated fault planes (as curves) and slip-vectors (striae) as arrows; b) rose diagram of the measured faults. c) histogram of the measured striation.

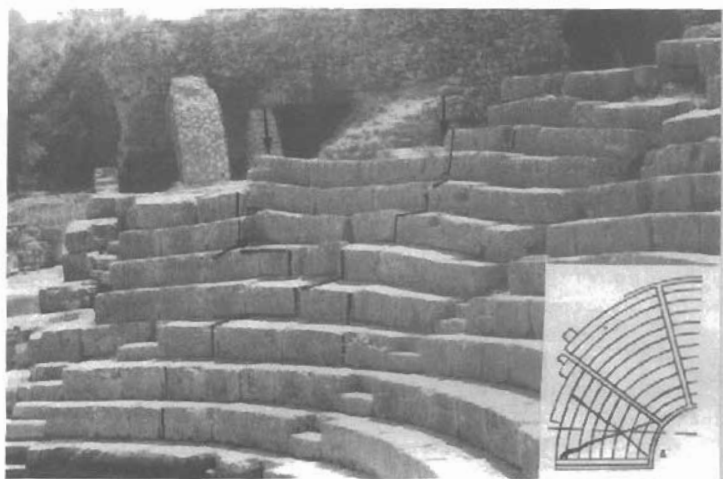
The main issue addressed in this study was the cause of destractive event which affected Roman building firstly and Byzantine secondly. In most of the Roman buildings there are observable fissures of possible earthquake origin. These are : Diagonal shear fissures (joints), opening cracks, inclination of wall blocks, displacements of foundation stones (offsets). The most characteristic are those of the theater (fig. 6) and the foundation offset of the eastern wall. The terraced seating (auditorium) and the area around the theatre is a typical example of earthquake damage. Terraced seating and the avenue aged to the 3[rd] century BC, while the stage is of the 2[nd] century BC. Shear diagonal fissures have been found on the terraced seating on both sides and on their support walls. Photograph of the figure 7 and the corresponding diagram is from the western side of the theater, while such joints passing through two or more adjacent blocks (troughgoing joints) and in infrastructure lying on the ground mainly as an old Greek theater is, could be formed only under high strain. Such joints require energy released from an earthquake event than to be related to weathering process or simply compaction. Numerous other examples of dislocated stones (joints) were observed. Some are also clearly visible on the Tower Gate (2[nd] century BC) and Lake Gate (4[th] century BC) (fig. 7). Within the walls shear diagonal fissures are orientated N60° E. Most of these monuments were built before the 4[th] century AD. Fissures have found also in two dwelling houses, close to the Amphitheater, Nympheum of 1[st]-2[nd] century AD, not so clear in Roman Baths, 4[th] to 2[nd] century BC, and in a Roman house of the 1[st] to 2[nd] century AD. On the later some vertical open cracks on the walls are probably due to seismic vibration or seismic fault activation.

Fig. 6. Photograph of the 3rd century BC terraced seating (auditorium) of Butrinti Theatre. Deformed construction and especially open fissures are shown by arrows at the western side of the auditorium. Right down corner: the sketch of the diagonal shear cracks.

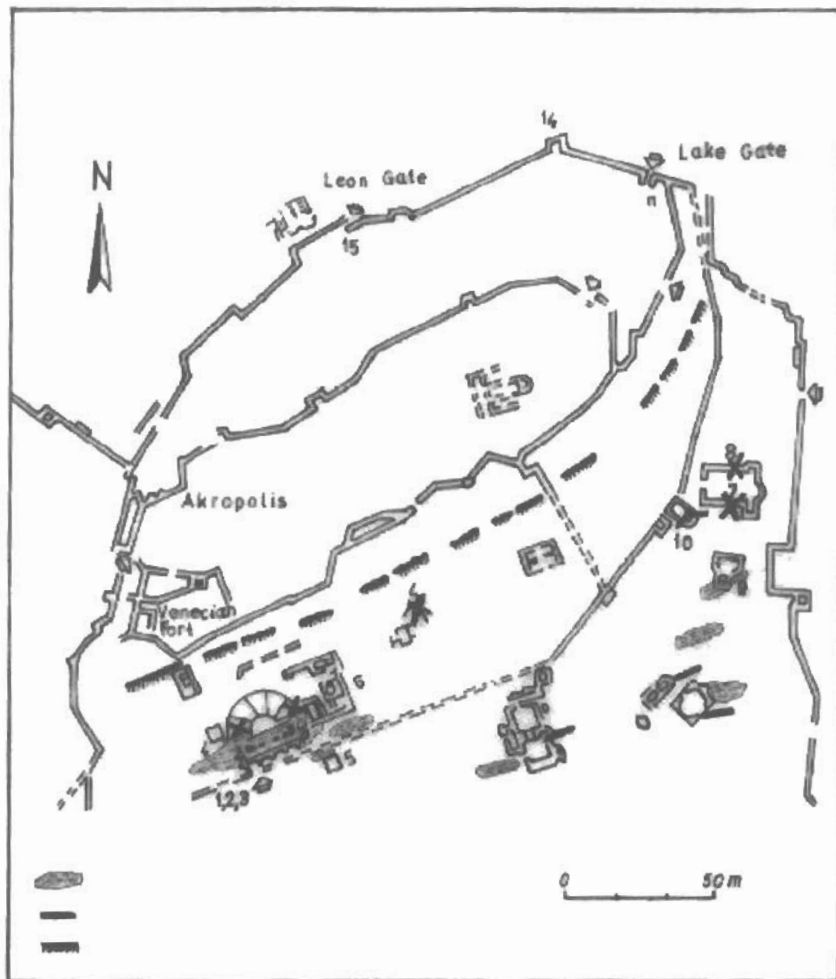
Mapping observed earthquake damage in the city (fig. 8) highlighted two sets of fissure orientations. The older set, trending NE-SW, occurs throughout the site and is concentrated on the NE and SW sides of the monuments. These are generally diagonal shear fissures (striking 60^0 N) and, occasionally, open cracks. The majority of the monuments displaying this type of damage were built before 4th century AD, for example the terraced seating of the theatre (3rd century BC), Tower Gate (2nd century BC) and the Lion Gate (2nd century BC). Therefore, this dama around the wall, that is the Hellenistic-Roman area, and remained un-repaired until they were excavated by archaeologists (second quarter

of 20th century). In conclusion this evidence infers that all these observed phenomena in the Butrinti artchaeological site are probably the result of fault activity, either co-seismic or sympathetic. They probably relate to the little known 358 AD earthquake.

A second set, comprising only shear diagonal fissures, strike $0°$ N, and occur on the N and S walls of the younger Christian basilica (5^{th}-11^{th} century AD) (Hasani, Xh. 1990), which was built in the 5^{th} to 6^{th} century AD and reconstructed twice, in the 9^{th} and 13^{th} century AD. Therefore, this damage is only in the eastern northeastern part of the town where the Byzantine monuments extent. These can probably be related to a possible seismic destruction of the 1153 earthquake, a poorly documented event, as it is also referred in the Albanian earthquake catalogues (Sulstarova 1975; Muco 1996).

Fig. 8. *Map of earthquake damages observed inside the archaeological site. Numbers indicate the places of observed "seismic" fractures and shadow areas covered by water (under see level). 1,2,3, Amphitheater (3rd-2nd c. BC) and surrounding Hellenistic (?) and Roman walls. 4, Small Temple of Esculap (Aesculapius). 5, Roman house. 6, Greek house foundation. 7,8, Palaeochristian Basilica (Cathedral). 9, Nympheum. 10, Tower Gate. 11, Lake Gate. 12, Foundation. 13, Church. 14, Wall. 15, Leon Gate.*
