## CONDITION OF THE SEA WALL AT FARM COVE, AUSTRALIA

D. DRAGOVICH<sup>1</sup>

The history and present condition of the sandstone sea wall at Farm Cove, are described. The wall has cultural and historical significance and forms the seaward margin of land reclaimed for the Royal Botanic Gardens over the period from 1849 to 1879. The landward fill reaches to high tide mark and the wall extends about a further metre above this level. Both stones and mortar are subject to very active salt weathering. Maintenance has involved block replacement, repointing, cementing over numerous lower course blocks, use of epoxy cement, and infilling of weathered surfaces. Pitting/hollowing is most frequent in the top course of stones. Past unsympathetic repairs include use of a weatherable reddish sandstone, and sawn blocks of durable pale sandstone.

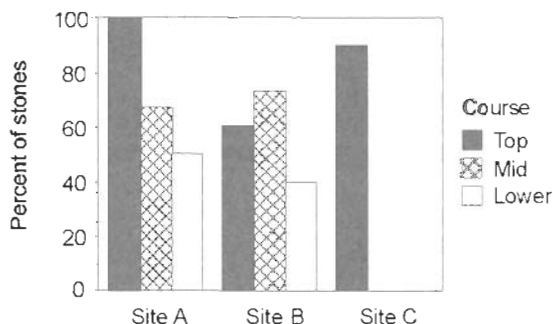
Many stones are insufficiently weathered to warrant replacement or cement-coating but do show pitting or hollowing (Figure 2). Pitting/hollowing was most evident at Site A, where all stones in the top course were affected and six stones in the middle course (Figure 3). Five of the cement-covered blocks in the lower course showed fretting/pitting. At Site B, eight of the middle course stones were pitted/hollowed, along with others in the top and lower courses. Nine of the ten stones in the top course at Site C had pitting/hollowing. The lower course at Site C was artificially pitted with tool marks from stone working but a number of these marks seemed to show enlargement from weathering. In total, pitting/hollowing was most evident in the top course of stones (Figure 3) with more than 80% of stones affected.

**Fig.3. Percentage of stones with pitting/hollowing in the top, middle and lower courses at Sites A, B and C at Farm Cove.**
