ROCK SLOPE STABILITY PROBLEMS IN NATURAL SIGHTSEEING AREAS - AN EXAMPLE FROM ARVANITIA, NAFPLIO, GREECE

Loupasakis C.¹, Galanakis D.² and Rozos D.³

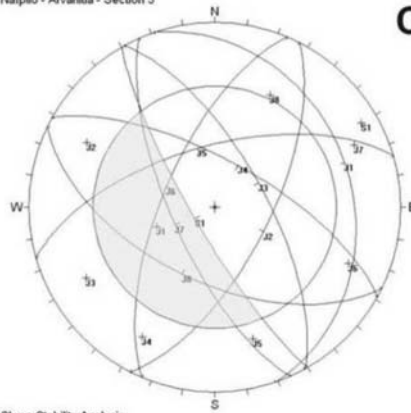
Nafplio - Arvanitia - Section 3

Slope Stability Analysis

Fig 4. Photos presenting the condition of the rock mass in the before mentioned parts A, B and C of the walkway. Pictures A', B' and C' present focus on main wedges in the corresponding slopes.

and C are constructed attached to the base of the slopes without leaving any space for the installation of any protection measure. Those sections appear serious stability problems, due to the rock mass fracturing, and the disturbance caused by the excavation procedure.

The proposed measures are unavoidable going to cause an aesthetic destruction to the site. The installation of netting along the entire slope faces of sections A, B and C is going to cover the natural wildness of the rockmass but also to abolish the numerous birds nesting along the slopes.
