GEOTECHNICAL INVESTIGATION OF THE ROCK SLOPE STABILITY PROBLEMS OCCURRED AT THE FOUNDATIONS OF THE COASTAL BYZANTINE WALL OF KAVALA CITY, GREECE

Key words: *Rock slope stability, rock wedges, Panagia coastal Byzantine wall, Kavala*

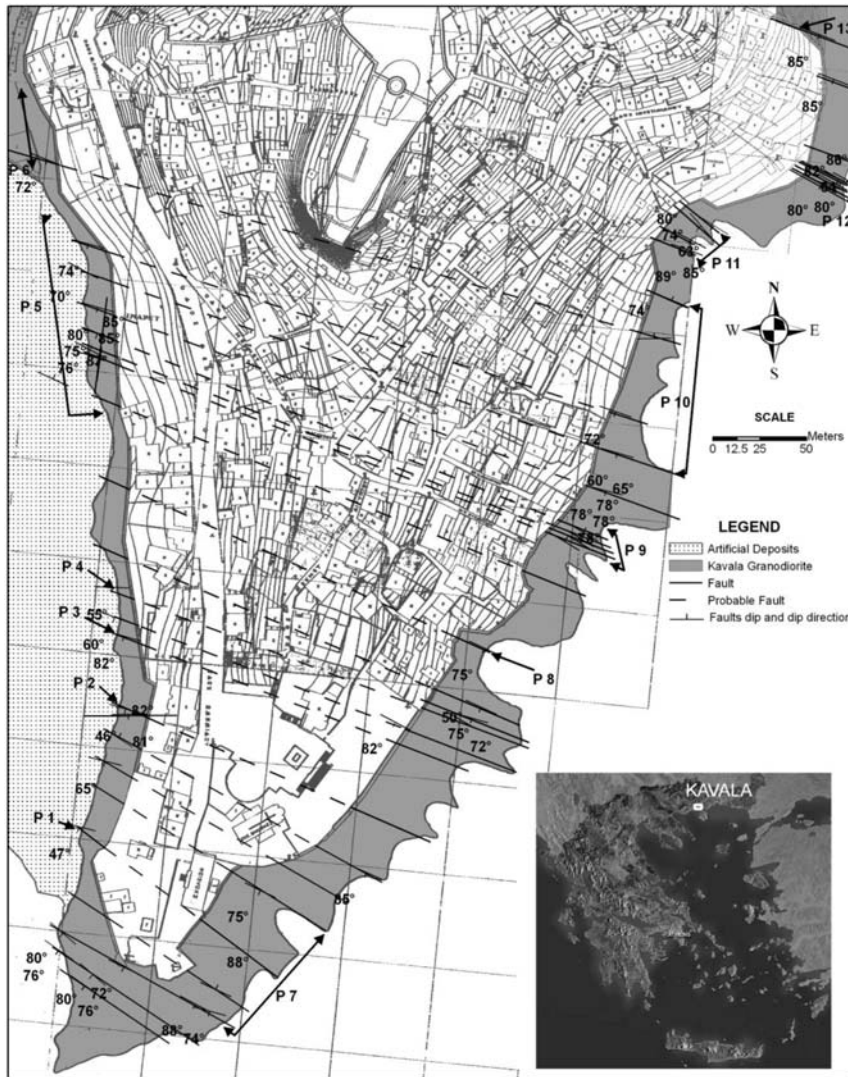
Fig. 1: Geological map of the peninsula presenting the location of the numerous normal faults recorded along the slopes. The gulfs excavated, by the wave erosion, along the faults' zones are clearly presented. The locations indicated by the P1 to P13 signs refer to parts where slope stability problems occur.

The main systems of faults of the Rodopic mass have SW – NE and NW – SE direction. Panagia peninsula is intersected by numerous parallel normal faults (Fig. 1), forming extended zones of intensively fractured rock mass. The sub-horizontal shearing, the dense systems of joints and the perpendicular faults intersect the rock mass forming numerous wedges along the slopes of the peninsula.

Along the slopes were located thirteen (13) parts with serious stability problems, able to effect the Byzantine wall (Fig. 1 Parts P1 to P13). These problems are a) wedge or plain failures (Varnes, 1978; Koukis & Sabatakakis, 2007), especially along the W-SW slopes and the fault zones, b) toppling failures (Goodman & Bray, 1976), along the SE slopes and c) extensive underexcavation problems, especially along the unprotected by the pier SE slopes. Further more, random rockfalls were recorded all around the peninsula, even along the stable parts of the slopes, because of the rock blocks sited along the slopes. Those blocks were formed by the joints intersecting the rock mass and they were displaced by the marine erosion and/or by the human activities.
