LANDSLIDE IN NACHTERSTEDT OF GERMANY

On July 18, 2009, an important landslide occurred in Nachterstedt City toward to the artificial Concordia Lake, which was created, in 1994, at the place of an old coal mine, at the edge of the city. The area is located to North-East of Harz, between the cities of Aschersleben and Quedlingburg. An underground coal mine is responsible for this damage which caused the damage of a privet house and a big building. Three people were also died. The mine apparently closed in 1991 whereupon it was converted into a recreation area. The landslide was caused by the increase of the groundwater level, in the coal mine, after a heavy rain, in relation to the water level of the lake.

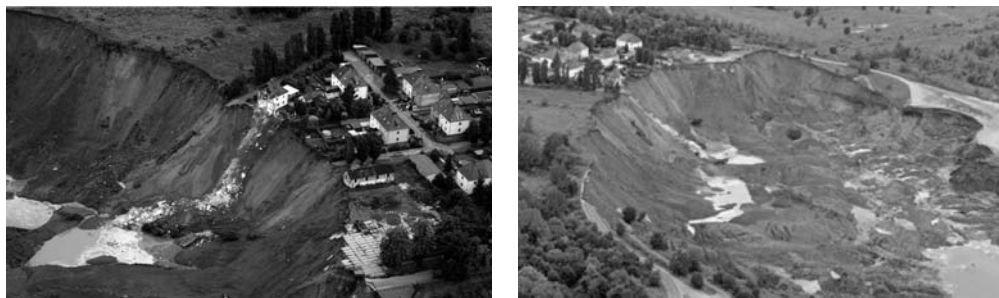
Fig. 1: The landslide of July 19, 2009, in Nachterstedt (Petley, 2009, <http://daveslandslideblog.blogspot.com/>).

On July, 18, 2009, an important landslide created at coastal part of Nachterstedt City toward to Concordia Lake. Three people were died and a privet two-floor house was destroyed together with a big building (Fig.1). The sliding was related to existence of a coal mine under the city. On Feb. 2, 1959, a similar landslide, of 5.8 million m³, had also activated by the coal mine works. One min worker died and many reactions were activated, in the East Germany of that period, regarding to the coal mine exploitation method used.
